## MEMORANDUM

### **COIT TOWER WATER INCIDENT**

Re: SFAC Coit Tower Monitoring CS20080

This memo serves as a report for mural inspection and moisture monitoring performed at Coit Tower from September 29<sup>th</sup> to October 15<sup>th</sup>, 2020. ARG/CS was contacted by the San Francisco Arts Commission to monitor the tower frescoes after a water leak was reported on *[date]*. The cause of the failure was related to the water storage tanks housed on the fifth floor of the building. These tanks were inspected by divers who could not determine a source of the leak from the interior of the tank. The exact cause and location of the leak remains unknown.

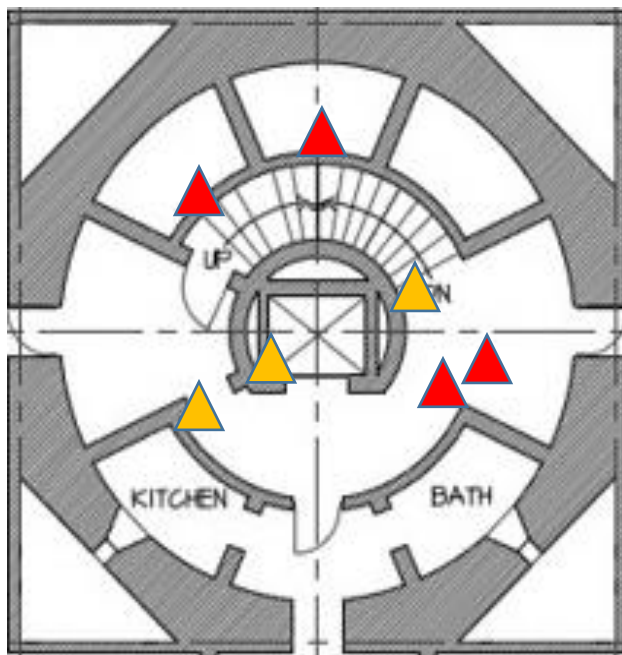
Water damage was visible in the middle of the mural on the south side of the stairwell. Moisture content at the bottom of the stairs that go from the first to the second floor had a range of 64.2% - 100%.

murals. Triangles show moisture content. Orange:25% - 50%= RISK. Red: > 50%= WET.

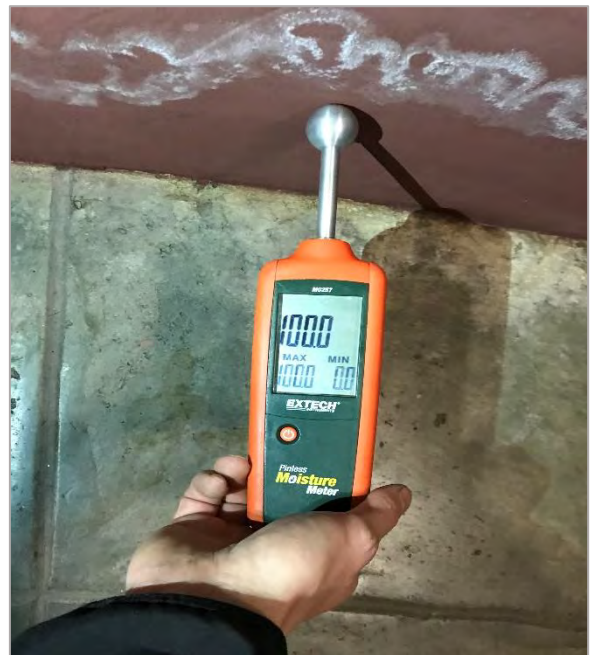
Figure 2: Detail of a reading taken at the bottom of the stairs on the Powell Street mural.

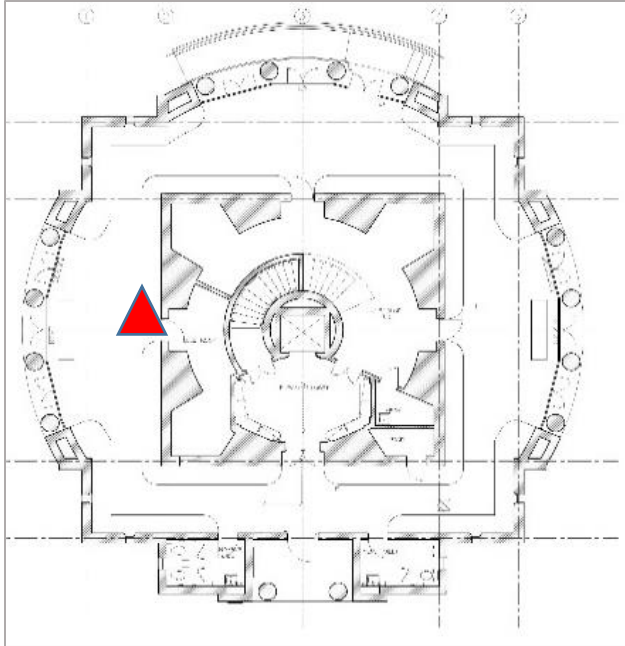
Only the *California* mural on the east side of the tower had signs of water damage from the incident. The moisture reading was 100% content at the top of the mural.

Figure 3: Moisture reading on the first-floor mural. Red triangle: > 50%= WET.

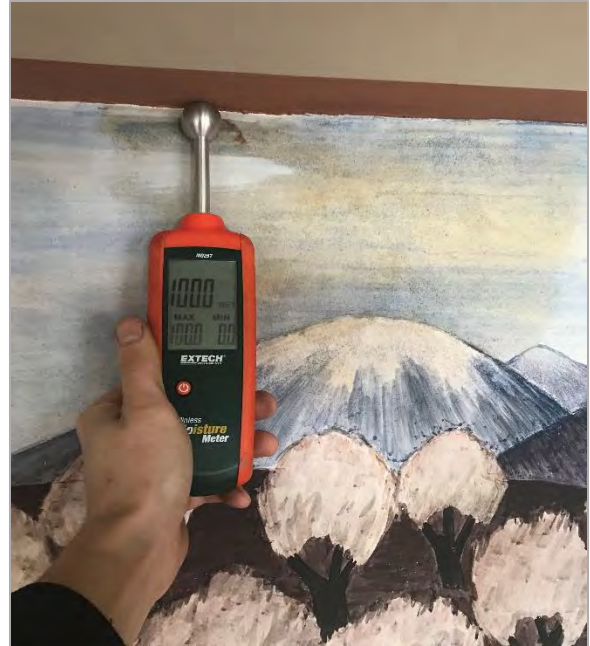
Figure 4: Detail of a reading taken at above the door frame at the California mural. Image shows 100% water content on the wall.

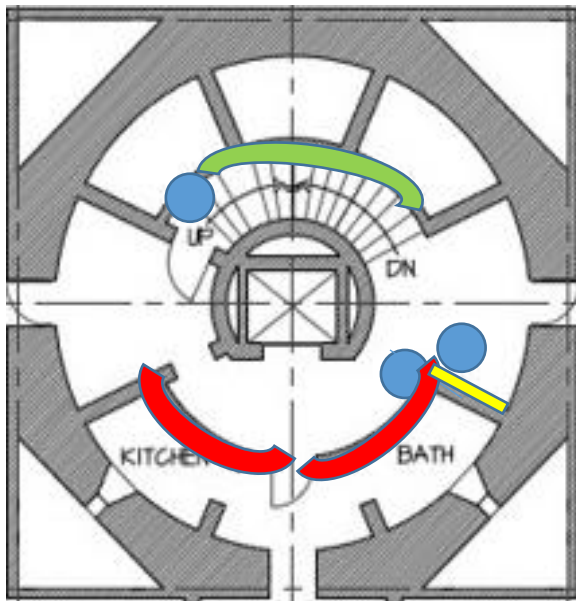
Salt efflorescence was observed on the *Sports and Outdoor Life* murals. The area most affected by efflorescence was detected at the bottom of the stairs on Powell Street mural.

Figure 5: Blue point show location of areas with efflorescence. Green line: *Powell Street* mural. Yellow line: *Sports* mural. Red line: *Outdoor Life* mural.

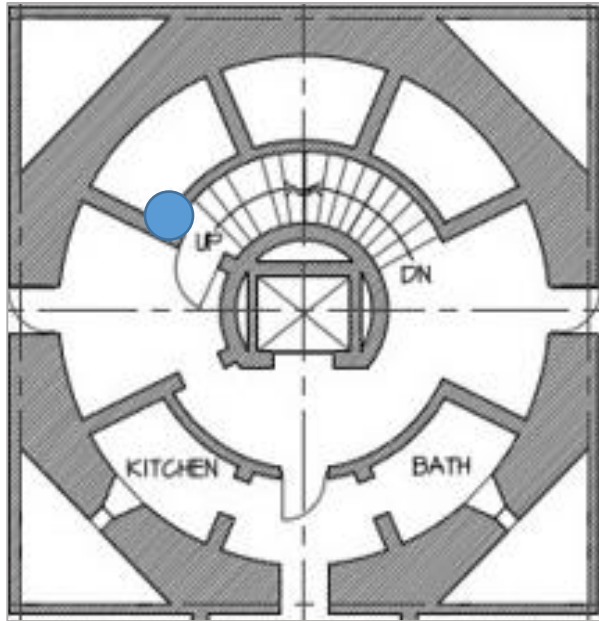
Figure 6: Blue dot shows florescence observed at the bottom of the stairs on the *Powell Street* mural.

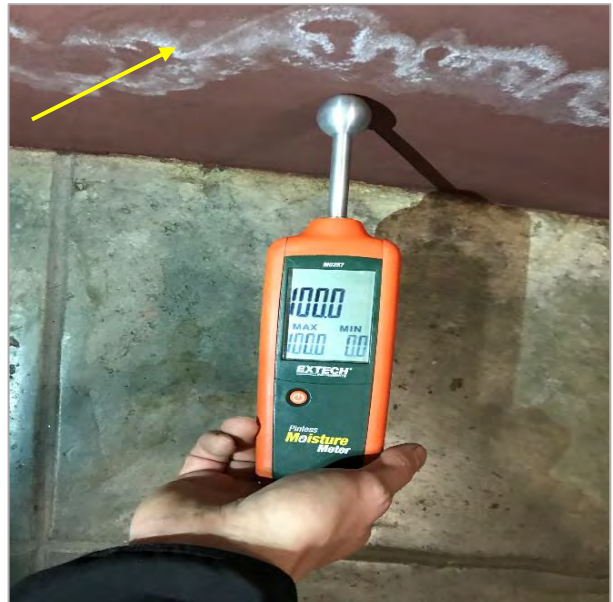
Figure 7: Yellow arrow shows heavy efflorescence on the stucco frame around the *Powell Street* mural.

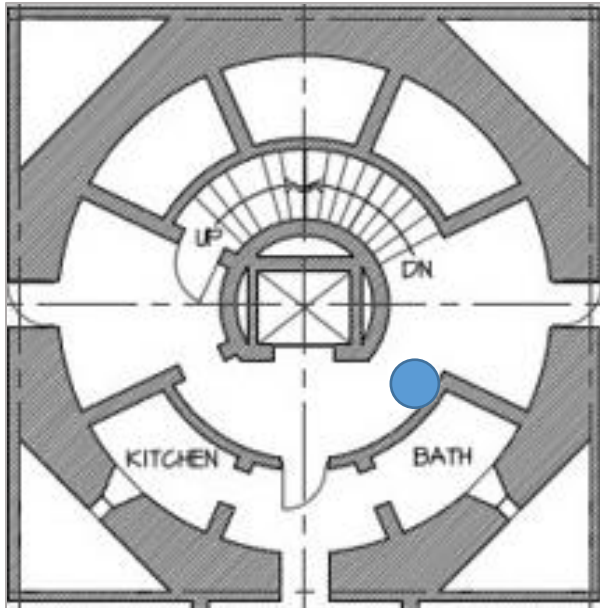
Figure 10: Blue dot shows florescence observed at the bottom of the stairs on the *Outdoor Life* mural.

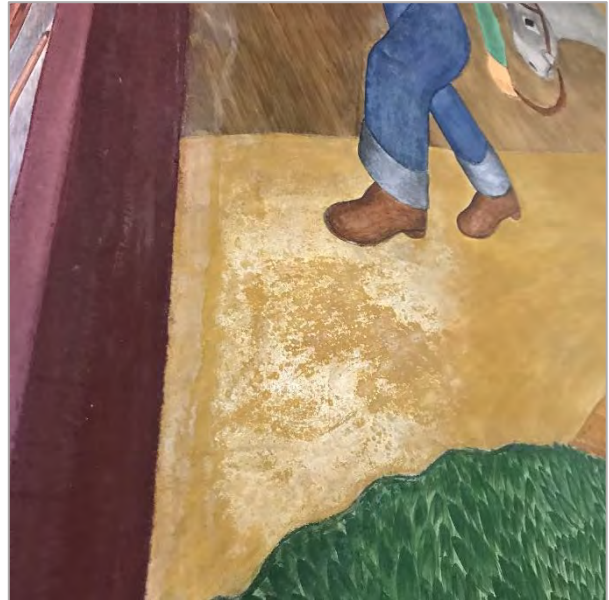
Figure 11: Detail of efflorescence on the *Outdoor Life* mural.

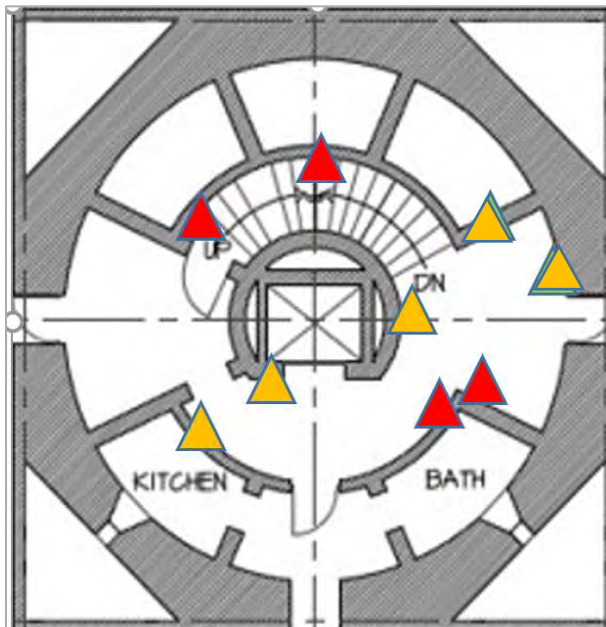
Figure 14: Moisture readings at the stairs and second floor murals. Although readings showed the walls drying out, the overall ranges stayed the same. Triangles show moisture content. Green: < 25% = DRY. Orange: 25% - 50% = RISK. Red: > 50% = WET.

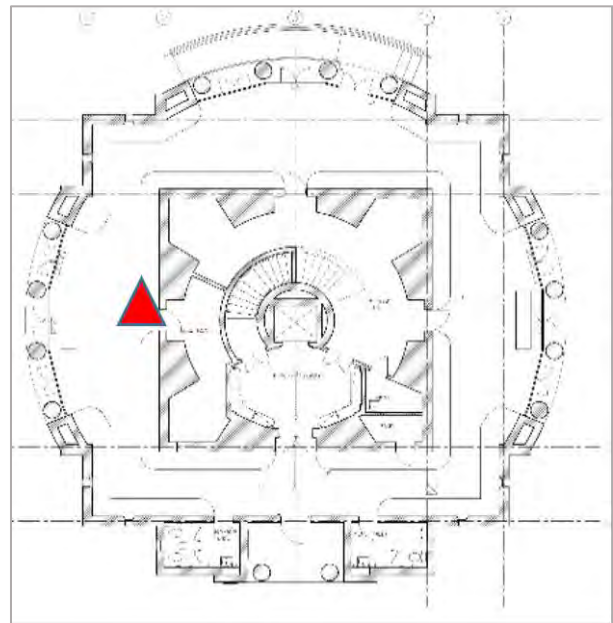
The *California* mural had a moisture reading of 87.4% content, which decreased from 100%.

Figure 15: Moisture reading on the first-floor mural. Red triangle: > 50% = WET.

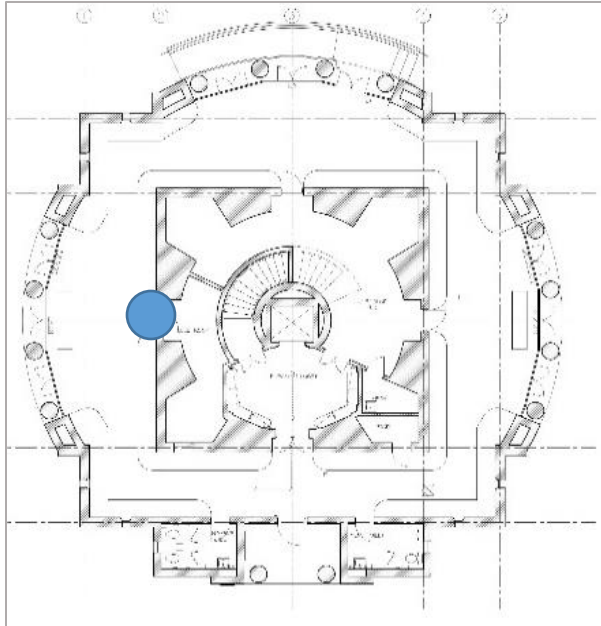
Although the *California* mural was affected by the water leak, no efflorescence was observed. The only changes corresponded to darkening/yellowing on the surface.

Figure 16: Location of the water damage on the *California* Mural at the first floor.

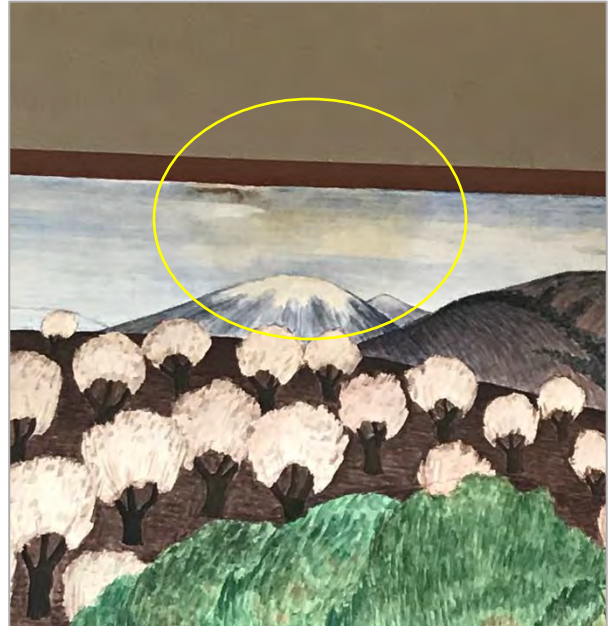
Figure 17: Detail of surface yellowing caused by water leak at the *California* mural.

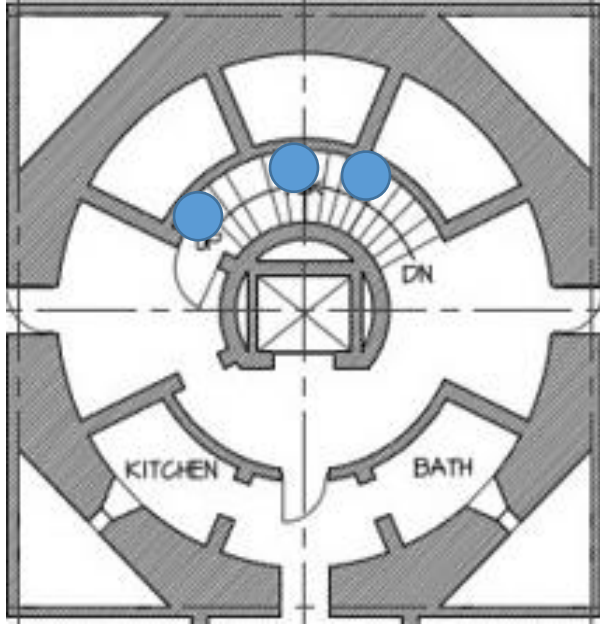
Besides efflorescence, conservators noticed dripping white stains on the frescoes. Some of them appear to be residues coming from the wall, while other appear as a shiny film covering localized areas. Some of these glossy spots seems to coincide with areas with previous conservation treatments. Moisture content probably modified/disturbed the characteristics of the applied materials.

Figure 18: Blue dots shows efflorescence and other damages observed on the *Powell Street* mural located on the stairs from the first to the second floor.

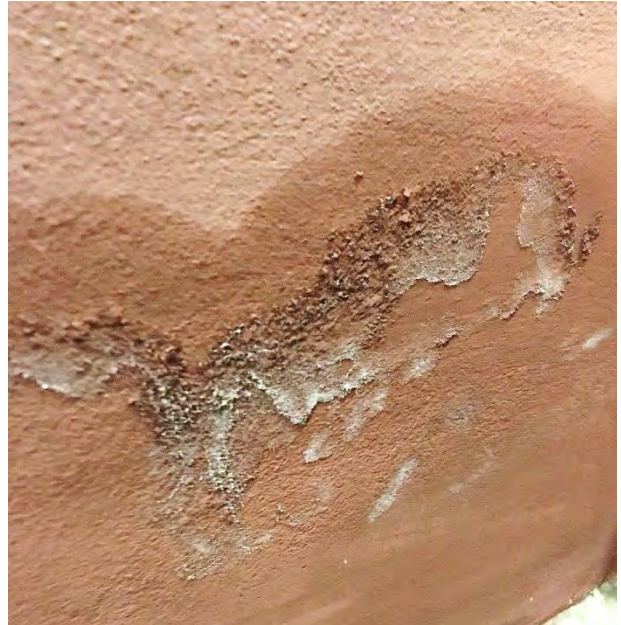
Figure 19: Detail of growing efflorescence at the bottom of the *Powell Street* mural's stucco frame. Notice wall still looks wet.

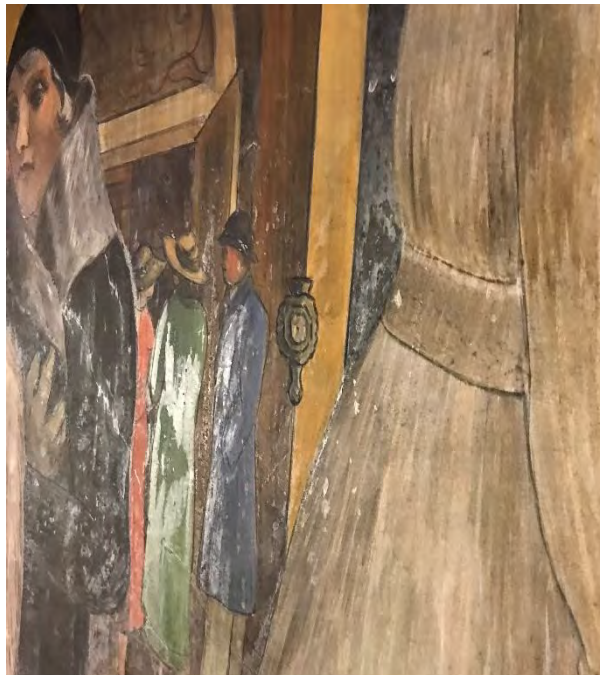
Figure 20: Detail of glossy film observed on some areas of the mural.

- It may be necessary to remove the failed coatings that became saturated and show signs of failure (glossy and white areas). This will require testing since it may be necessary to treat an entire mural to avoid differences in surface texture and sheen.

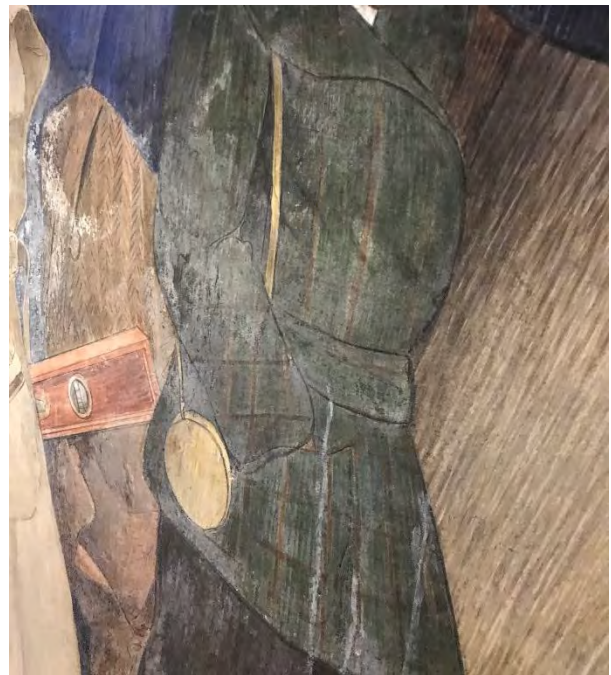
Figure 21: Detail of glossy film and white drips on a different area of the *Powell Street* mural.

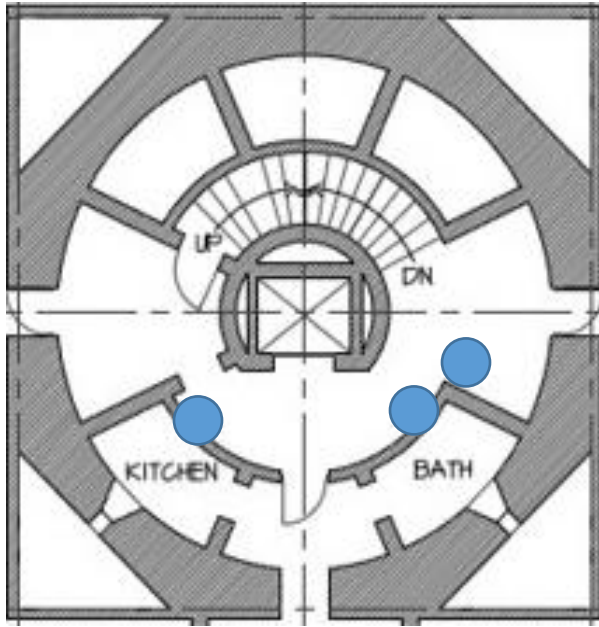
Figure 22: Blue dots shows florescence and other damages observed on the *Sports and Outdoor Life* murals located on the second floor.

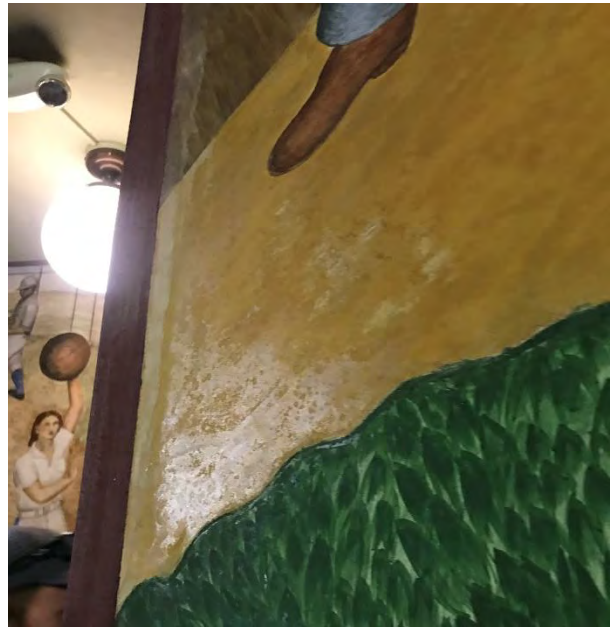
Figure 23: Detail of glossy film and efflorescence on the *Outdoor Life* mural.

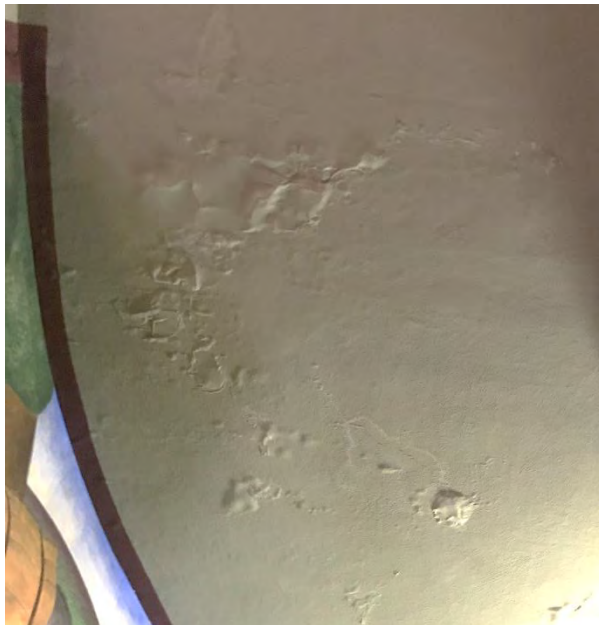
Figure 24: Detail of water damage on the second-floor ceiling.

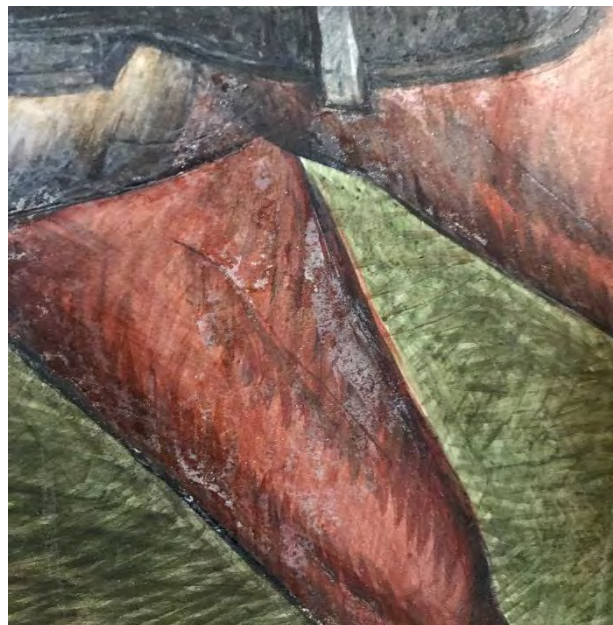
Figure 25: Detail of glossy film and efflorescence on the *Sports* mural.

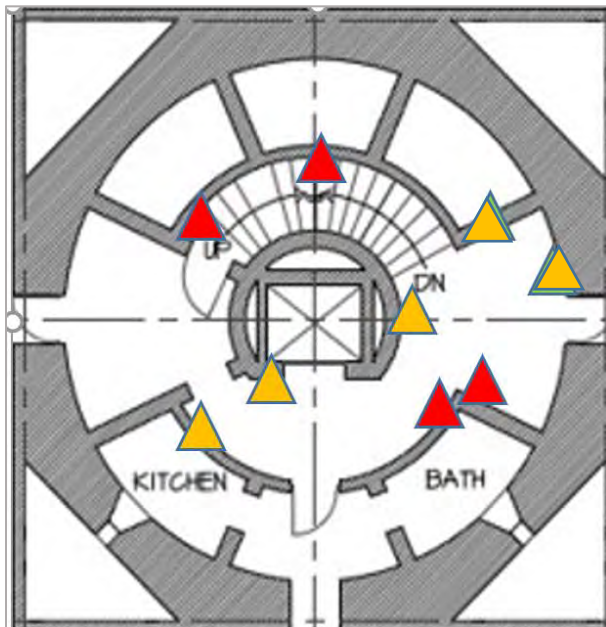
Figure 26: Moisture readings at the stairs and second floor murals. Although readings showed the walls drying out, the overall ranges stayed the same. Triangles show moisture content. Orange: 25% - 50% = RISK. Red: > 50% = WET.

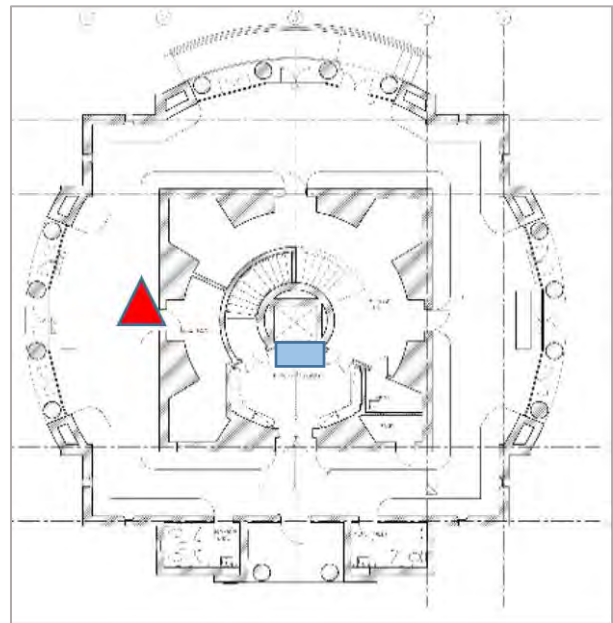
The *California* mural had moisture reading of 71.3% content, which is continuing a trend of drying.

Figure 27: Moisture reading on the first-floor mural. Red triangle: > 50% = WET. Blue rectangle shows location of pooling water under elevator.

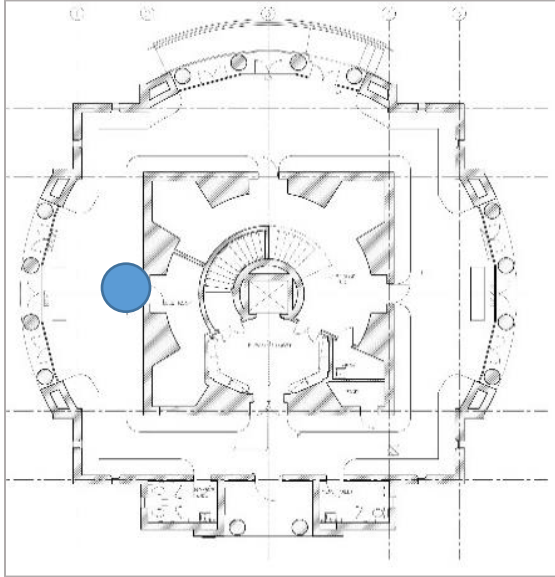
The *California* mural continued to dry slowly. Surface yellowing was still present, but the color had slightly faded.

Figure 28: Location of the water damage on the *California* Mural at the first floor.

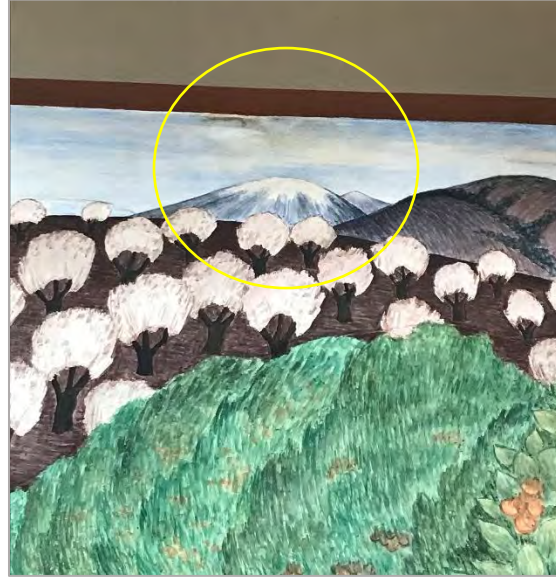
Figure 29: Surface yellowish had slightly faded away. Darker brown spot still remains.

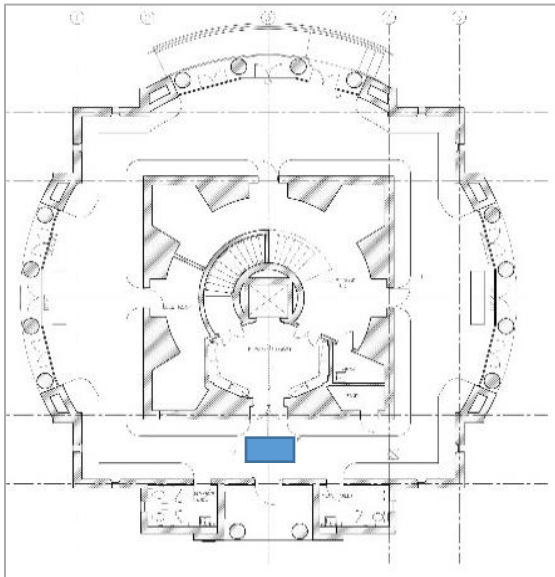
Figure 30: Water collected under the elevator is creating a continuous source or moisture for the surrounding walls increasing the risk for more damage on the frescoes.

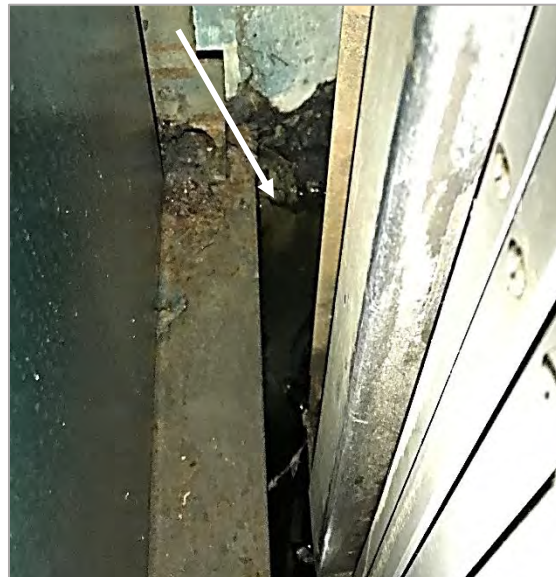
Figure 31: Detail of the accumulated water under the first-floor elevator. Arrow shows water level going up to the top of the elevator floor, which means that probably hundreds of gallons of water are currently contained in that area.

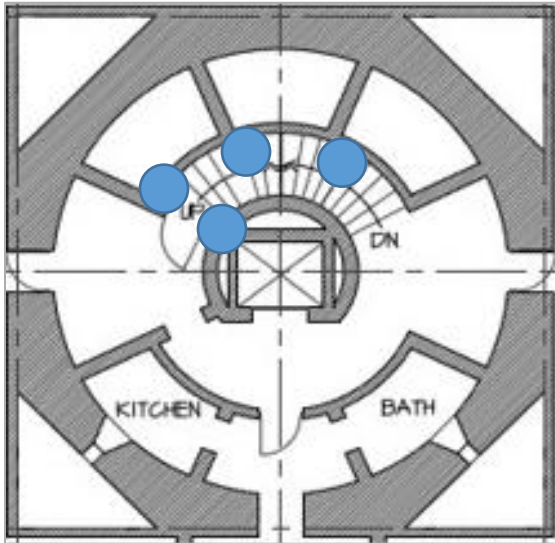
Salt efflorescence at the *Powell Street, Outdoor Living, Sports, and Hunting in California* were in general more noticeable and whiter. The most affected area continued to be the bottom of the stairs on the Powell Street mural's stucco frame. New areas of efflorescence appeared at the bottom of the stairs and around the elevator door on the second floor. White drip stains and glossy film looking areas appeared more conspicuous.

Figure 32: Location of observed efflorescence and other damages on the *Powell Street* mural.

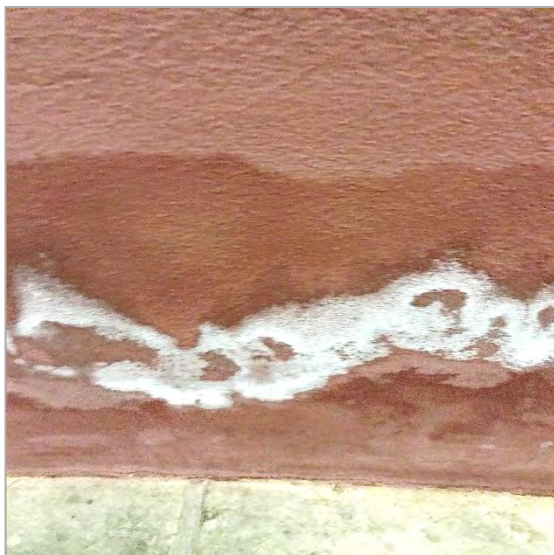
Figure 34: Detail of growing efflorescence at the bottom of the stairs on the frame surrounding the *Powell Street* mural.

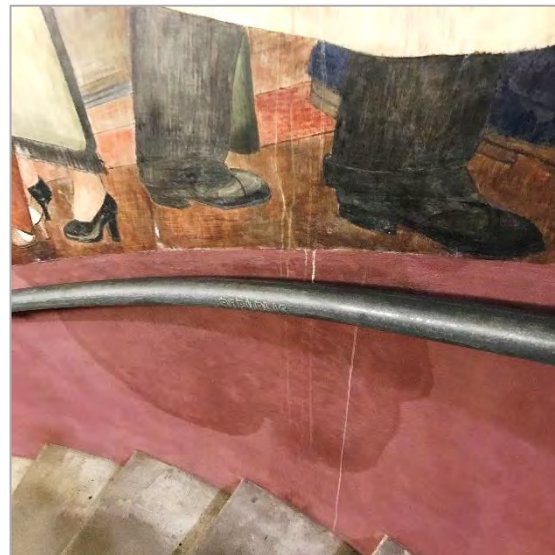
Figure 35: Detail of white drip and water stains on the *Powell Street* mural.

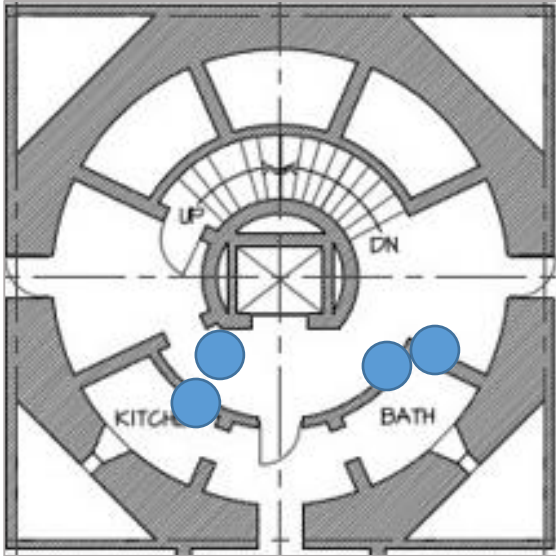
Figure 36: Location of florescence observed on the *Sports, Outdoor Life, and Hunting in California* murals located on the second floor

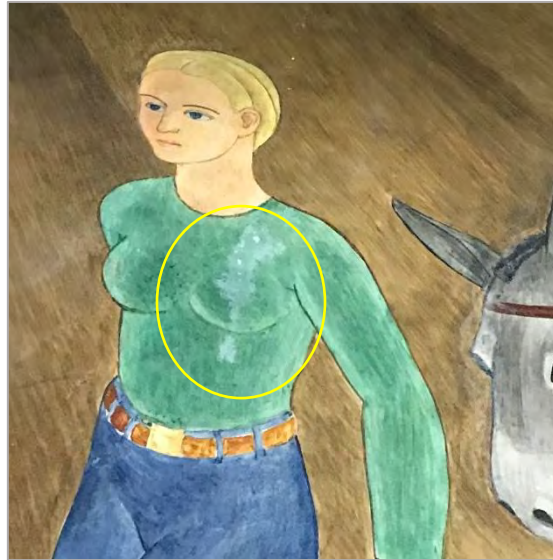
Figure 37: New white stain spotted, probably efflorescence, on the *Outdoor Life* mural.

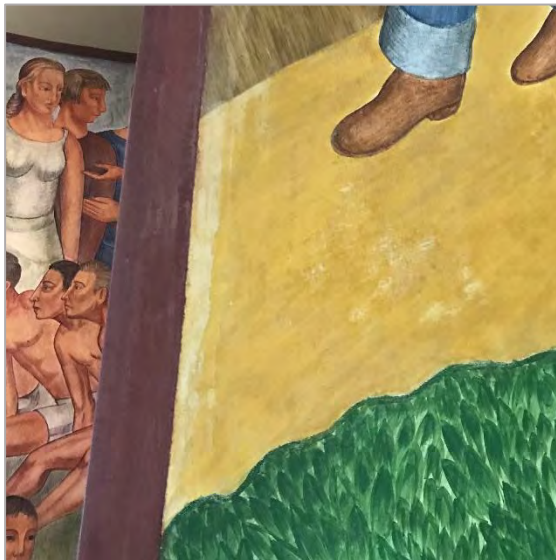
Figure 38: Detail of vertical stains, probably efflorescence, on the *Outdoor Life* mural. They appeared whiter and thicker in comparison to previous observations.

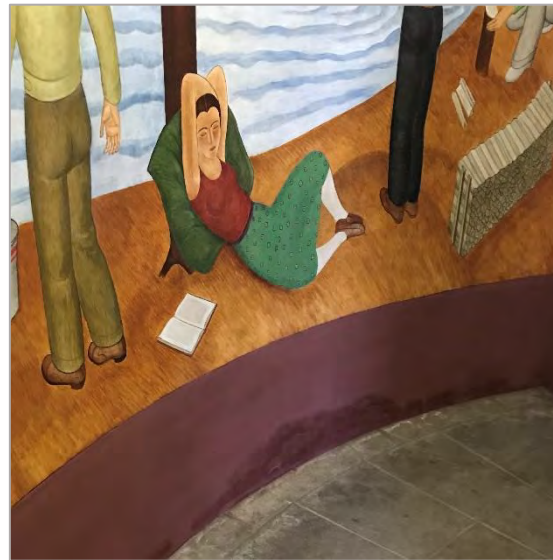
Figure 39: Efflorescence were starting to appear at the bottom of the frame of the *Outdoor Life* mural.

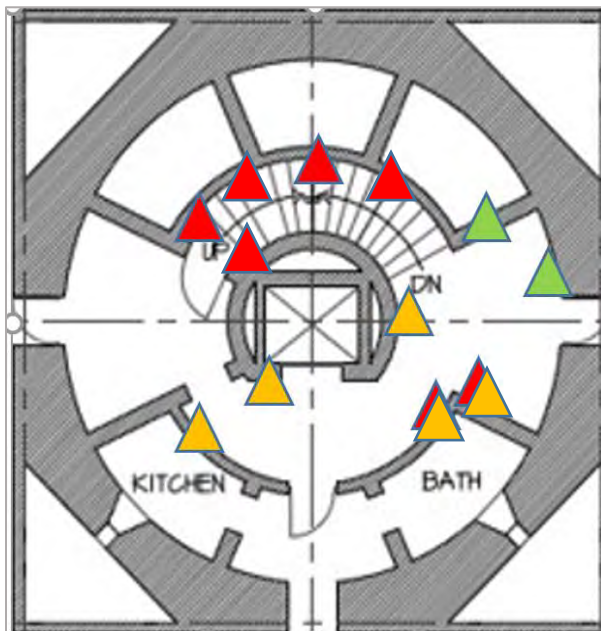
Figure 40: Moisture readings at the stairs and second floor murals. Although readings showed the walls drying out, the overall ranges stayed the same. Triangles show moisture content. Orange: 25% - 50% = RISK. Red: > 50% = WET.

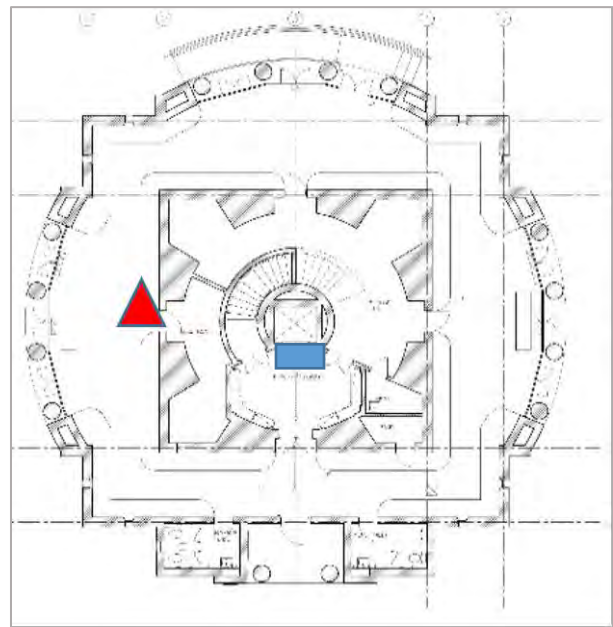
The *California* mural had moisture reading of 64.3% content, which is continuing a trend of drying.

Figure 41: Moisture reading on the first-floor mural. Red triangle: > 50% = WET. Blue rectangle shows location of pooling water under elevator.

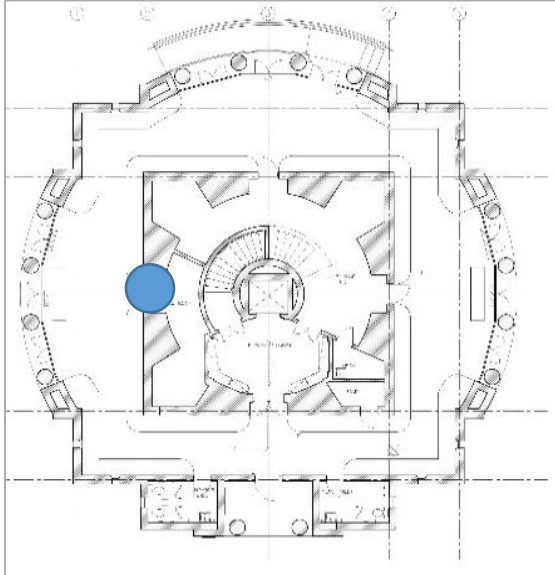
The *California* mural continued to dry slowly. Surface yellowing was still present, but the color had slightly faded.

Figure 42: Location of the water damage on the *California* Mural at the first floor.

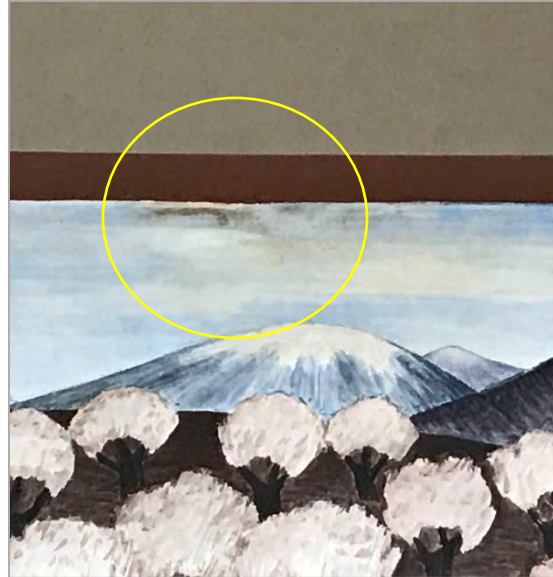
Figure 43: Yellow circle shows light yellowing and increasing of dark area, probably by biogrowth at the *California* mural.

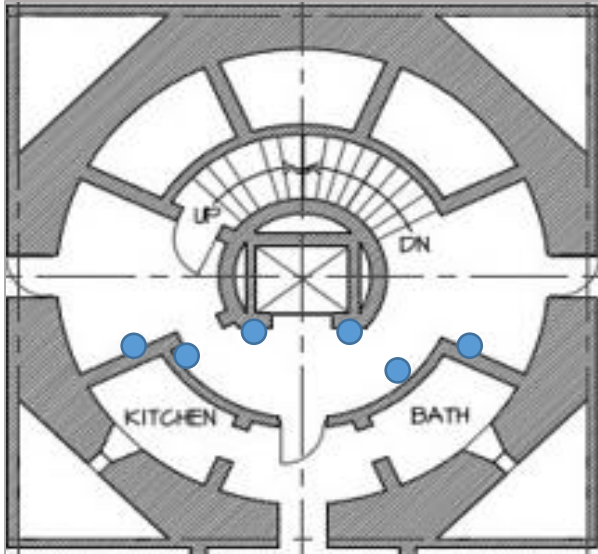
In general, efflorescence at the *Outdoor Life, Sports, and Hunting in California* remained the same in comparison to October 5<sup>th</sup>. The stucco frame around the *Powell Street* mural exhibited larger and thicker efflorescence in comparison to last visit, along with new areas of efflorescence at the nearby locations. White drip stains and glossy film areas appeared the same as October 5<sup>th</sup>.

Figure 50: Location of observed efflorescence and other damages on the second-floor murals.

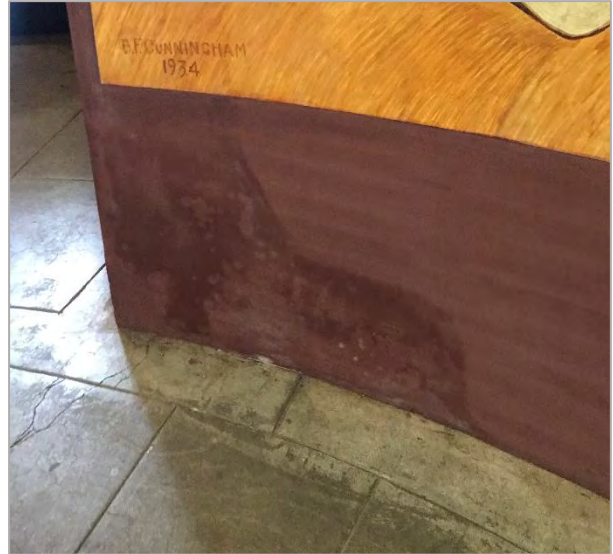
Figure 51: Location of observed efflorescence and other damages on the *Outdoor Life* mural.

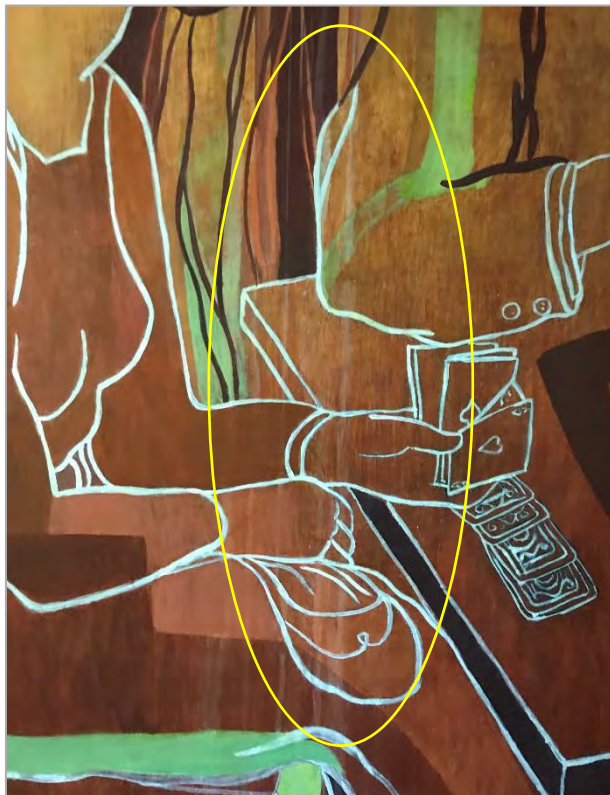
Figure 52: Location of observed water stains on one of the walls of the Berlandina Room.

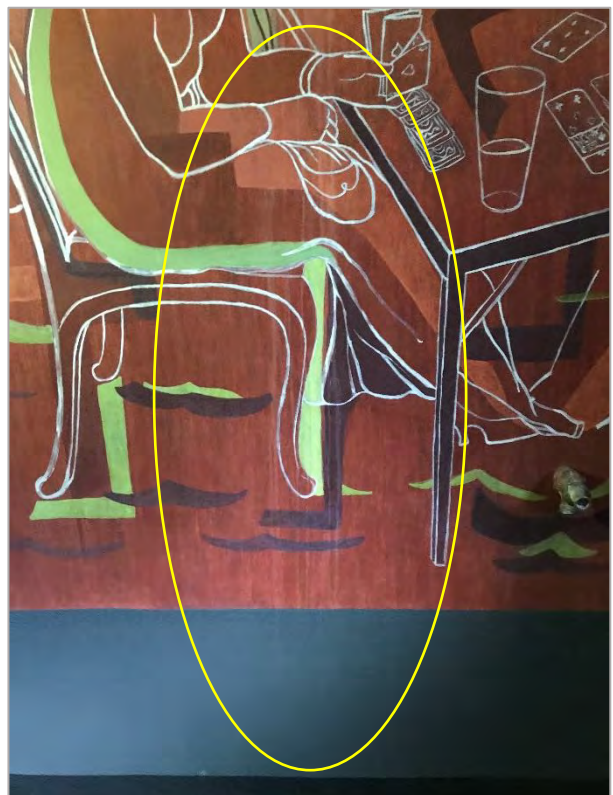
Figure 53: Another detail of the same water damage.

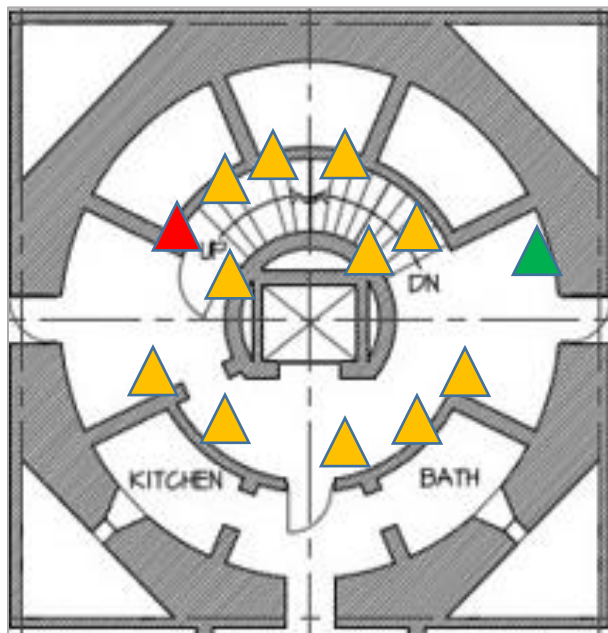
Figure 54: Moisture readings at the stairs and second floor murals. Although readings showed the walls drying out, the overall ranges stayed the same. Triangles show moisture content. Orange: 25% - 50% = RISK. Red: > 50% = WET.

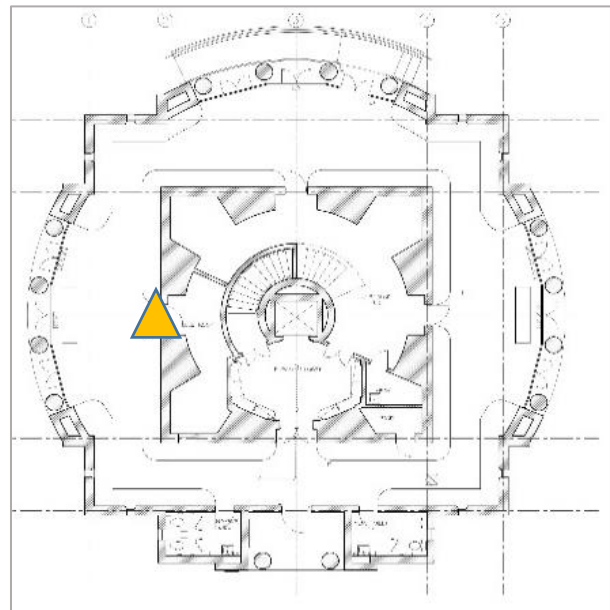
The *California* mural had moisture reading of 45.5% content, which is continuing a trend of drying.

Figure 55: Moisture reading on the first-floor mural. Orange triangle: moisture between 25-50% = Risk. Water under the elevator has been drained.

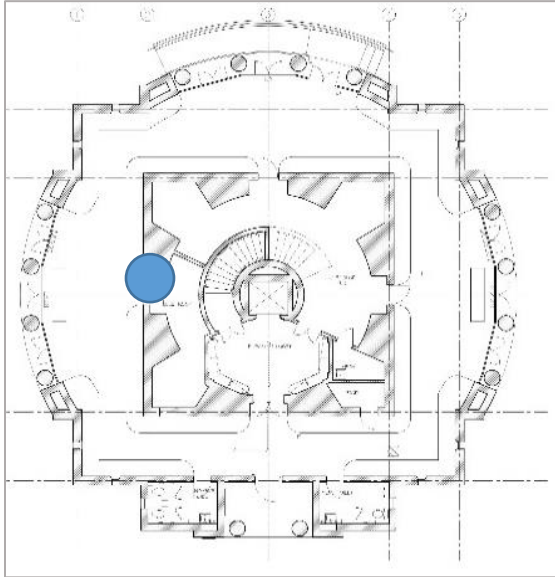
The *California* mural continued to dry slowly. Surface yellowing was still present, but the color had slightly faded. Darker area remains similar to observations from October 9<sup>th</sup>.

Figure 56: Location of the water damage on the *California* Mural at the first floor.

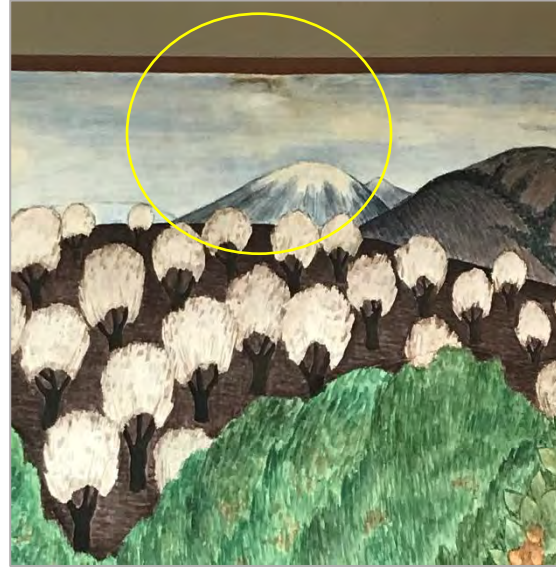
Figure 57: Yellow circle shows light yellowing and dark area, probably by biogrowth at the *California* mural.

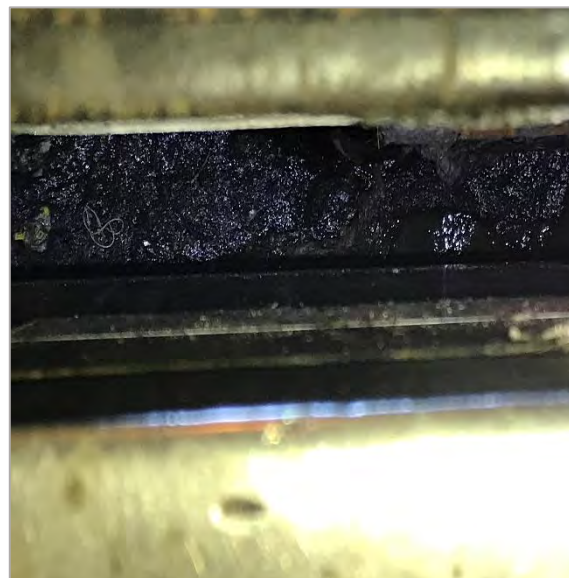
Figure 59: Water has been drained. Image shows bottom surface of the elevator. No water was observed.

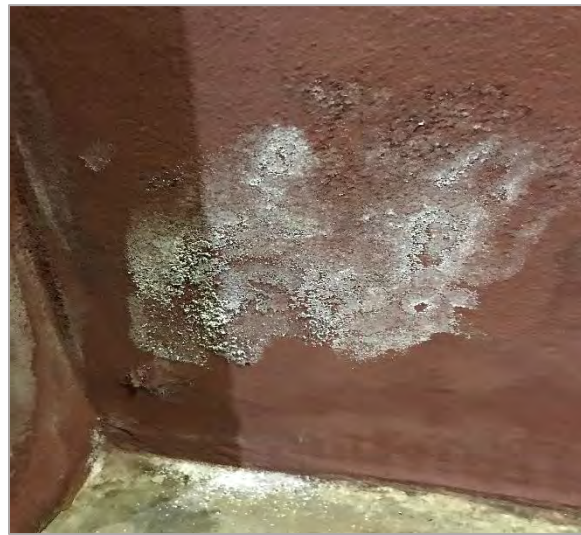
In general, efflorescence at the *Outdoor Life, Sports, and Hunting in California* remained the same in comparison to October 5<sup>th</sup>. The stucco frame around the *Powell Street* mural continues to show thicker efflorescence in comparison to last visit. White drip stains and glossy film areas appeared the same as October 9<sup>th</sup>.

Figure 63: Detail of observed efflorescence and on the *Powell Street* mural stucco frame. Notice effloresce residues accumulated on the ground.

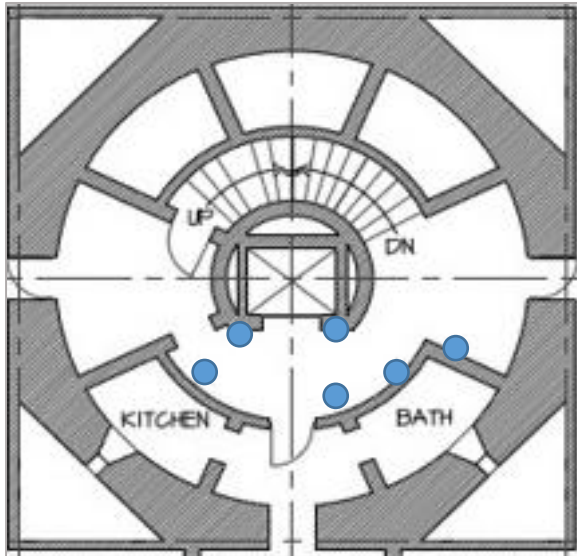
Figure 64: Location of observed efflorescence and other damages on the *Sports, Outdoor Life, and Hunting in California* mural.

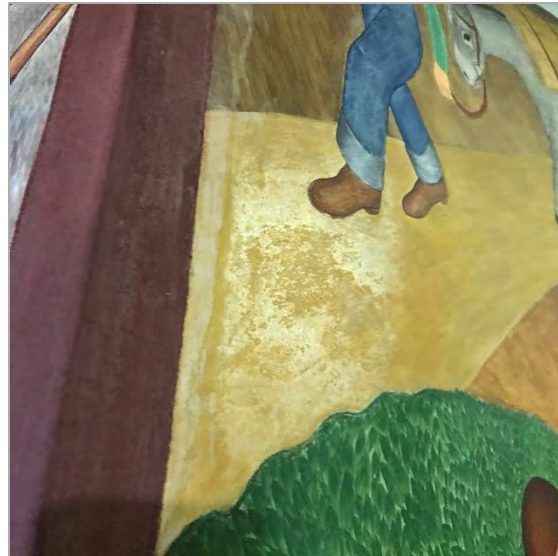
Figure 65: Location of observed efflorescence and other damages on the *Outdoor Life* mural.

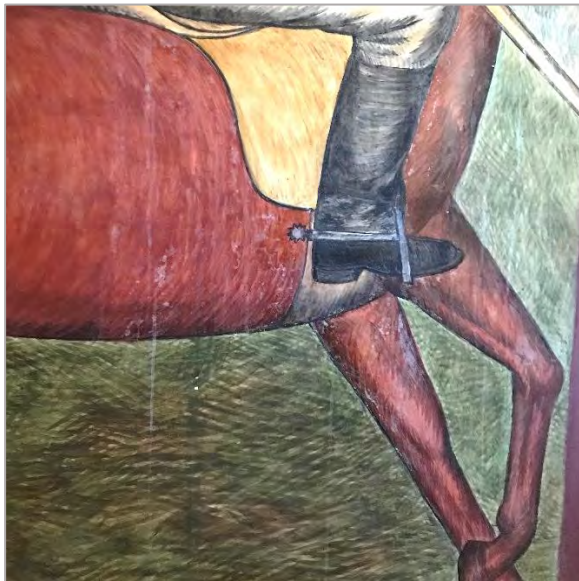
Figure 66: Location of observed water stains on the *Sports* mural.

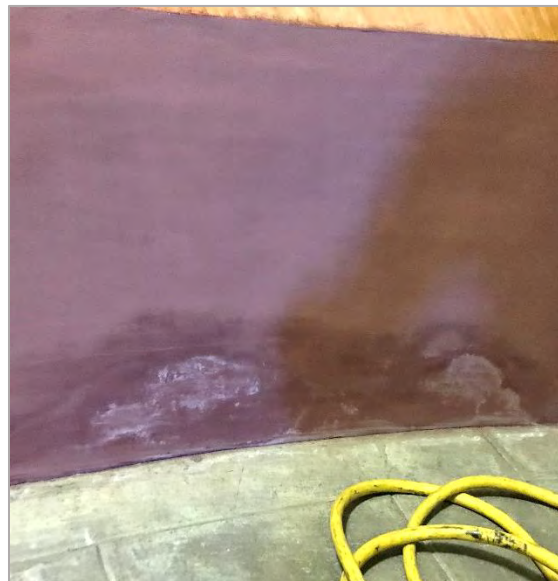
Figure 67: Growing efflorescence on the lower right side of the *Outdoor Life* mural.

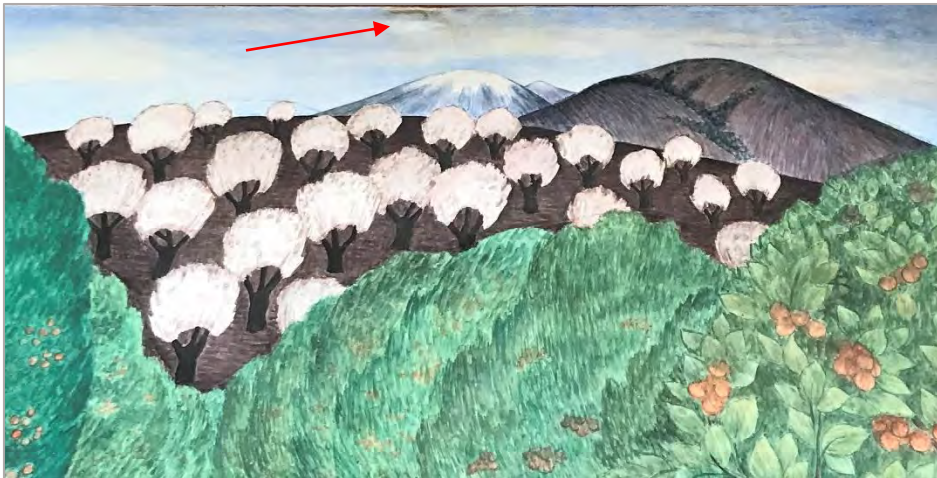
Figure 69: Same location after water leak. Red arrow shows dark stains on the fresco. Photo taken on October 9<sup>th</sup>.

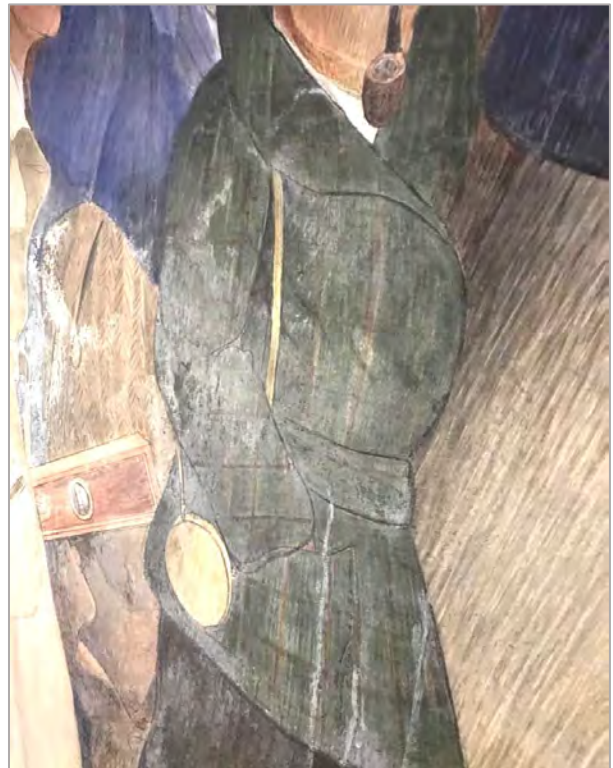
Figure 71: Detail of the same area after water leak. Photo taken on October 1<sup>st</sup>.

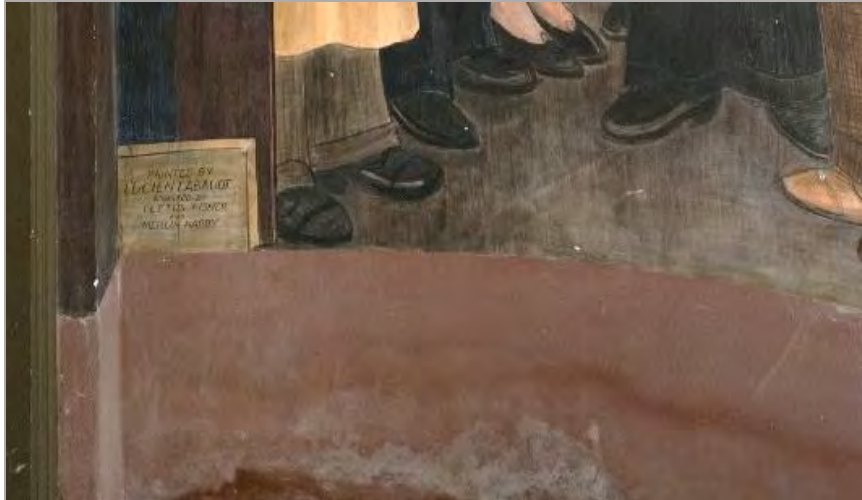
Figure 74: Detail of the central lower part of the *Powell Street* mural before water damage. Mild efflorescence in this area are common since this location always exhibits high percentage of water content in the winter.
