## MEMORANDUM

### **COIT TOWER WATER INCIDENT**

Re: SFAC Coit Tower Monitoring CS20080

This memo serves as a report for mural inspection and moisture monitoring performed at Coit Tower from September 29<sup>th</sup> to October 15<sup>th</sup>, 2020. ARG/CS was contacted by the San Francisco Arts Commission to monitor the tower frescoes after a water leak was reported on *[date]*. The cause of the failure was related to the water storage tanks housed on the fifth floor of the building. These tanks were inspected by divers who could not determine a source of the leak from the interior of the tank. The exact cause and location of the leak remains unknown.

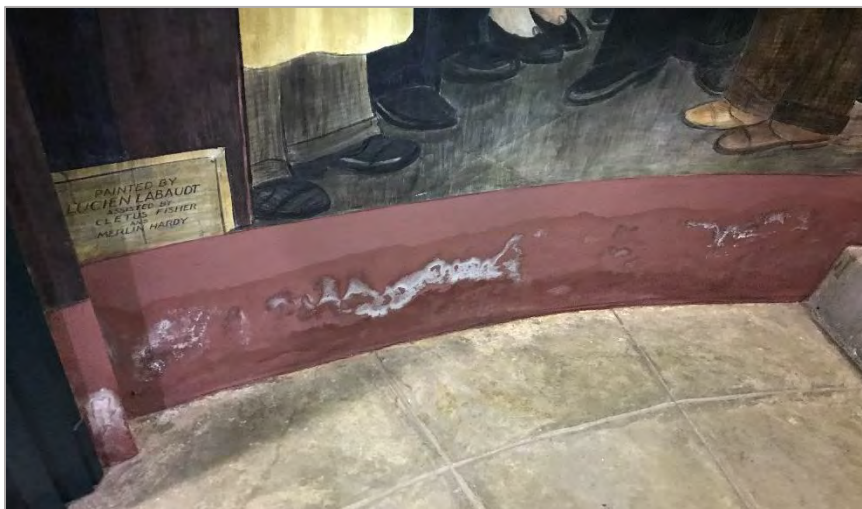
Figure 75: Detail of the central lower part of the *Powell Street* mural before water damage. Efflorescence this time are bigger and thicker than usual, which appeared right after the water leak.

- ARG/CS recommends performing conservation treatments on the affected murals to remove efflorescence and address damaged areas with previous conservation treatments. This process will require a conservator specializing in fresco conservation to create a comprehensive scope of work for the treatment.

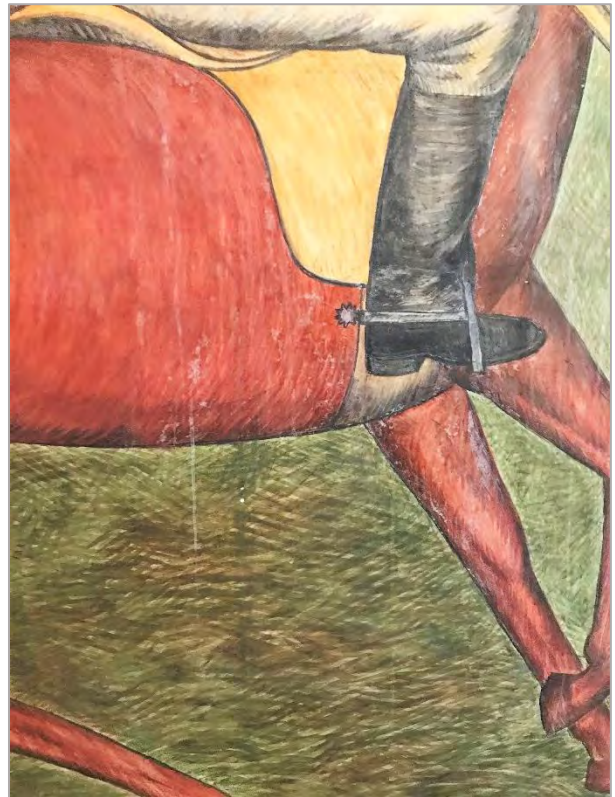
Figure 77: Detail of the same location after water damage. Image shows efflorescence and white drip stains of the surface.

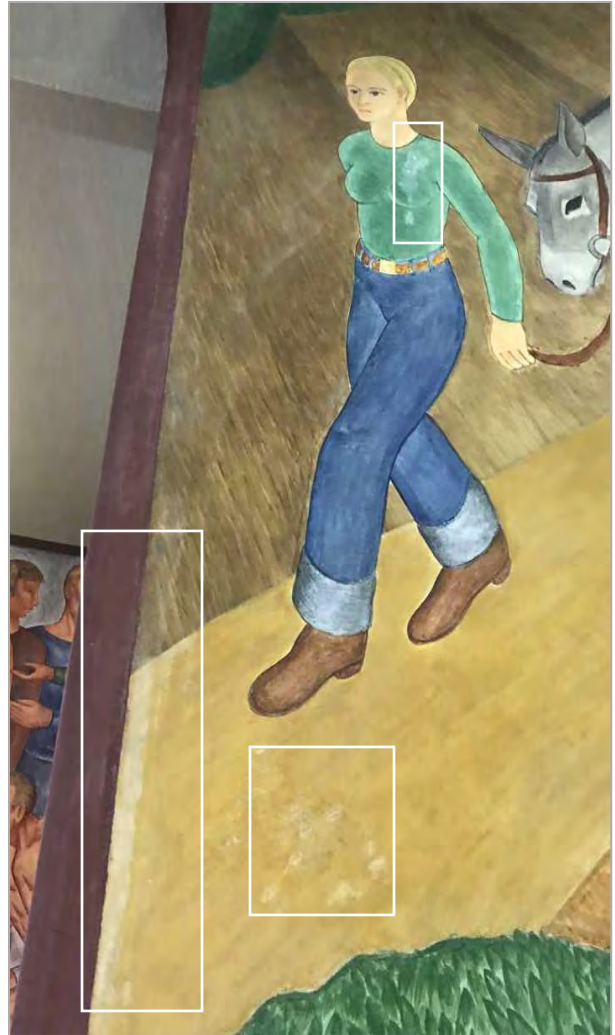
Figure 79: Detail of same location after water damage. Image shows areas with efflorescence.

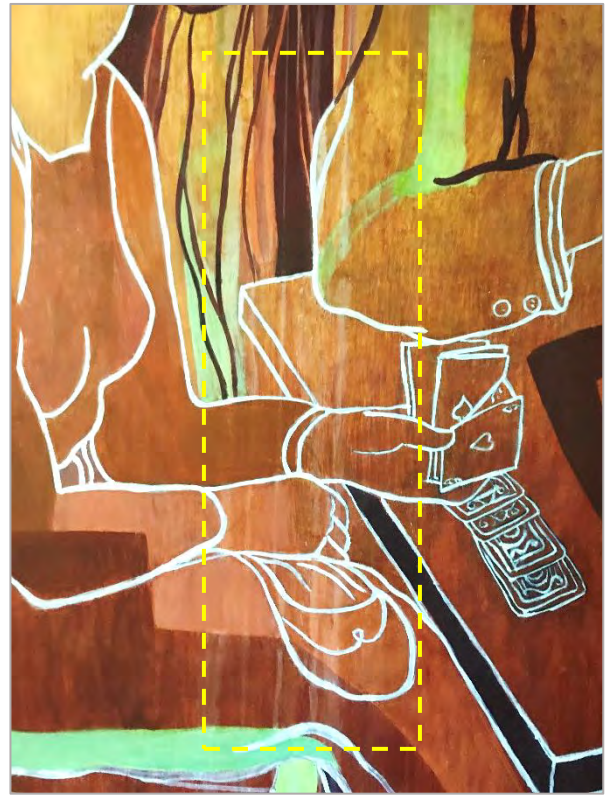
Figure 81: Detail of the same location after water leak. Conservators noticed current water stains correspond to location of water damages reported on previous treatments.
