FINE ART CONSERVATION

CONDITION ASSESSMENT

DATE: 5/31/19
CLIENT: San Francisco Arts Commission
OBJECT: 'Street Life', 2010 by the artist group Rebar.
Artists: Matthew Passmore, John Bela, Blaine Merker, Teresa Aguilera
ACCESSION NO: 2010.6
DIMENSIONS: 17-18' (variable)

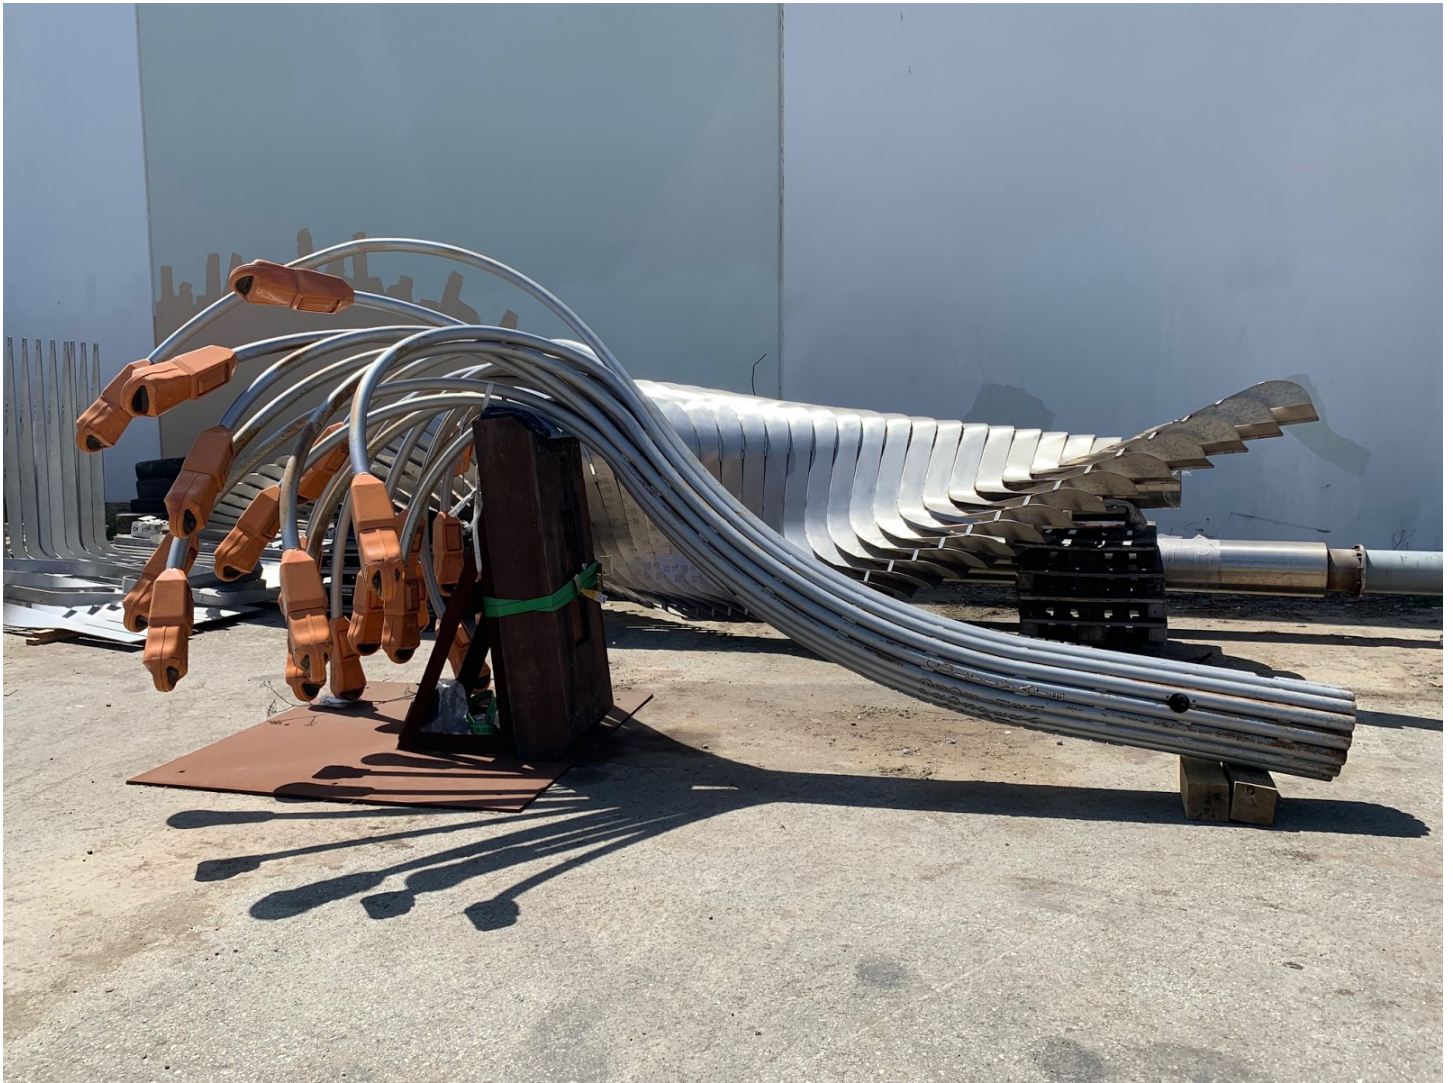
Current Deinstalled Condition

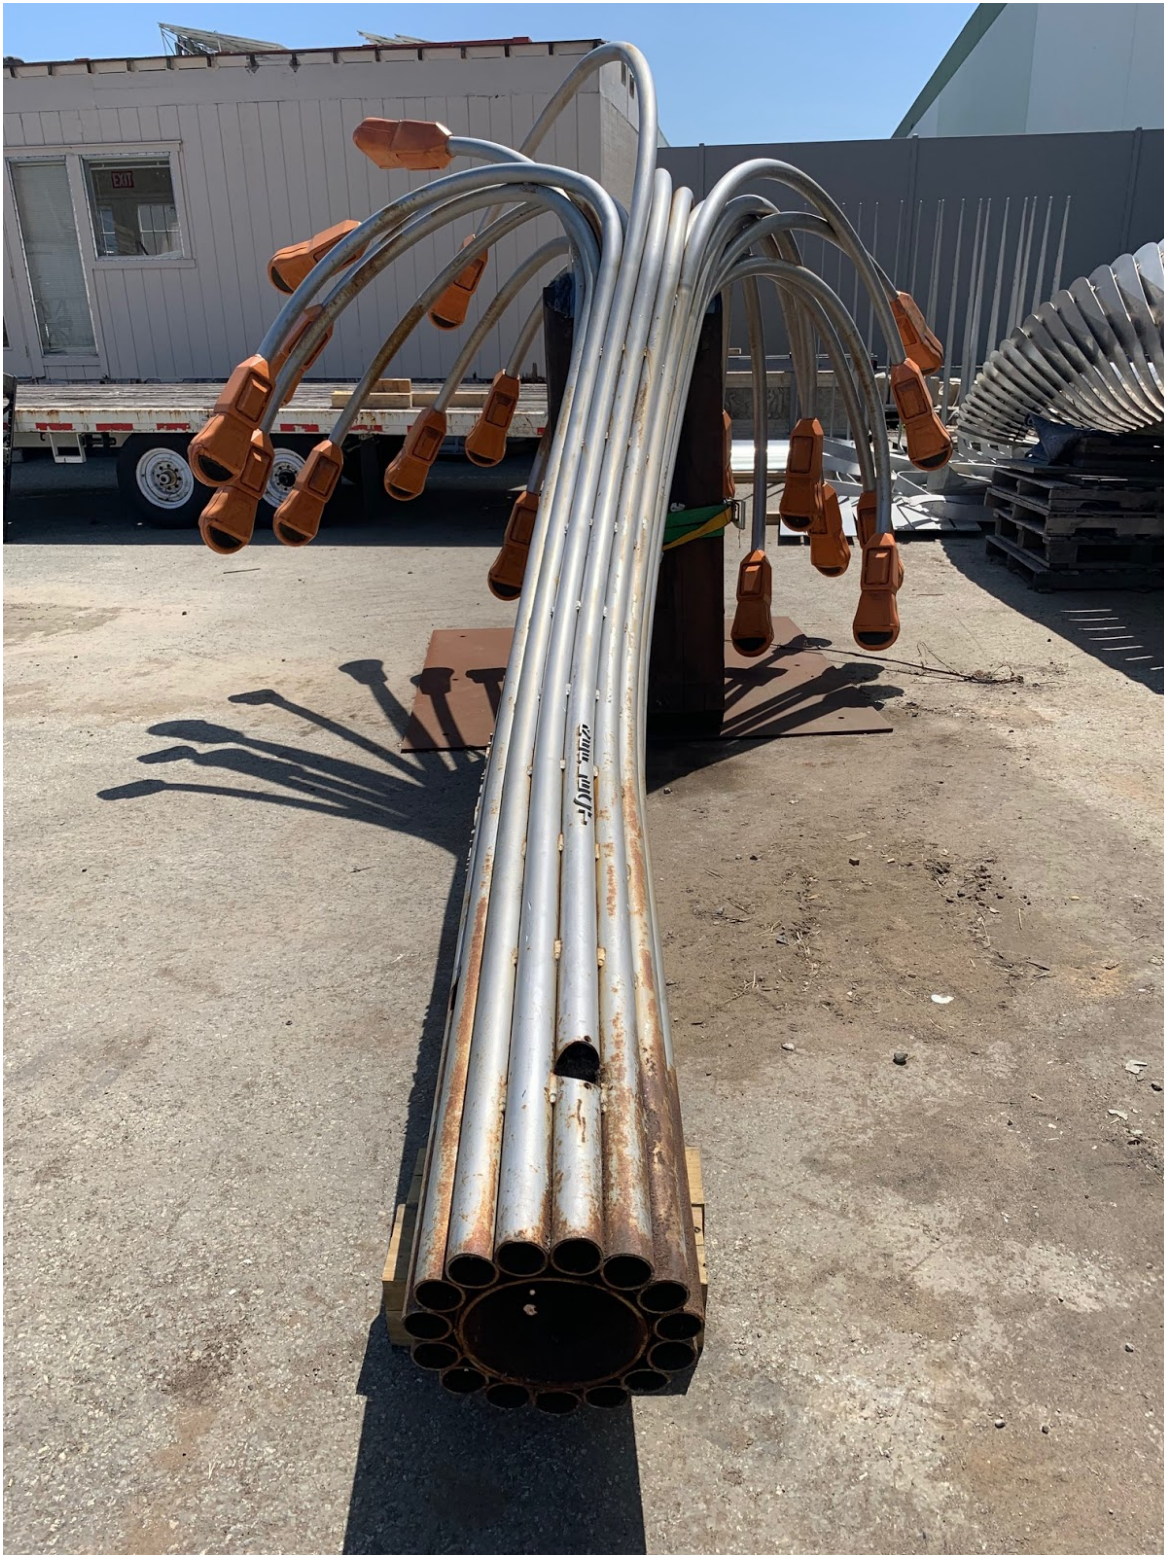
Overall View of Back of Sculpture

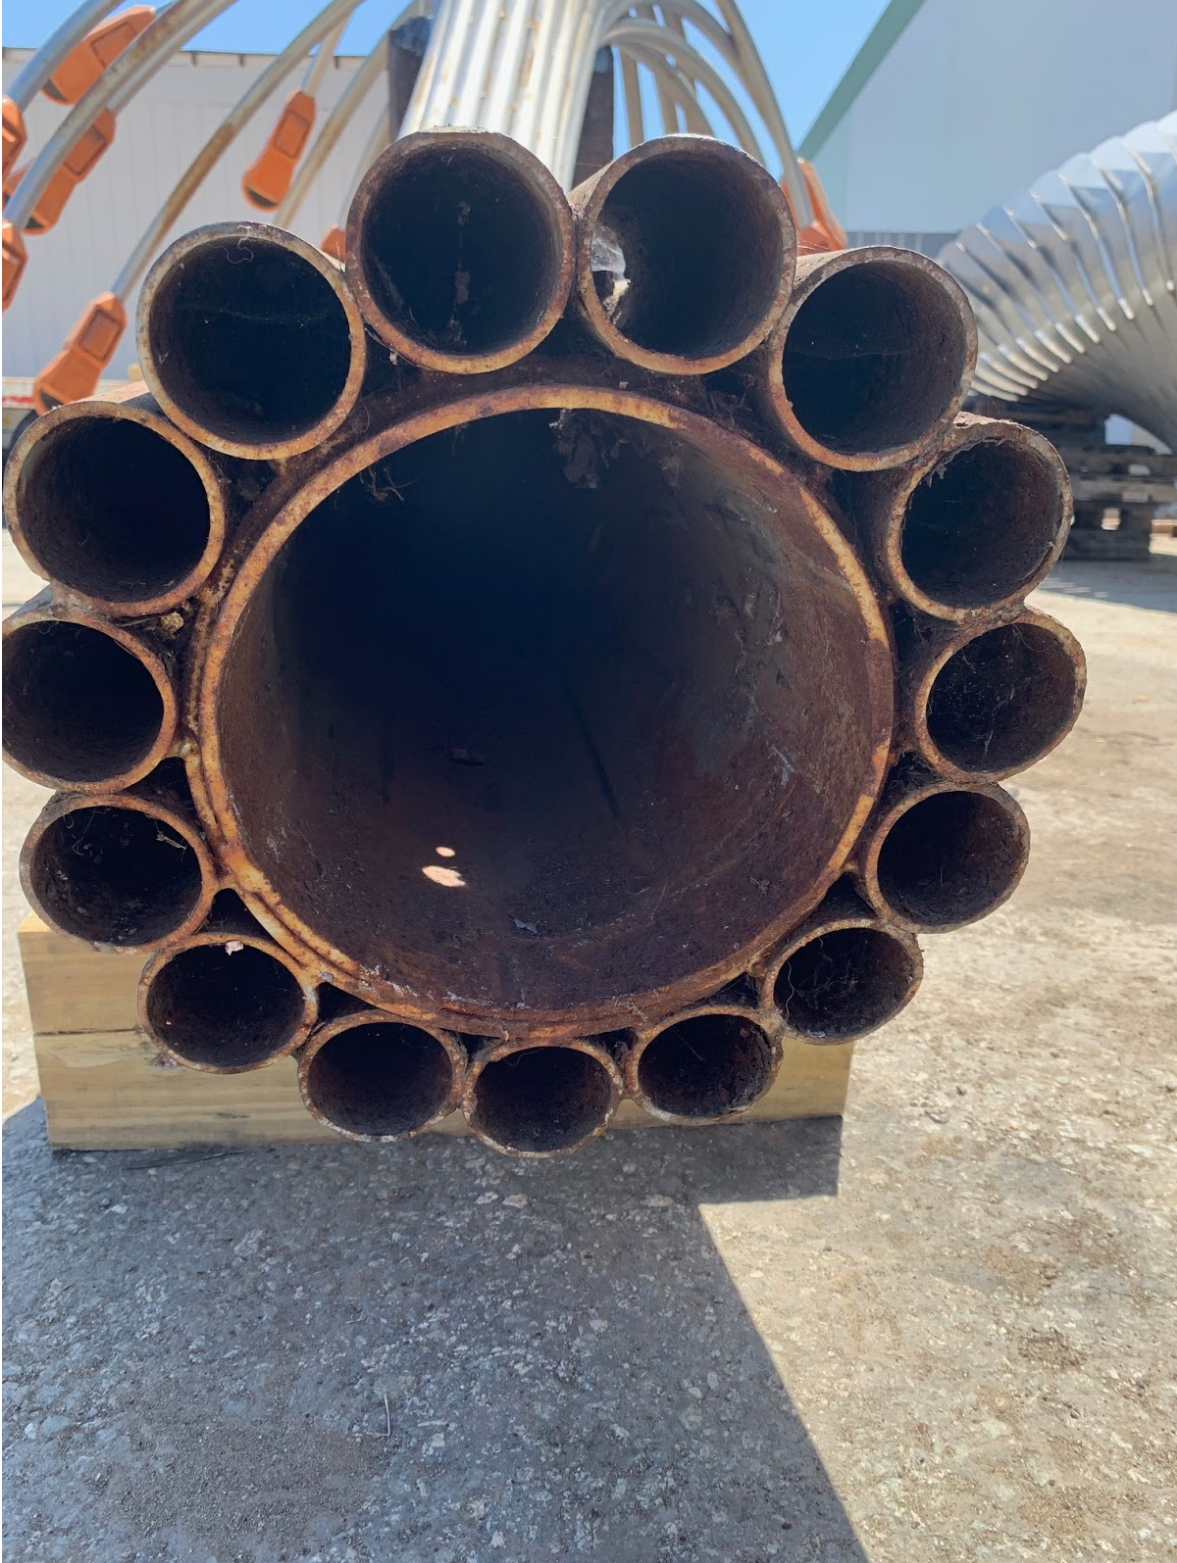
- Viewing of the interior of the sculpture from the bottom, it is clear that the interior of the pipes were not coated and are extensively corroded. Removal of the interior rust and painting is unlikely to be successful and so the sculpture will likely continue to rust from the inside out.

3. The interior of the pipes were never protected with coatings and exhibit extensive corrosion. This will eventually lead to rusting of the sculpture from the inside out.

Interior View of Bottom End of the Sculpture Showing lack of Coatings and Extensive Corrosion

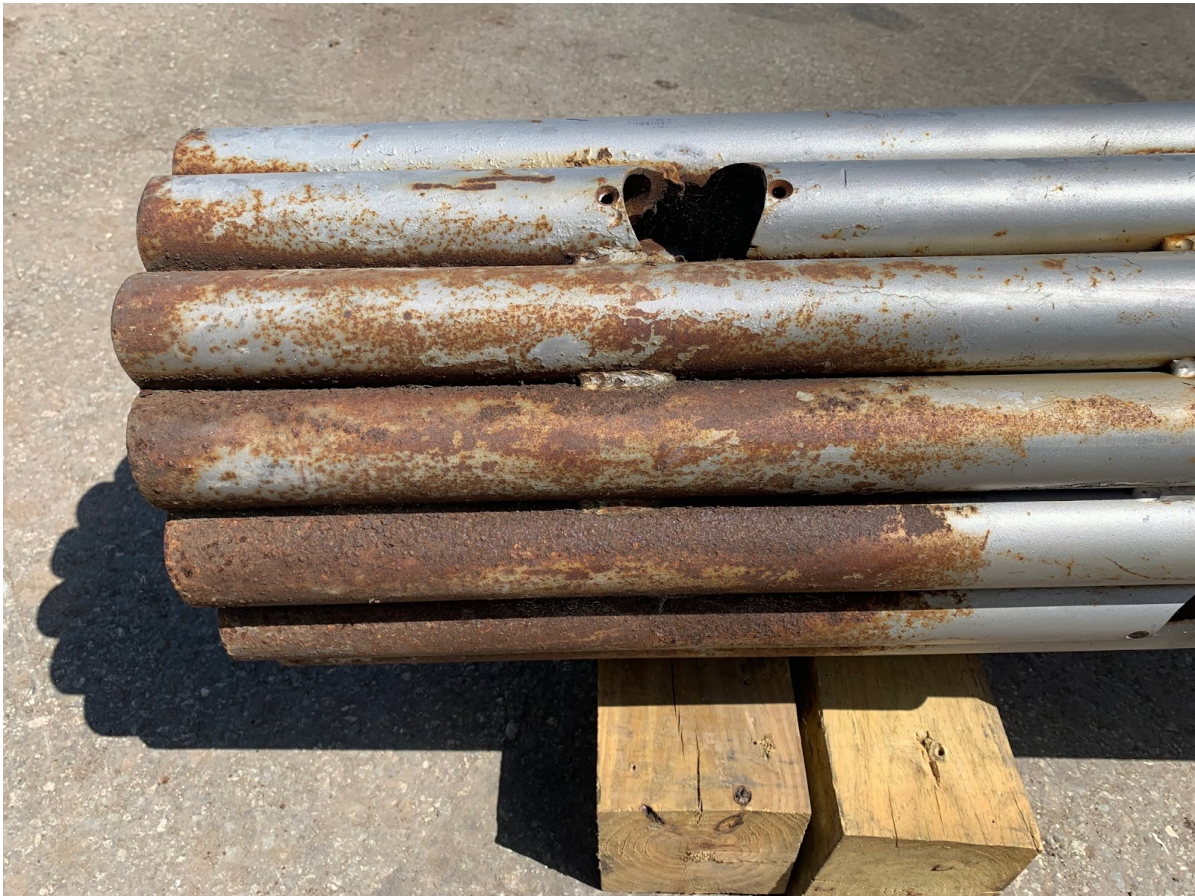
- On the exterior, there is an overall failure of the protective coatings. The polyurethane and rustoleum primer have not sufficiently protected the mild steel from exposure to the environment, largely because they are not a high performance system and there appears to be some compatibility issues. There has been a widespread delamination of the polyurethane from the primer and some large areas of loss to the primer. Failure of the polyurethane appears to be widespread, and the primer has failed noticeably around the base, exacerbated by acidic dog urine.

- Where the primer is failing, there are extensive areas of ferrous corrosion. This has deeply pitted the steel around the base and is causing delamination of the metal where it is most severe. This is likely to lead to some structural issues.

Bottom of the Sculpture Showing Advanced Ferrous Corrosion to Metal; Pitting, Blistering and Failure of Paint System

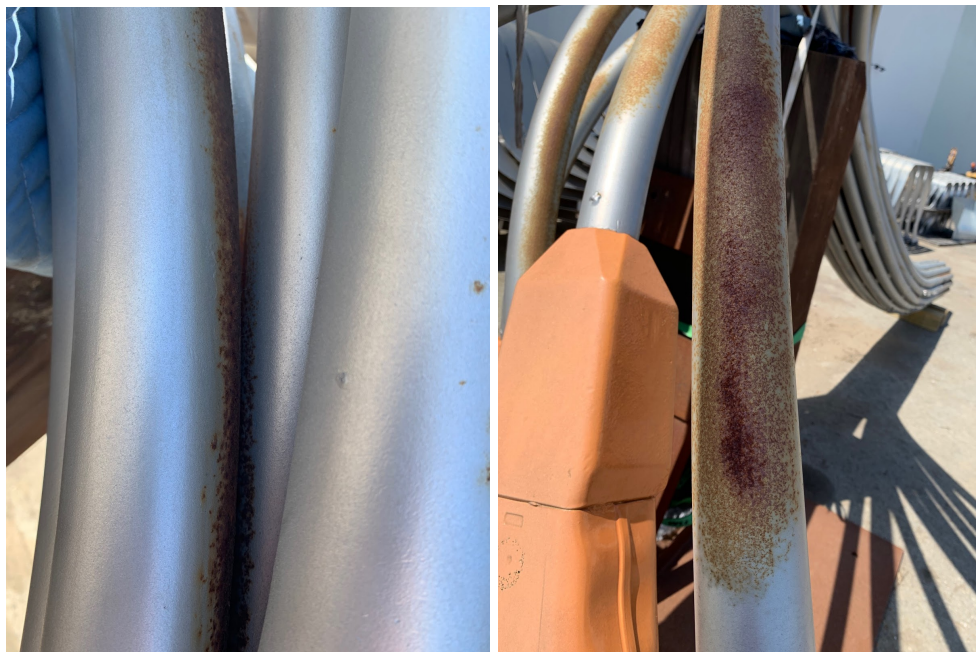
- Also as a result of the design, the upper area where the pipes start to bend outwards from the main stem also form an inaccessible area where dirt and debris can accumulate also leading to corrosion, despite the fact that the stitch welds between the pipes allow drainage.

Corrosion on Inaccessible Areas Between Pipes and Upper Surfaces, and Failure of Paint System

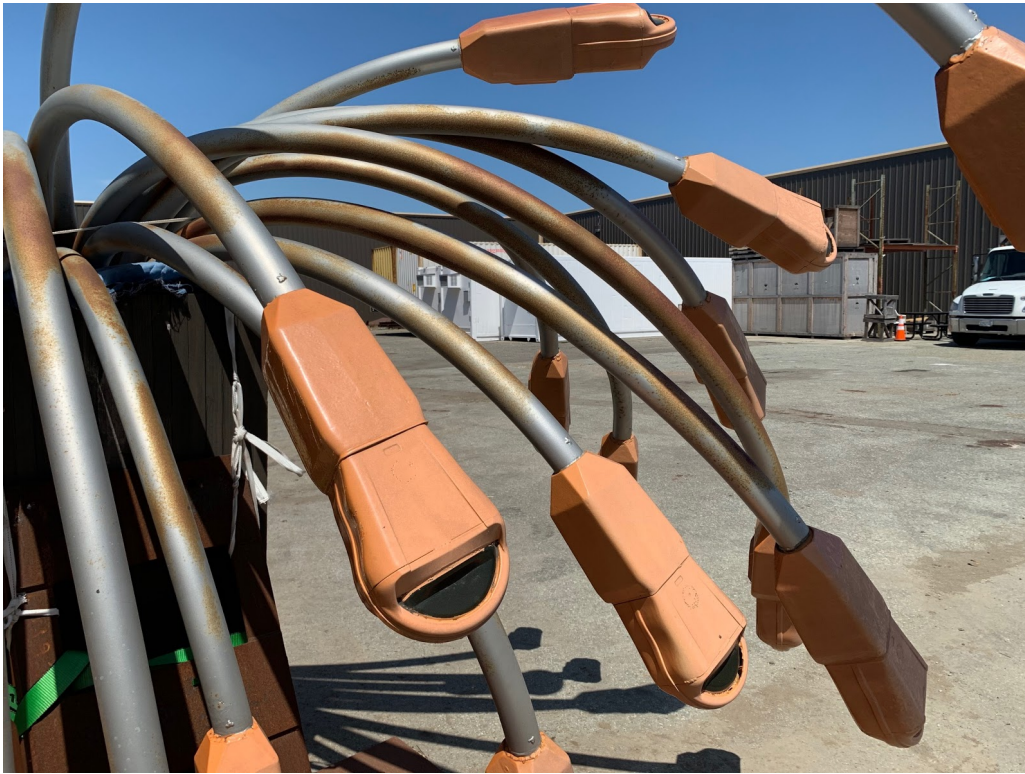
Corrosion on Upper Surfaces of Pipes, and Fading of Orange Paint on Meters

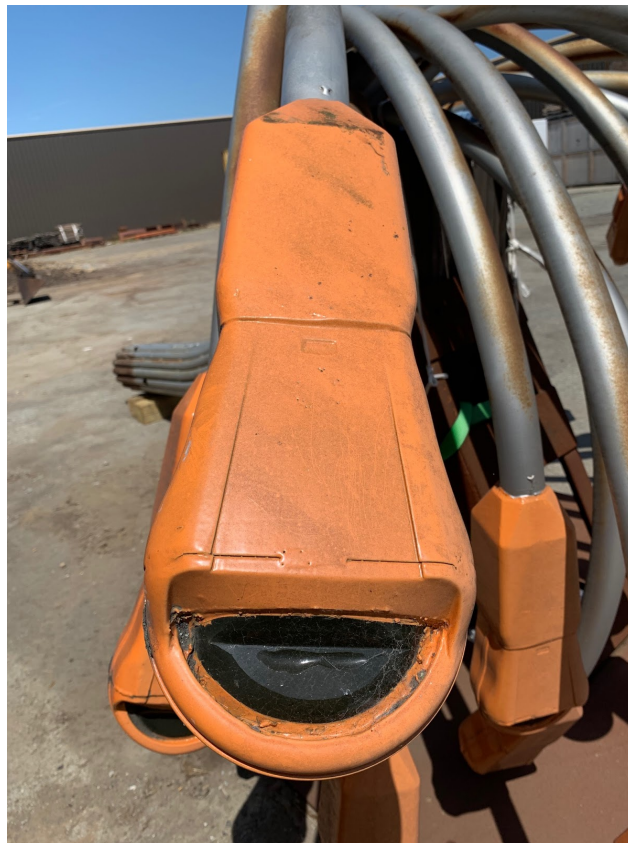
- The once chartreuse color of the glass in the parking meter heads is now black, suggesting that a considerable amount of surface grime has been able to penetrate inside the meters. This may require opening of the meters, although it is not known whether that is possible at this time.
- The paint system on the parking meter heads is also deteriorating to a chalked finish and has faded, especially on the more exposed upper surfaces.

Surface Dirt, and Discoloration of the Glass
