# *Street Life*, 2010 by REBAR

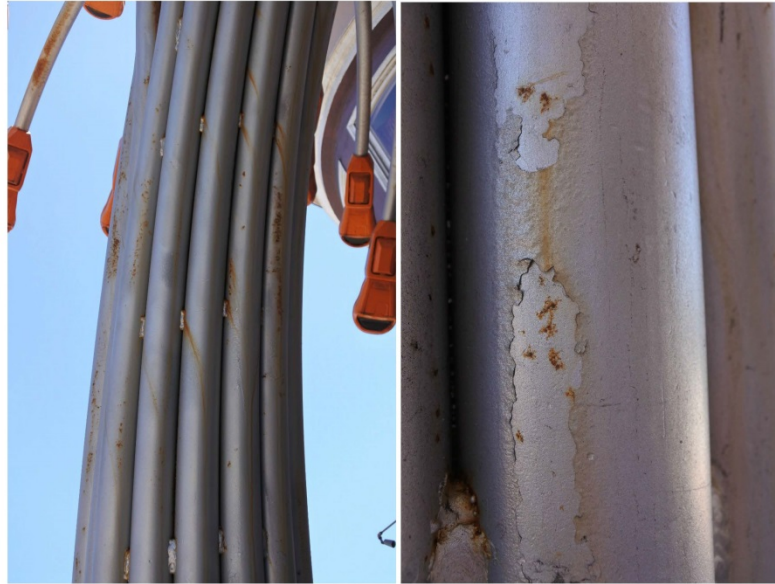
View of Center Section (Left) with corrosion forming along lines of water migration between the pipes  
Detail of Deterioration of Top Coat Exposing the Primer on Center Section (Right)

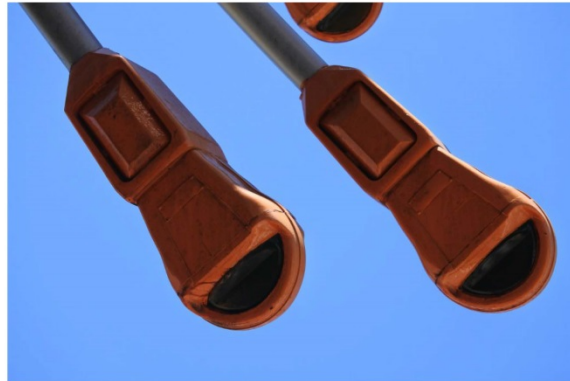
Detail of Parking Meter Heads. The once chartreuse colored glass now appears black, possibly from dirt inside the heads.

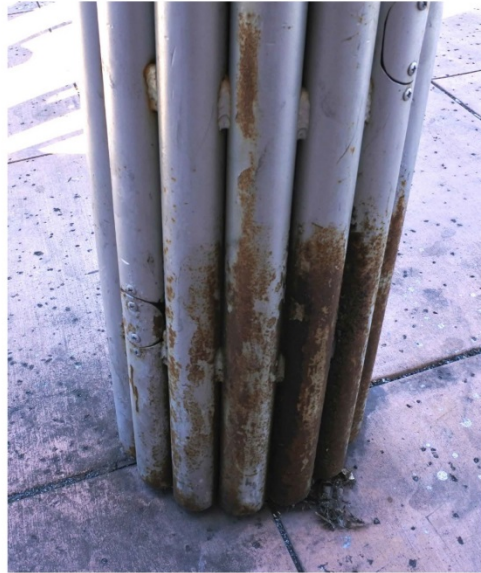
View of the Base, Loss of Coatings and Extensive Ferrous Corrosion

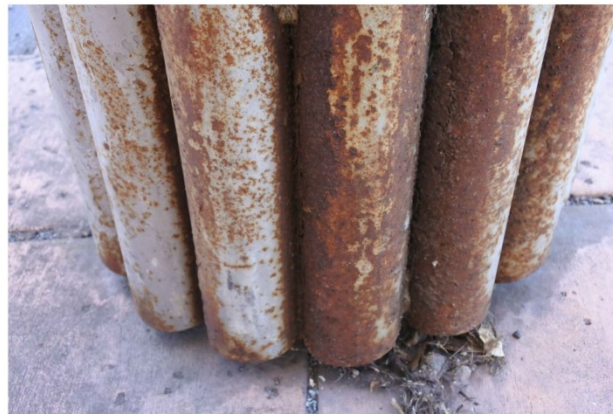
Detail of Corrosion on the Base, Largely from Dog Urine
