# **PHYSICAL NEEDS ASSESSMENT**

## **MIDTOWN PARK APARTMENTS**

**1415 SCOTT STREET**  
**2121 GEARY BOULEVARD**  
**2141 GEARY BOULEVARD**  
**2040 O'FARRELL STREET**  
**2060 O'FARRELL STREET**  
**1450 GEARY STREET**  
**SAN FRANCISCO, CA 94106**

NOVEMBER 1, 2012

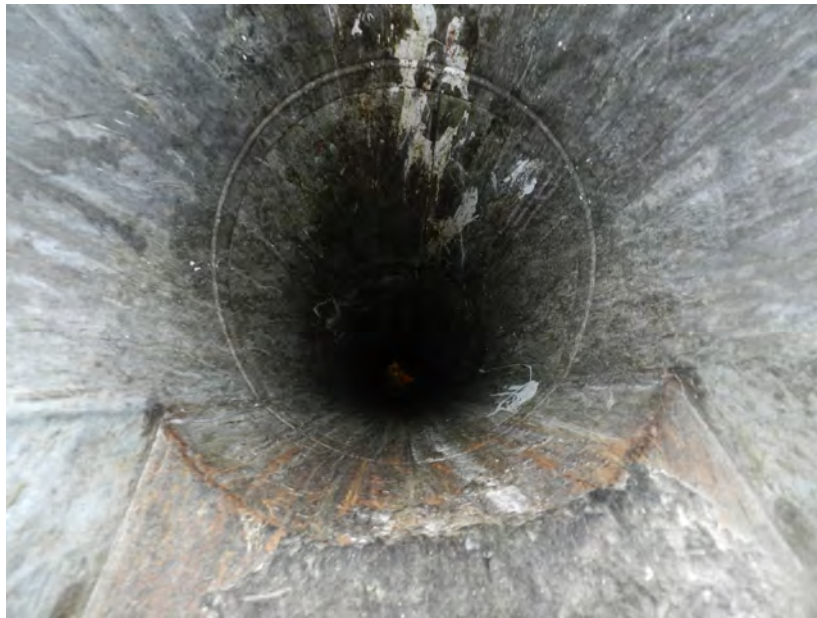
The chutes empty into dumpsters located at the garage levels. Trash dumpsters are wheeled out to the street on trash collection days. The chute rooms at 1415 Divisadero and 2060 O'Farrell were inspected. Both were found to be in similar condition – somewhat filthy but functional. The chutes are believed to be original – making them about 49 years old. It is recommended that all chute materials be replaced and all chute openings be replaced. Chute and trash rooms should be cleaned in the immediate scope of work. Hose bibs are already installed though it may beneficial to power wash the rooms on a regular basis.

*Trash chute at 2060 O'Farrell*

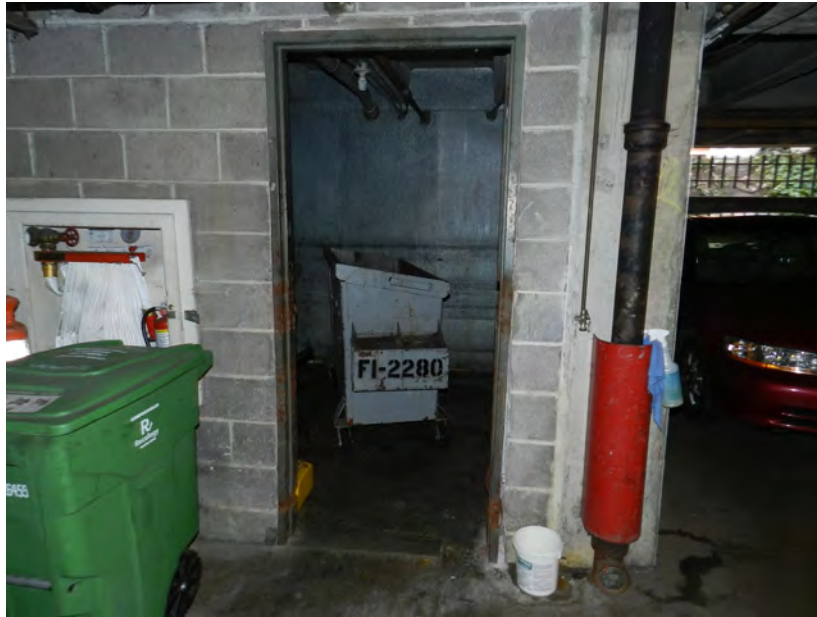
*Trash room at 2040 O'Farrell*

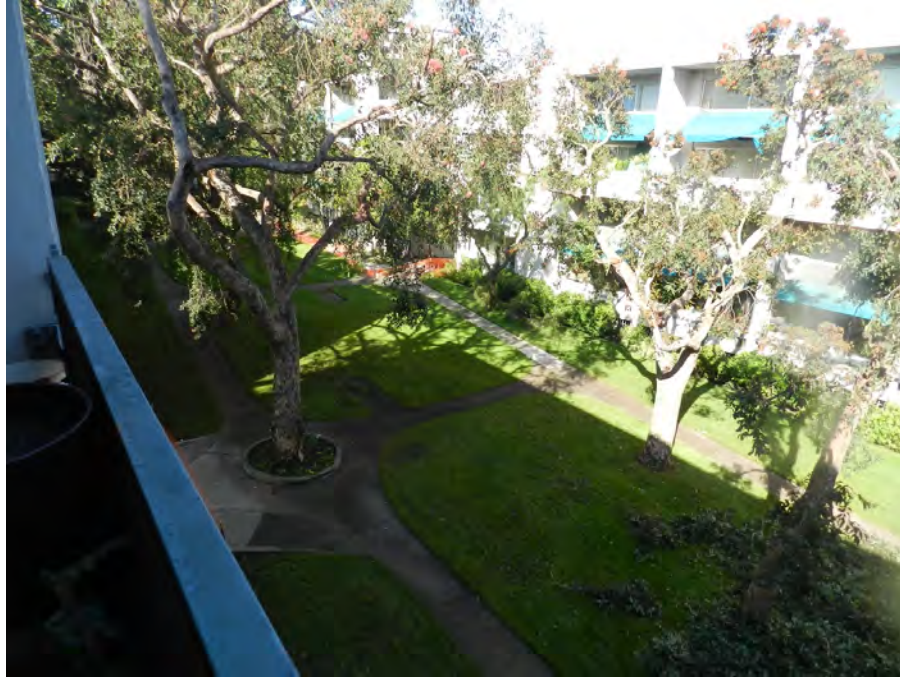
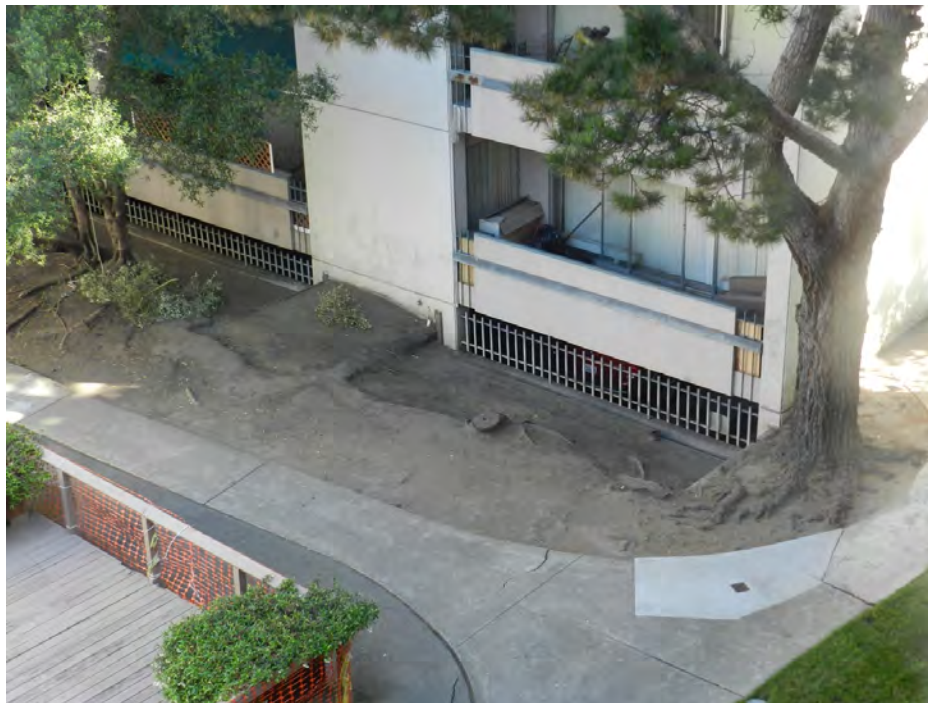
Landscaping drainage occurs into the soils or into drains located in the landscaped areas. Landscaping drainage is discussed below in "Landscaping." Drainage around the building perimeters is not ideal in that excessive rainwater can run off and sheet in the down slope direction. Erosion around the buildings was noted.

*Soils erosion around building 1415 Scott*

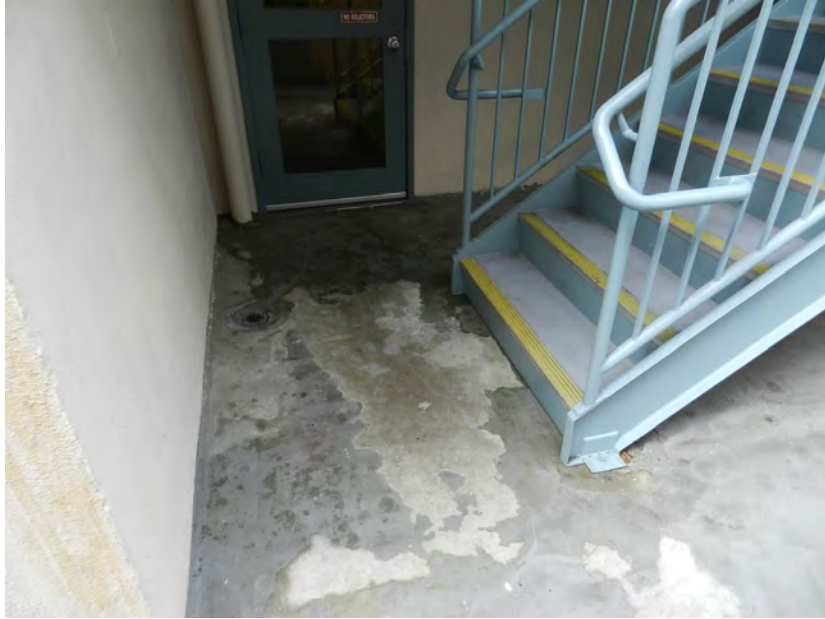
The other issue with the entry stairs is clearance. There is inadequate clearance between the 1<sup>st</sup> floor stairs and entry/door swing into the first floor. See photo below. Removing the stairs or otherwise altering them to create more clearance is not truly and option.

*Stair at level 1 with corridor entry door beyond*

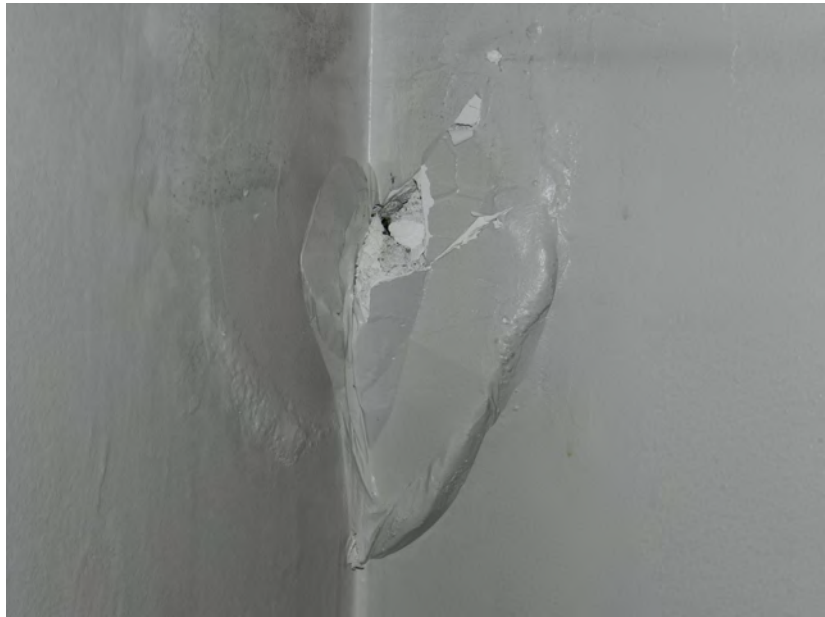
Building entry stairs are located at each end of the buildings. Each building, therefore, has two sets of stairs that provide access into the each level of the buildings. The stairs were installed in mid 2010. The new stairs are constructed of metal framed landings, metal framed stair sets – metal tread sets, stringers and railings. The steps are finished with a waterproof topping and textured metal tread nosing. The stairs themselves are in good condition. Installation of the stairs was done by attaching the stair sets to the building exteriors – the results of which have been problematic. Attaching the stairs to the building framing caused and continues to cause moisture penetration into the unit interiors that exist on the other side of the stair walls. The impact of installation damaged the concrete walls. While some repairs were made after installation, the damage inside units was not completely repaired. In some units, such as the end units at 2040 O'Farrell (Unit 101) and 1450 Divisadero, the concrete at the living room walls is bulged in from stair installation.

*Damage from stair installation at living room of 1 bedroom unit*

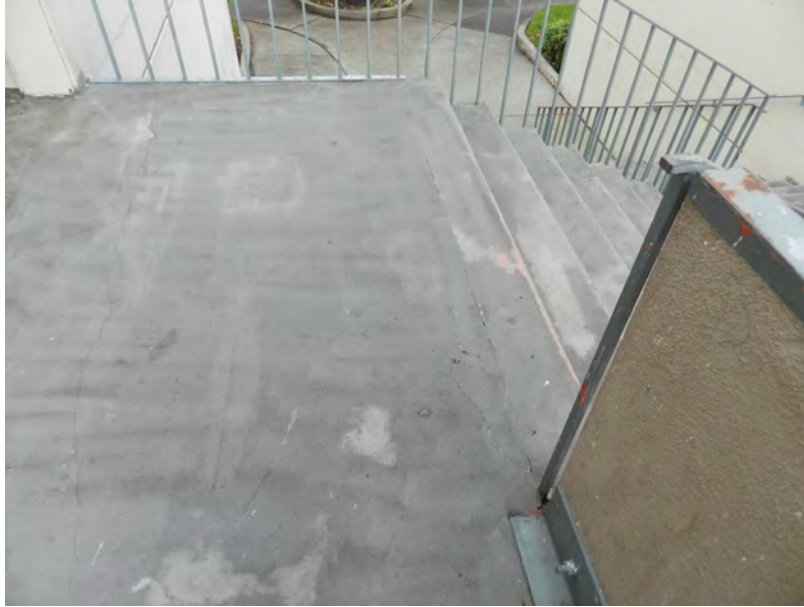
Each building is accessed via concrete steps that lead up to a landing section. Buildings 2-3 and 5-6 share entry steps and landings. Without exception, these exterior steps are in poor condition and should be replaced with redesigned building approach stairs and landings. The issues with the stairs and landings are the ongoing failure of the concrete topping, compromised framing, excessive wear and accessibility. Accessibility is discussed later in this report.

*Landing at approach stairs at 2060 O'Farrell*

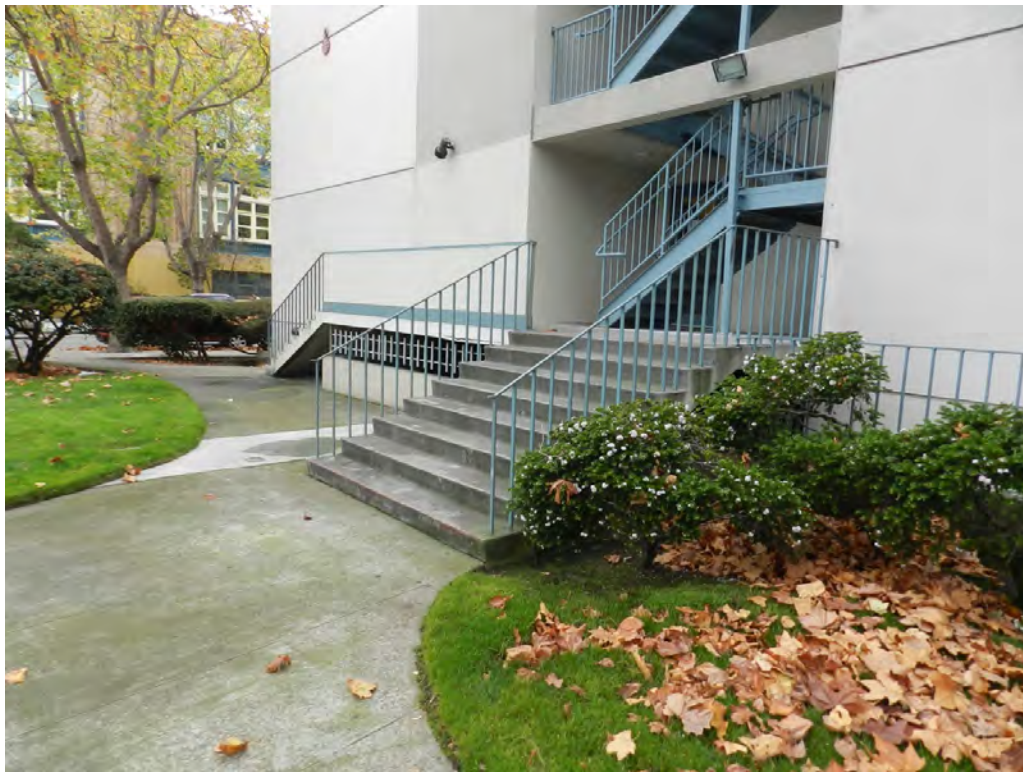
*1415 Scott – north side steps and access stairs*

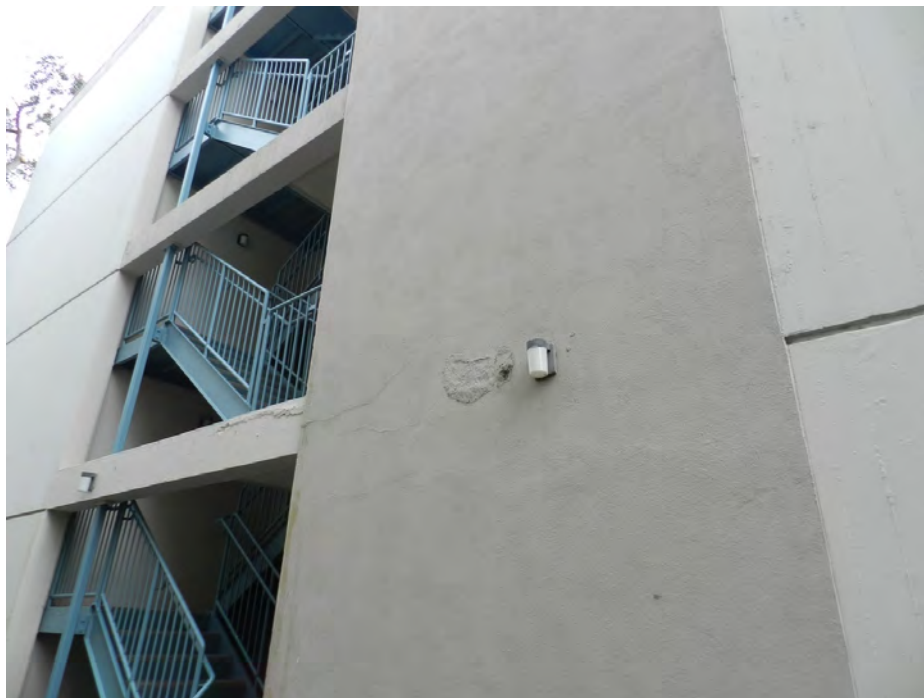
Lighting was not observed during dark hours, but it is assumed given the age, quantities and location of the exterior lighting that lighting is inadequate. All exterior lighting, including building mounted lights and garage lights, should be replaced with upgraded and efficient fixtures. Additional lighting is recommended around and in the garages.

*Building mounted lights*

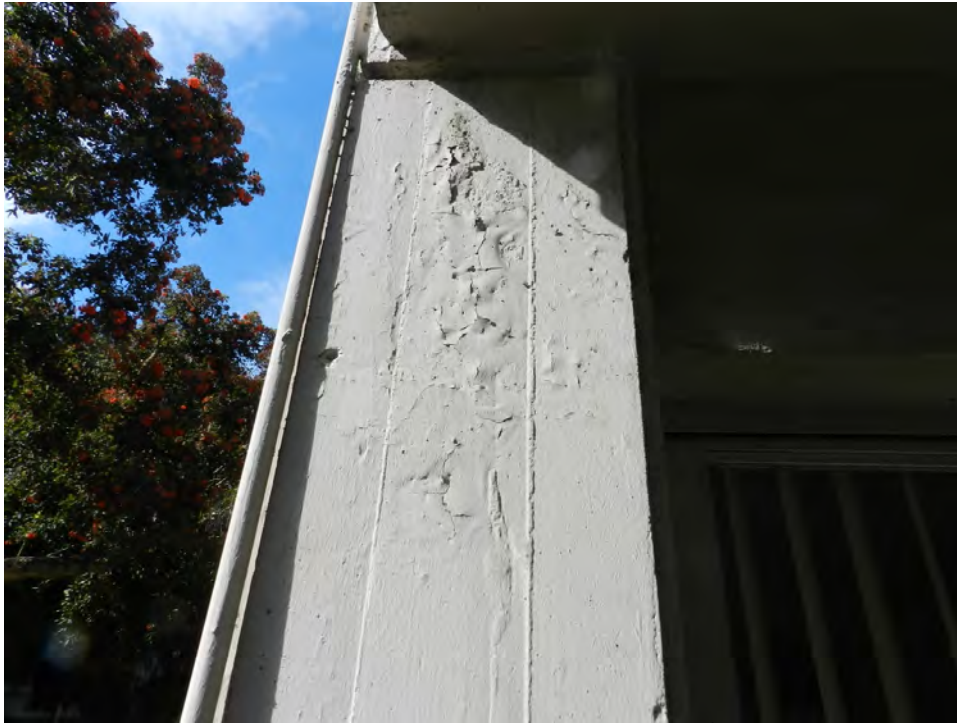
The condition of the exterior siding is fair to poor, depending on location and wear over time. Paint is peeling in many locations. Damages to the building exteriors from age and wear and water penetration have occurred. Extensive siding work for repairs, waterproofing and paint will be necessary in the immediate scope of work. All siding work should be conducted in conjunction with any necessary structural, envelope, roof replacement and deck repair work.

*Bubbling paint at exterior wall – 2040 O'Farrell 2<sup>nd</sup> floor balcony*

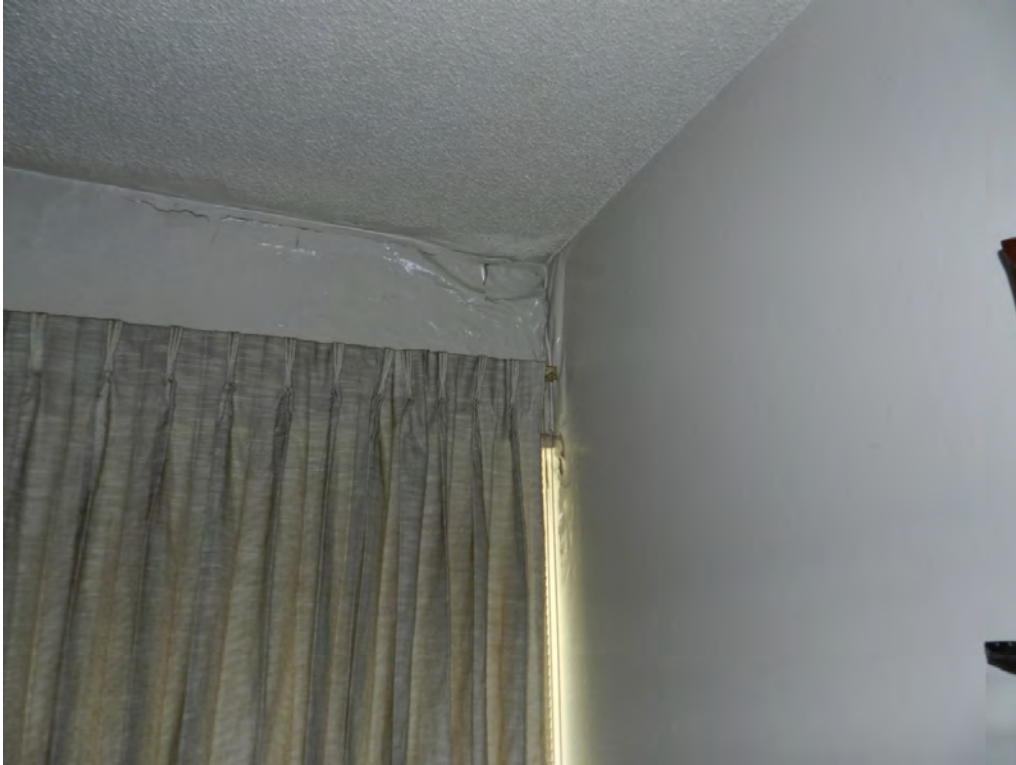
*Water penetration into unit – presumably from deck or window above*

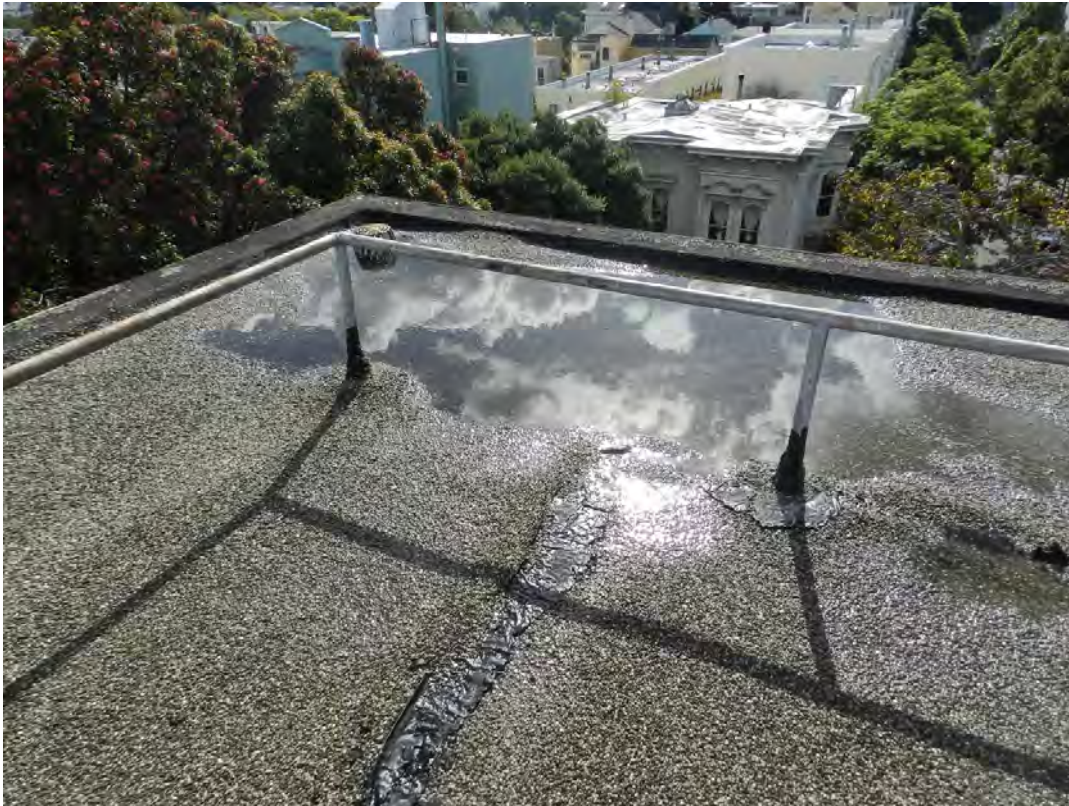
The roofs of all buildings were observed and inspected on October 23, 2012, one day after a moderate rain storm. The roofs of 1450 and 2060 had been patched because of leaks from that storm. All roofs had standing water.

The condition of all roofs is poor and all need to be replaced in the immediate scope of work.

*Standing water at 2060 O'Farrell – repairs had been done the day before*

When roof systems are replaced, drainage schemes should be evaluated. At a minimum, the installation of overflows and additional drains should be considered. Roof deck sloping should also be corrected since water ponding is prevalent on all roofs. Installation of maintenance safety systems may also be necessary.

When roof surfaces are replaced, the contractor should provide a minimum 20 year guarantee on the materials and an acceptable minimum term guarantee on installation. Consideration should be given to using a “cool” roof finish material to maximize energy efficiency.

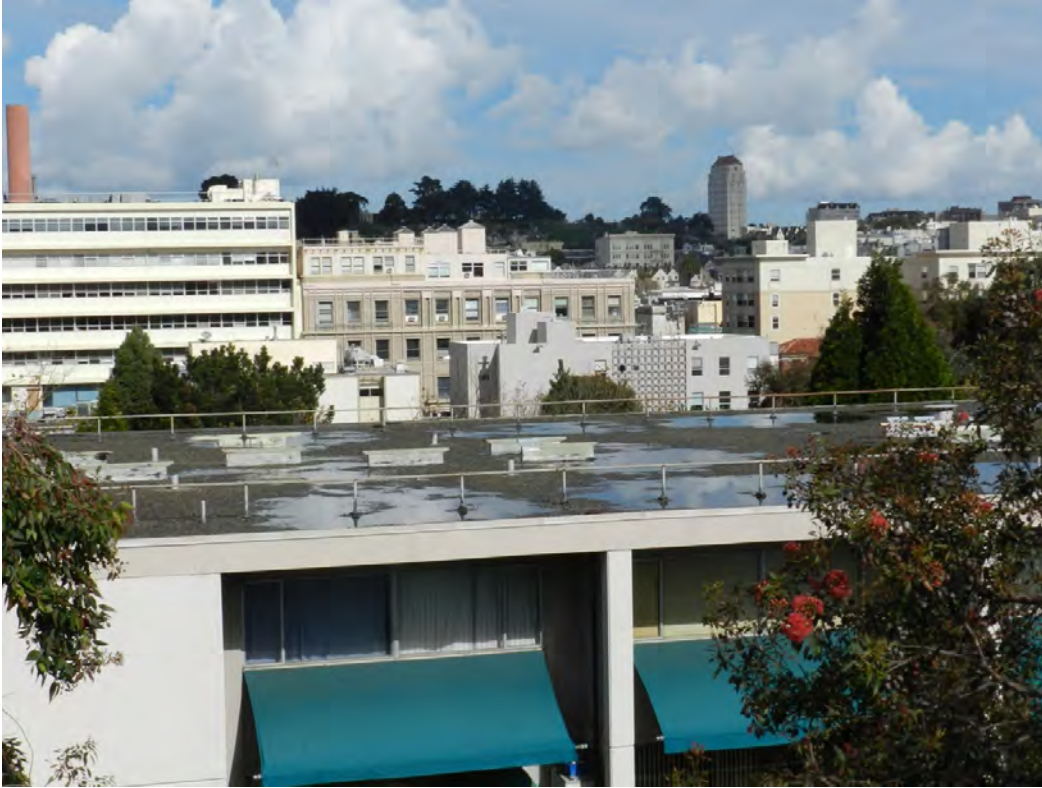
*2141 Geary Roof*

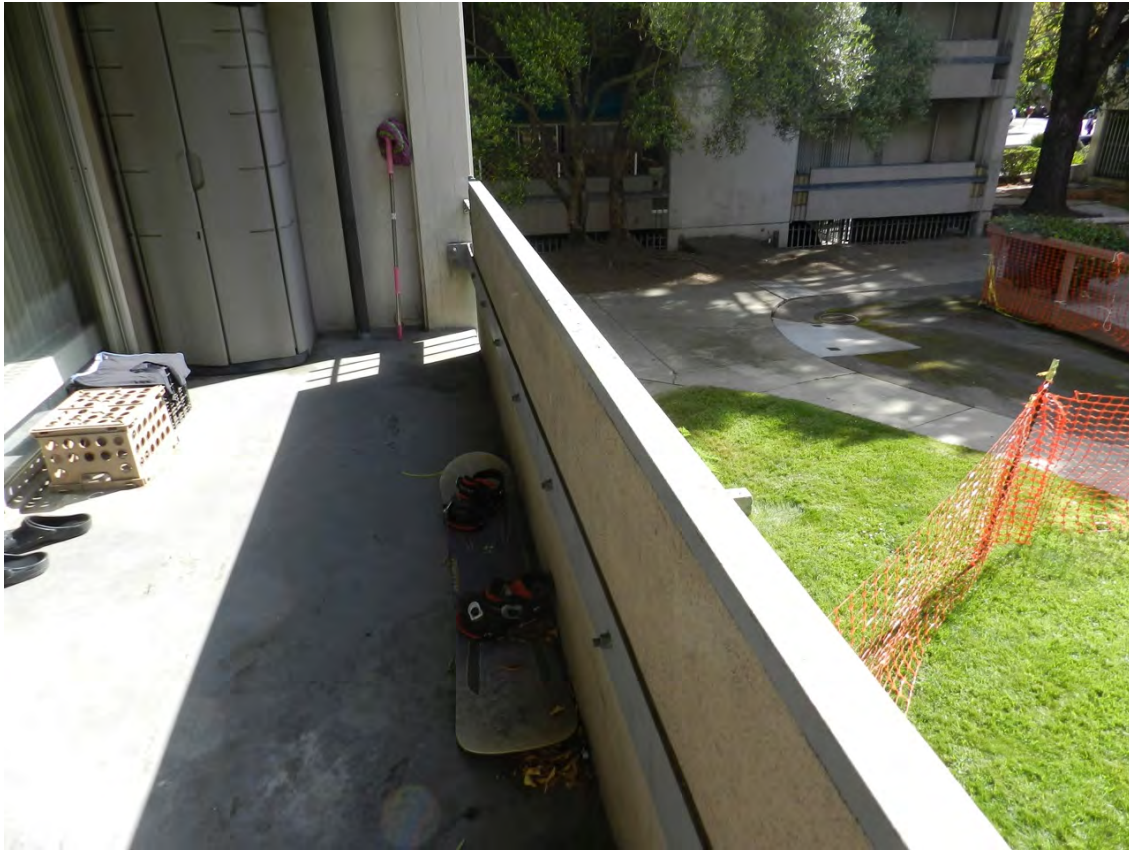
Each unit has at least one balcony. A few of the three bedroom units have balconies on the 2<sup>nd</sup> floor. The condition of the balconies is uniformly poor. The decks are framed into the buildings. They are constructed of reinforced 8" concrete. Most decks have been painted over and over again with various types of paint or waterproofing materials. Deck railing consists of metal railing sections and lightweight concrete or stucco walls. Some reinforcement metal was installed to fortify the wall-to-railing connections in most units.

Decks have been problematic over time because of drainage and sloping. Drain openings have become worn or clogged over time. Decks do not slope away from the sliding glass doors or windows. In several units, improvisations have included drilling holes through the concrete at various locations to allow water to drain down. In some cases, draining down means draining onto the deck below or into the garages. In some cases, the drilled holes are placed within a few inches of the sliding glass door walls.

*Balcony – Solid wall and deck surface*

The solutions for improving the deck drainage may be challenging. Re-sloping the decks in a long-lasting way would involve extensive changes, and it would be very costly. At the very least, the existing drains should be unplugged or repaired. The drilled holes should be plugged up. Deck surfaces should be resurfaced. This work will involve removing the existing paint and other materials to achieve a smooth, material ready surface. The solid walls for the deck fencing should be repaired as needed.

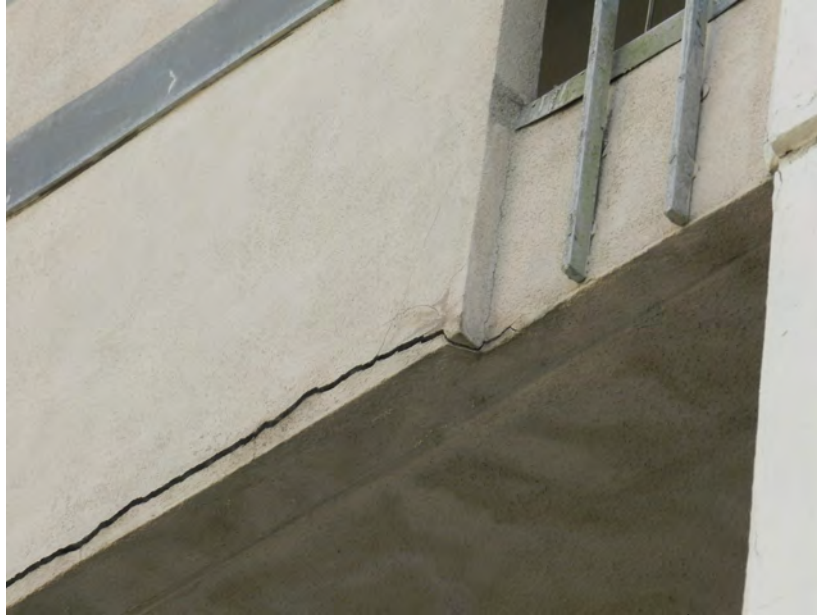
*Deck wall detail – separation noted in some locations (this is the 3<sup>rd</sup> floor of 1450 Divisadero)*

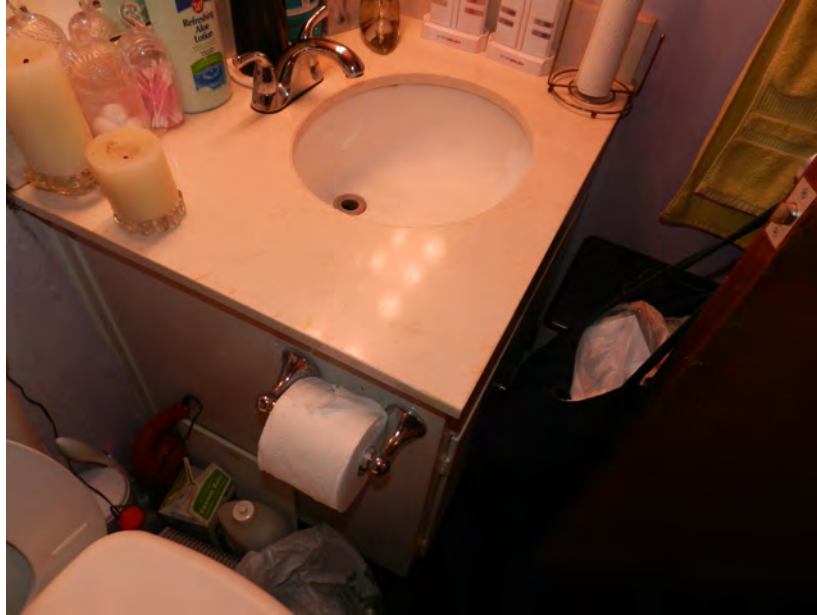
The bathroom sinks are nearly all “sunk in” installations where the counter is installed over the top of the sink. The sinks are set in plastic laminate vanity counters. Many sinks, counters and cabinets at the bathrooms are in poor condition - as noted on the Unit Matrices. Uniform replacement of the vanity cabinets and sinks is recommended in the immediate scope of work.

*Typical vanity in two bedroom unit*

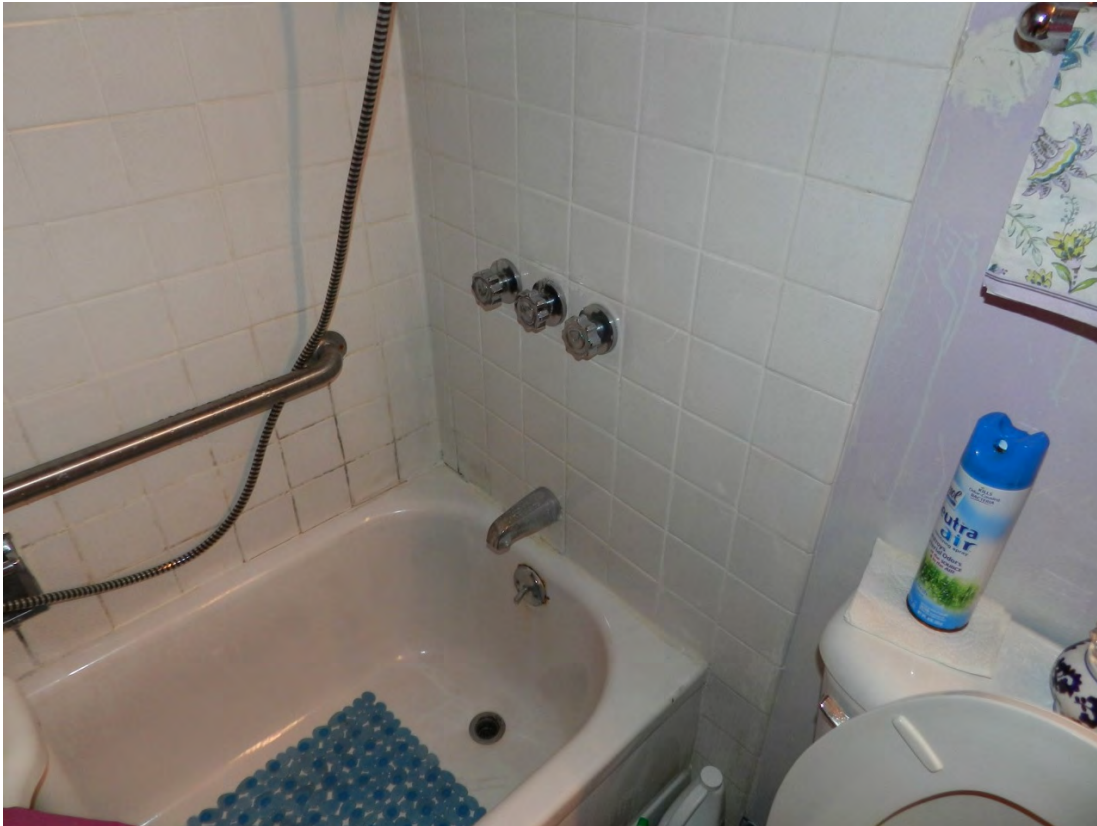
All units have at least one bathroom with a tile surround and enameled steel tub. The three bedroom units where both bathrooms are upstairs, the hallway bathroom contains a stand up shower stall and pan. Without exception the shower stalls are in poor condition. In some cases, the deterioration is remarkable. All surrounds, tubs and stalls should be replaced in the immediate scope of work.

*Typical original surround and tub*
