ASSET RESERVE ANALYSIS

35 – 45 Onondaga Avenue, San Francisco, CA

September 2016

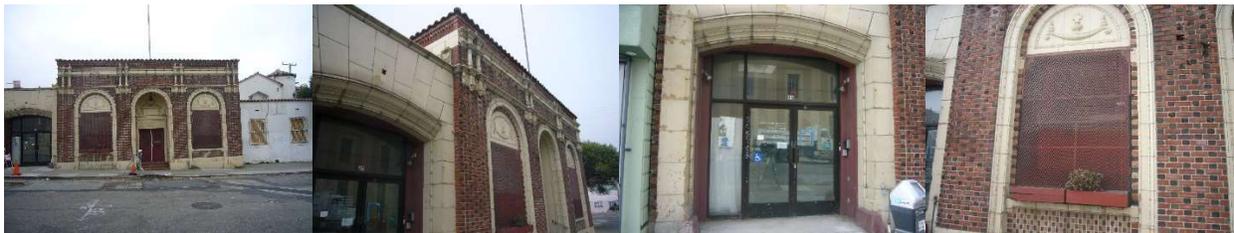
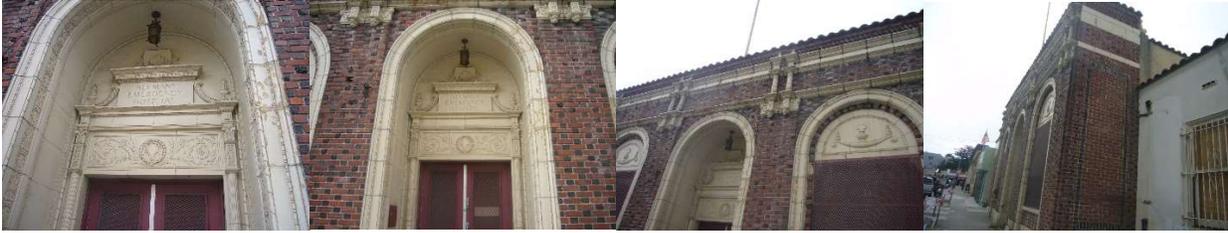
35 Onondaga Exterior

The exterior at 35 Onondaga is a brick façade with marble tile at the entry archways and trim. The windows include one large window and the storefront system on Onondaga, and several windows facing west toward 45 Onondaga. There are some exposed walls at the sides and rear of the building that maybe stucco and should be patched and painted as part of the short-term improvements to the property. The windows are intact and would likely only need some cleaning and painting. The majority of natural lighting are from 24 skylights. We were unable to observe the roof area but it is reported through an architectural survey there are likely damage to the glazing. Repairs to the skylights should be included as part of the immediate improvements prior to any occupancy. There are two entrances on Onondaga. The former emergency entrance is an aluminum storefront, and a pair of metal doors at the main entrance. The doors appear intact and may only require minor maintenance and new hardware in the short term. There appears to be no other immediate needs to be addressed as part of the short-term improvements to the property.

- Replace Roofing
Estimated cost: \$35,000 - \$40,000 35 Onondaga
Estimated cost: \$10,000 - \$15,000 45 Onondaga
- Repair, prep, and paint exterior. Includes major stucco repair at 45 Onondaga
Estimated cost: \$10,000 - \$15,000 35 Onondaga (rear and side areas)
Estimated cost: \$35,000 - \$45,000 45 Onondaga

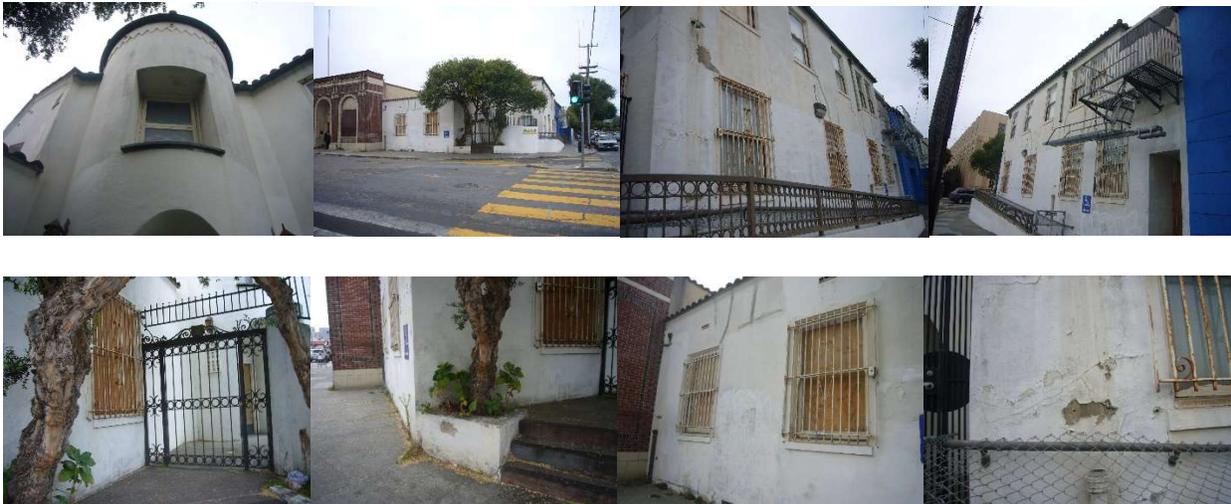
45 Onondaga Exterior

The exterior at 45 Onondaga is a stucco finish on metal lath. There is a large amount of cracking and damage to the stucco, and requires immediate patching and painting at the very minimum prior to any occupation in the building. There is potential for dry rot and mold inside the walls and some destructive surveys behind the stucco is recommended to determine the extent of damage to the framing. The windows include one large window and the storefront system on Onondaga, and several windows facing west toward 45 Onondaga. There are 26 double-hung windows with varying amounts of damage to the glazing and many are boarded up. The windows appear relatively intact and should be repaired and glazing replaced as part of the immediate improvements to the property. There are also 3 skylights of unknown condition. The security bars over the lower level windows should be removed and, if needed replaced with safety gates. There are two forms of egress along Alemany. The rear entrance needs a new door frame, door and hardware, and the front door may require some repairs and new hardware.

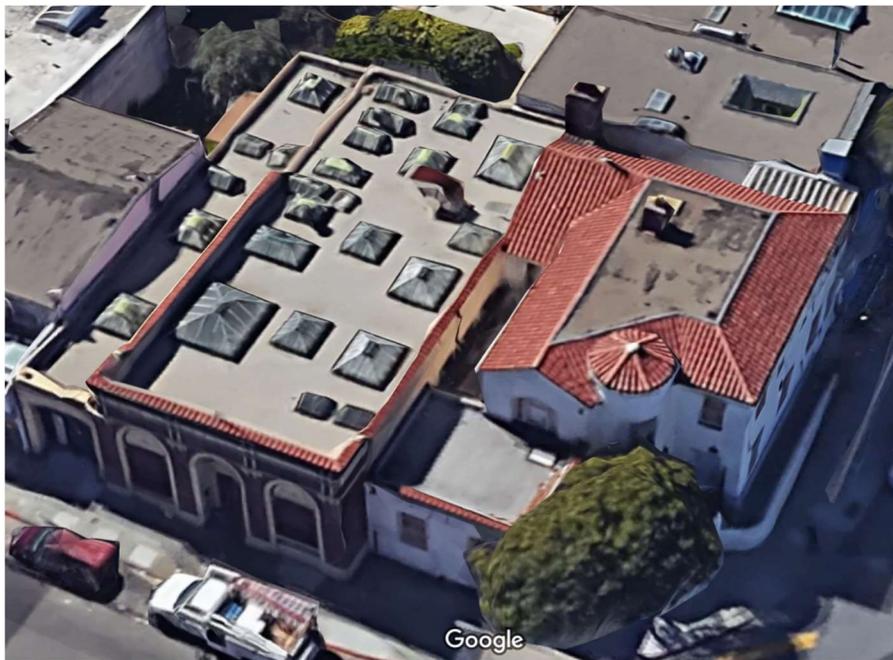
35-45 Onondaga Roof Areas

We were not able to access the roof for this survey. The roofing appears to primarily a flat roof with clay barrel roof tiles around the perimeter. The roof at 35 Onondaga has 24 skylights of varying sizes, and based on what was observable from the interior of the space, most need extensive cleaning throughout, and likely replacement of the wire glazing in many of the skylights. Additionally, 45 Onondaga has 3 skylights over the low roof section. The roof tiles appear intact and undisturbed. There is evidence of some roof leaks at both properties and the flat roofs should be assessed for replacement as part of the short-term improvements to the property. There is record of a roof replacement in 2006 for 35 Onondaga but an assessment is recommended.

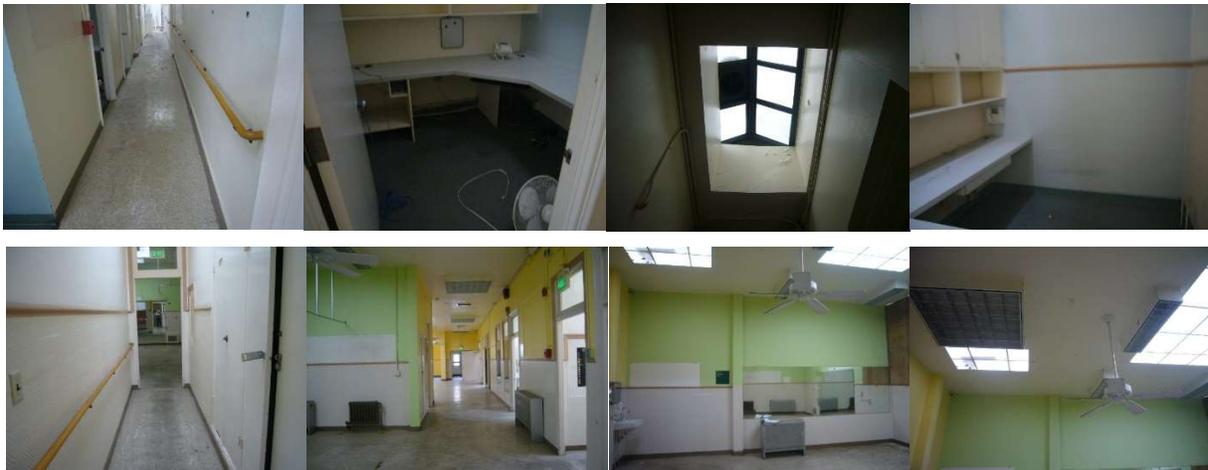
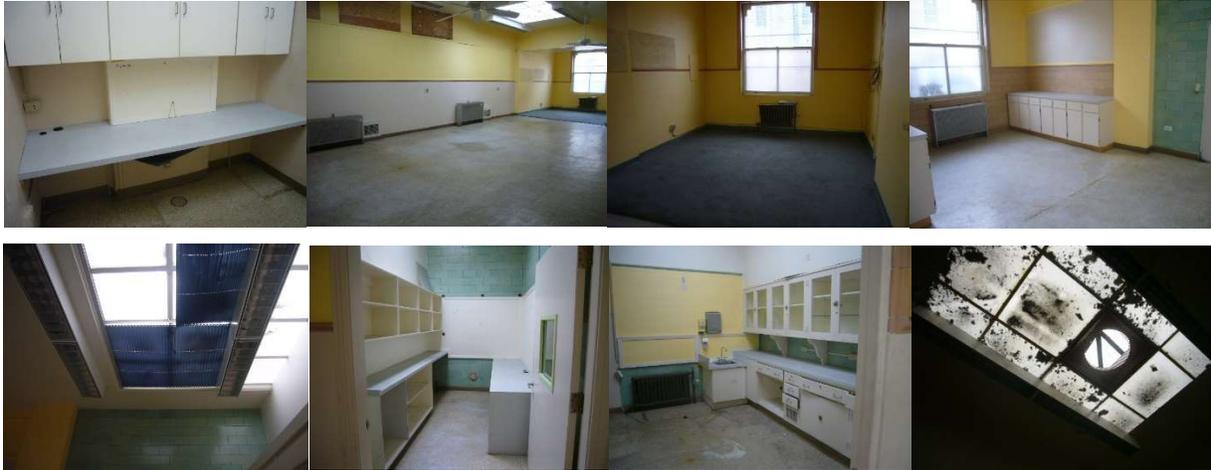
35 Onondaga Interiors

The property interior includes a concrete wall along the west side of the former emergency entrance, the remaining primarily plaster walls, and possibly some gypsum wall where there appears to be some added partition walls. The walls at the open activity areas and hallways appear to have a burlap fabric wainscoting to 5' above the finished floor and trimmed out with a ceramic tile bullnose trim. There are also areas that have ceramic tile wainscoting that varies from 5' to full height walls. The ceilings are mostly open to the deck with some plaster ceiling sections. There is a large amount of peeling of paint at the walls and ceilings but the walls and ceilings all appear generally intact

The flooring is primarily linoleum in the corridors, and activity areas. There are tiled flooring in the restrooms at the emergency side of the building and linoleum in the restrooms on the activity side of the building. There is carpeting in the offices on the emergency entrance side of the building. The flooring overall is generally poor but serviceable in most areas. Carpeting and the restrooms with linoleum should also be replaced in the short-term improvement plan. The remaining linoleum ideally should be replaced, but is serviceable and could potentially be deep cleaned and sealed. Another option that could be explored is that the hospital flooring may have been a terrazzo concrete finish (The mop sink in the other building happened to be terrazzo). If this is the case, pulling off the flooring and polishing the floor could be a possible.

There is a large amount of built-in casework in many of the rooms, and they appear in generally serviceable condition. A minimum of cleaning and minor repairs may only be needed for reuse.

- Prep and paint interior finishes.
Estimated cost: \$20,000 - \$25,000 35 Onondaga
Estimated cost: \$25,000 - \$30,000 45 Onondaga
- Replace flooring
Estimated cost: \$25,000 – \$30,000 35 Onondaga (Linoleum)
Estimated cost: \$1,500 – \$2,000 35 Onondaga (Carpet)
Estimated cost: \$15,000 – \$20,000 45 Onondaga (Carpet)
Estimated cost: \$600 – \$700 45 Onondaga (Kitchen)

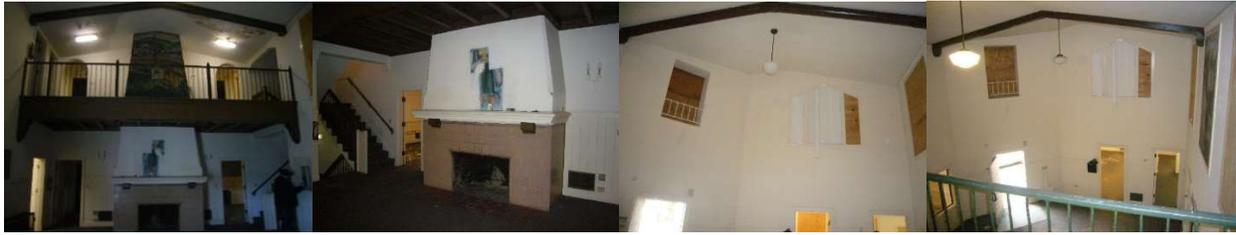
45 Onondaga Main Lobby Area

The main lobby area with the fireplace and murals are in good condition and require only new flooring and paint.

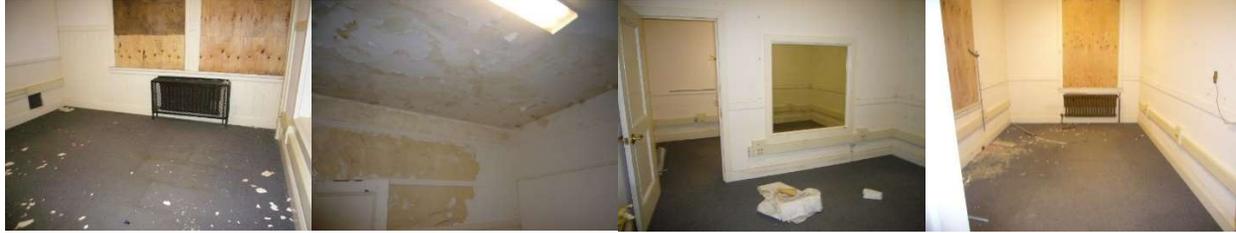
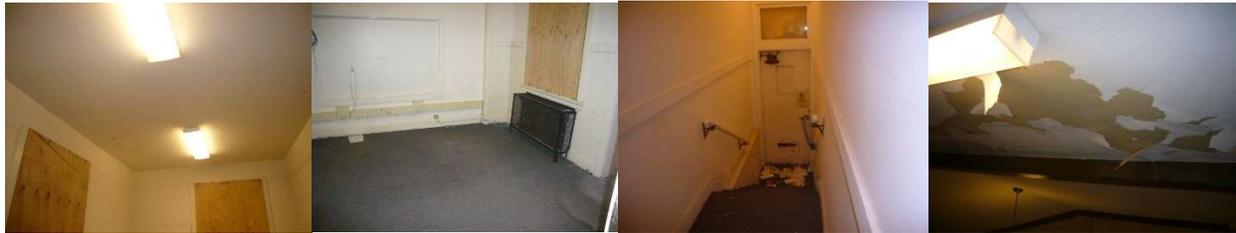
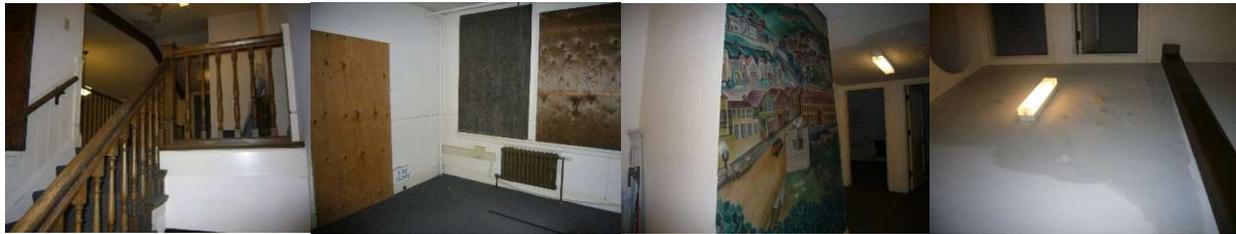
45 Onondaga Interiors

The property interior is primarily plaster walls, and possibly some gypsum wall where there appears to be some added partition walls, in particular, there are two walls with observation mirrors built in, one on each floor. The ceilings are plaster ceilings. There is a significant amount of peeling of paint at the walls and ceilings but the walls and ceilings all appear generally intact and cleaning, patching, and painting will be needed.

The flooring is primarily carpeting, which will need to be replaced. There are restrooms on the first and second floors, which are not accessible, with tile or terrazzo finishes, and a mop sink on the first floor with terrazzo finish.

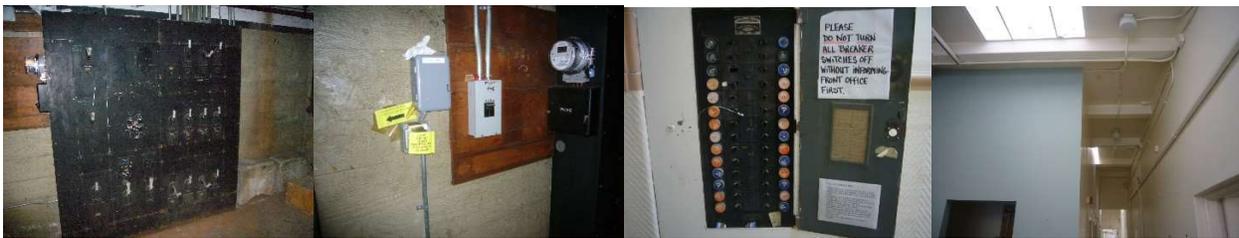
35 Onondaga Electrical Panel, Meter, and Distribution

The main switchgear panel and meter is located in the basement. A subpanel is located in the rear of the building between the emergency corridor by the kitchen. The lighting is a mixture of ceiling-mounted fluorescent fixtures. There are illuminated exit signage and emergency lights throughout the building. The lighting and electrical appears adequate for immediate occupancy.

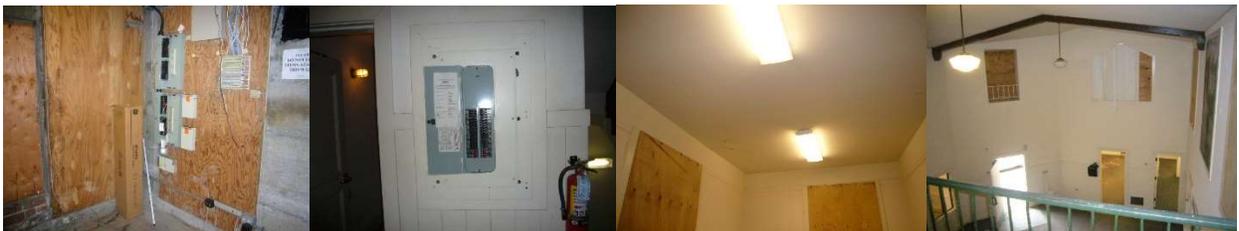
45 Onondaga Electrical Panels and Lighting

The main panel is located in the basement. A subpanel is located on the first floor by the main stairs. The lighting includes original pendant fixtures in the main lobby, and ceiling-mounted fluorescent fixtures throughout. All appears adequate for immediate occupancy.

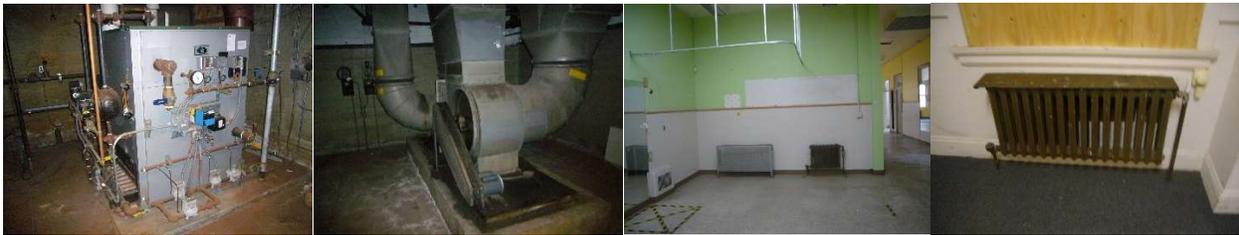
HVAC at 35 – 45 Onondaga

The HVAC consists a single 850,000 BTU boiler providing hydronic heating throughout both building through radiators. The system was (installed) maintained and repaired by the SFDPW from 2004 through its decommissioning in 2012. Recommissioning would be required for occupancy. There is an existing exhaust fan system at 35 Onondaga but the operational status is unknown. There are ceiling fans in the main activity areas. There are no other existing cooling or ventilation systems.

- Recommission Boiler and Heating System
Estimated cost: \$3,500 - \$5,000 Recommission Boiler
Estimated cost: \$2,500 - \$3,000 Inspection and Maintenance of Radiators

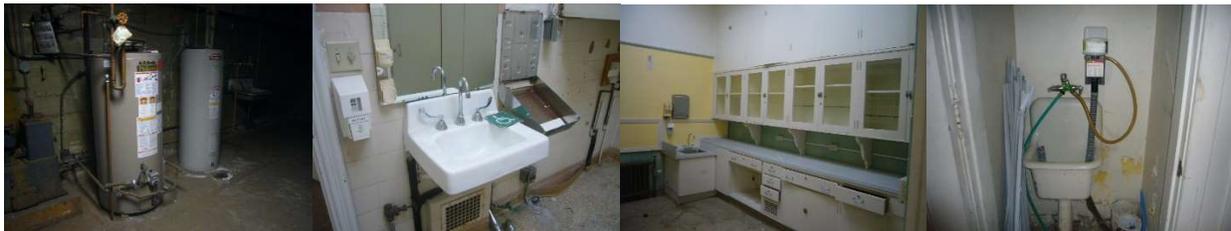
35 – 45 Onondaga Plumbing and Fixtures

Domestic water is assumed to be through a combination of iron and copper piping throughout based on what limited access allowed. Domestic hot water is provided by separate hot water heaters in each building. It is unknown the condition of the existing water heaters, but should be replaced prior to occupancy. The fixtures in both buildings are relatively intact and require only cleaning and maintenance to bring it up to serviceable levels for immediate occupancy.

- New Fire Alarm System
Estimated cost: \$12,000 - \$15,000 35 Onondaga
Estimated cost: \$12,000 - \$15,000 45 Onondaga
- New Water Heaters, Commercial Grade
Estimated cost: \$3,000 - \$4,000 35 Onondaga
Estimated cost: \$3,000 - \$4,000 45 Onondaga

- Repair/Replace Plumbing Fixtures, Commercial Grade
Estimated cost: \$3,000 - \$4,000 35 Onondaga
Estimated cost: \$3,000 - \$4,000 45 Onondaga
- Allowance for Ingress/Egress ADA compliance
Estimated cost: \$40,000 Hardware Upgrades, Door Swing Changes

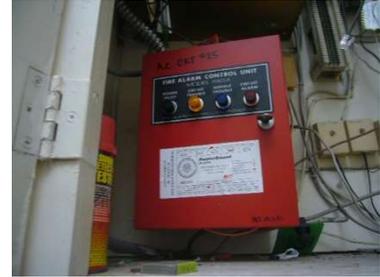
The space is non-sprinklered, and a fire alarm was previously installed, which includes emergency alarms/ pull stations. There appears to be no smoke alarms, and no horns/strobes. The system needs to be checked for operational conditions and may not be up to current code. Fire and life safety will need to be determined for compliance.

Per observations by a report by Steiner Architects dated February 22, 2016: *Compliant egress hardware and exit signage and evacuation signage are missing throughout. There are two double-door exits at the front of the building for occupant egress to Onondaga Avenue.*

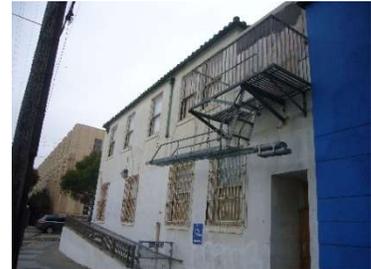
The space is non-sprinklered and there is no fire alarm in the building. The second floor includes a rear exit door to a porch and fire escape. Fire and life safety will need to be determined for compliance.

Per observations by a report by Steiner Architects dated February 22, 2016: *The rear exit door at the first floor (required second means of egress) is non-functional/ secured shut. At the second floor, the rear exit door (to the northwest sun porch) and fire escape (installed in 1993) need further investigation to determine compliance, or corrective measures, to ensure a second means of egress. Egress door swing directions based on current code and occupant loads need to be verified or corrected as required.*
