2021 de Young Museum Accessibility Review - Key Findings

APPENDIX A: DEFICIENCY REPORT

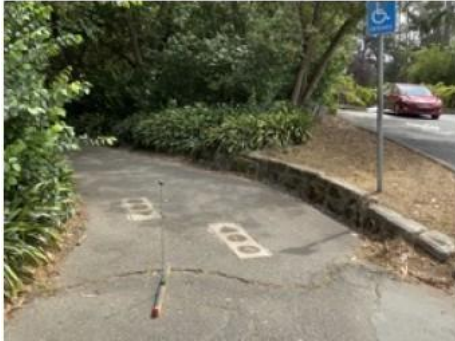
Deficiency: Accessible Route - Vertical Displacement - Height

Accessible route leading from bus stop and 2 accessible parking spaces located at Fulton Street entrance to accessible route has a large crack creating a 2-inch change of elevation and creates a tripping hazard along entire width of walk.

Measurement: 2 inches

Replace/grind locations where changes in elevation occur. Changes in level of ¼" high maximum shall be permitted to be vertical and without edge treatment. Changes in level between ¼" high minimum and ½" high maximum shall be beveled with a slope not steeper than 1:2. ADA Advisory: Change in level of ½" is permitted to be ¼" vertical plus ¼" beveled.

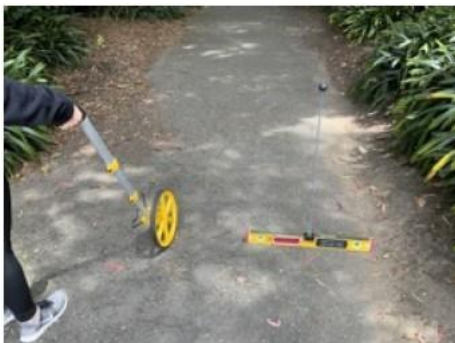
Deficiency: Accessible Route - Slopes - Cross Slope

The cross slope of accessible routes exceeds 1:48 (2.0 %). 21' into accessible route from Fulton street cross slope of 3.6%.

Remove and replace walk. Install walk that provides cross slopes at circulation route of 1:48 maximum.

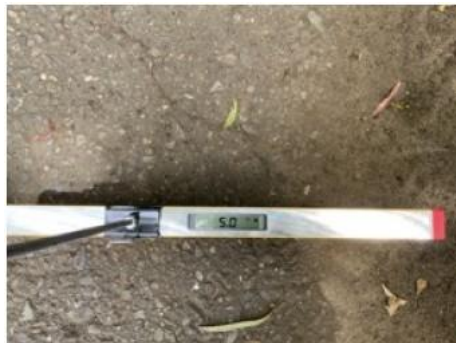
Deficiency: Accessible Route - Slopes - Cross Slope

The cross slope of accessible routes exceeds 1:48 (2.0 %). 29' into accessible route from Fulton street cross slope of 5%.

Remove and replace walk. Install walk that provides cross slopes at circulation route of 1:48 maximum.

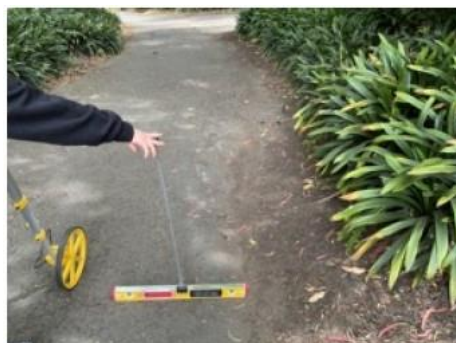
Deficiency: Accessible Route - Slopes - Cross Slope

The cross slope of accessible routes exceeds 1:48 (2.0 %). 37' into accessible route from Fulton street cross slope of 5.7%

Remove and replace walk. Install walk that provides cross slopes at circulation route of 1:48 maximum.

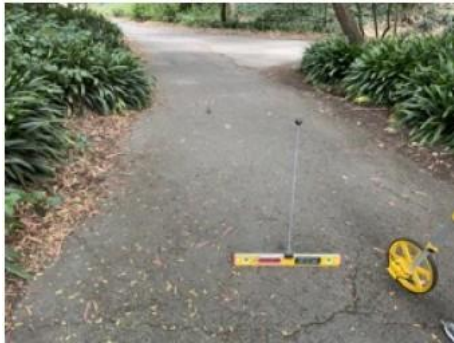
Deficiency: Accessible Route - Slopes - Cross Slope

The cross slope of accessible routes exceeds 1:48 (2.0 %). 52' into accessible route from Fulton street cross slope of 3.0%

Remove and replace walk. Install walk that provides cross slopes at circulation route of 1:48 maximum.

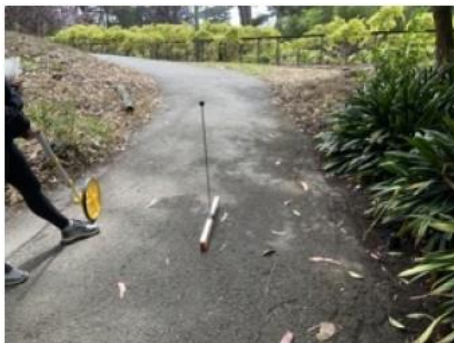
Deficiency: Accessible Route - Slopes - Running Slope

The slope in the direction of travel exceeds the allowable 5%. Approximately 110' into accessible route from Fulton street running slope of 19.2%.

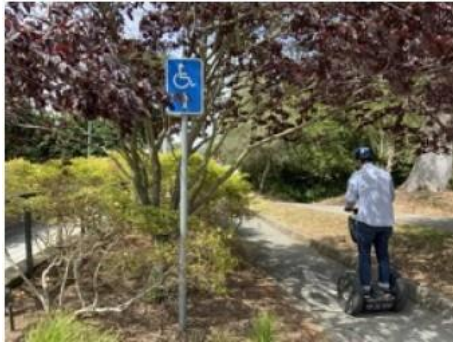
Deficiency: Accessible Route - Directional Signage - General

Along JFK Street the directional sign is located at the designated bike path. Signage is not aligned correctly at the beginning and the end of the routes. Signage needs to be added and revised once accessible routes are designated correctly.

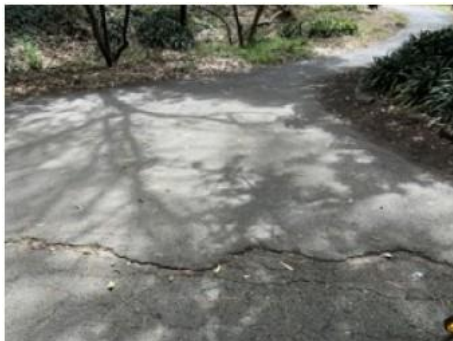
Deficiency: Accessible Route - Directional Signage - General

There is no directional signage where paths connect to the accessible route. Path leads to playground and up to JFK drive and de Young Museum. Neither connect to an accessible route even though entrance to path shown as designated accessible route.

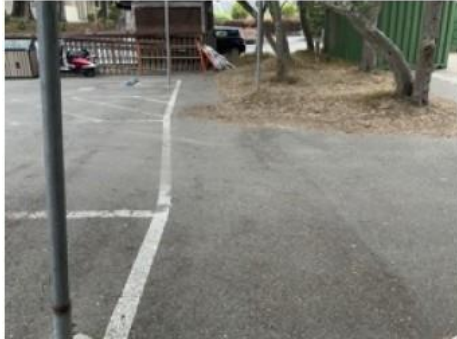
Deficiency: Parking - Accessible Route - Adjacent

Access aisle is not located to an accessible route. It appears ponding had led to debris collecting along the accessible route that connects stall 1 access aisle to an accessible route. The other 3 stalls were compliant.

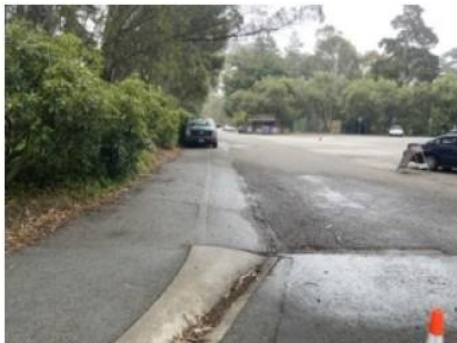
Deficiency: Parking - Accessible Route - Adjacent

The access aisle is not connected to the shortest accessible route that leads to a facility entrance. Vehicles were parked on what would be considered the shortest accessible route leading to the Japanese Garden and de Young Museum both days of the site assessment.

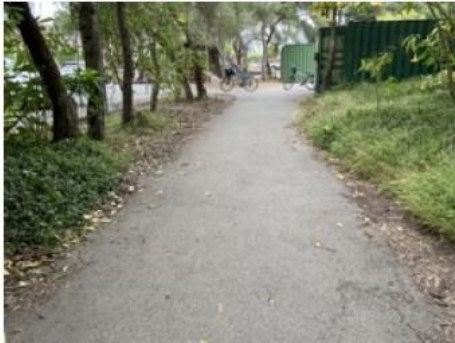
Deficiency: Parking - Accessible Route - Adjacent

The access aisle is not connected to the shortest accessible route that leads to an facility entrance. Containers are blocking the route leading to the other route that would be directly linked to the Japanese Tea Gardens and the de Young Museum. Parking spaces are also located at the far end of the parking lot.

Recommend reviewing the layout of the existing parking lot and relocating the accessible parking spaces that serve a particular building or facility to be located on the shortest accessible route from parking to an accessible entrance.

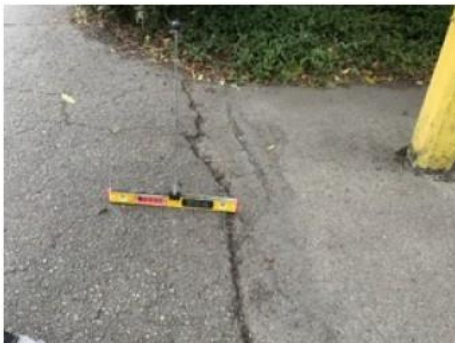
Deficiency: Accessible Route - Slopes - Running Slope

The slope in the direction of travel exceeds the allowable 5% where accessible route from accessible parking at Japanese parking lot connects to MLK Drive.

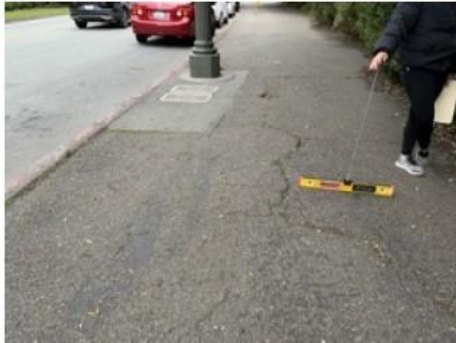
Deficiency: Accessible Route - Slopes - Cross Slope

Multiple locations along MLK where cross slope of accessible routes exceeds 1:48 (2.0 %). Cross slopes ranged from 3.2% to 8.6% between connection to circulation path of parking lot and Hagiwara Tea Garden Drive.

Remove and replace walk. Install walk that provides cross slopes at circulation route of 1:48 maximum.

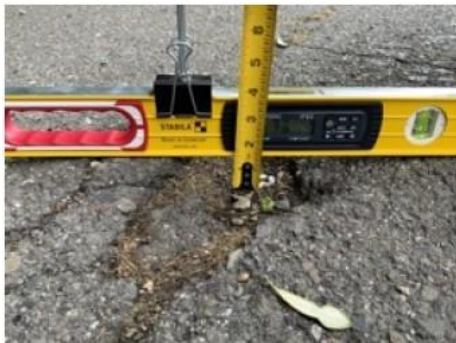
Deficiency: Accessible Route - Vertical Displacement - Height

Accessible route has multiple locations where changes in level over 1/4" vertical or 1/2" beveled occur. Gap in asphalt of 1-1/2" deep x 6" wide is located adjacent to light standard just beyond entry to circulation path leading to accessible parking off of MLK Street.

Replace/grind locations where changes in elevation occur. Changes in level of 1/4" high maximum shall be permitted to be vertical and without edge treatment. Changes in level between 1/4" high minimum and 1/2" high maximum shall be beveled with a slope not steeper than 1:2. ADA Advisory: Change in level of 1/2" is permitted to be 1/4" vertical plus 1/4" beveled.

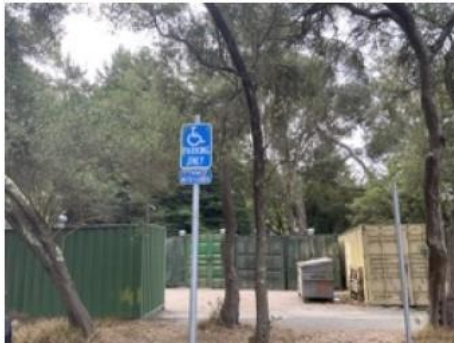
Deficiency: Parking - Signage - Minimum Fine

The parking identification sign does not include the text "Minimum Fine \$250" below the ISA. Typical at all accessible stalls.

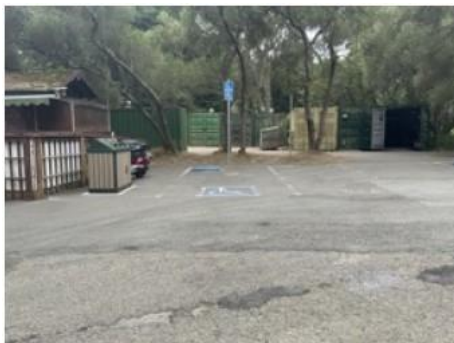
Deficiency: Parking - Access Aisle Markings - General

The adjacent access aisle are not marked correctly. Painting has faded and is not in contrast with asphalt.

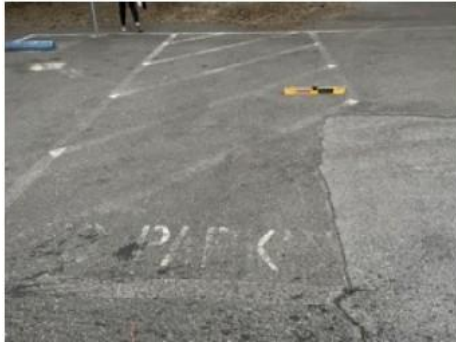
Deficiency: Parking - Access Aisle - Slope

The slope of the access aisle in any direction exceeds 1:48 (2.0%) grade.

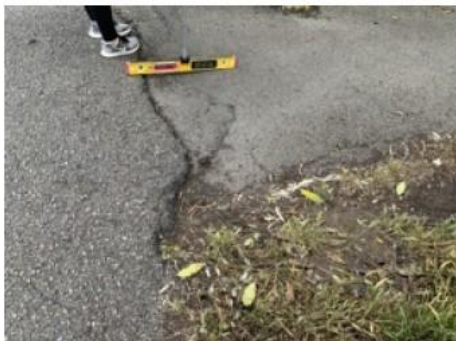
Deficiency: Accessible Route - Vertical Displacement - Height

Accessible route has a change of elevation of 1-1/4" where accessible route from accessible parking at Japanese parking lot connects to MLK Drive.

Replace/grind locations where changes in elevation occur. Changes in level of 1/4" high maximum shall be permitted to be vertical and without edge treatment. Changes in level between 1/4" high minimum and 1/2" high maximum shall be beveled with a slope not steeper than 1:2. ADA Advisory: Change in level of 1/2" is permitted to be 1/4" vertical plus 1/4" beveled.

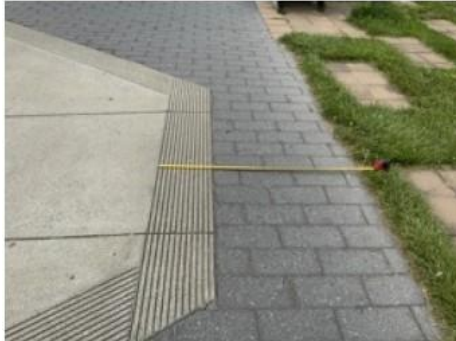
Deficiency: At Grade Transitions - Perpendicular Curb Ramp - Landing Length

Landing does not provide minimum 48 inches length at the top of the perpendicular curb ramp.

Measurement: 46 inches

Replace curb ramp landing. Landings shall be provided at the tops of curb ramps and blended transitions. The landing clear length shall be 48 inches minimum.

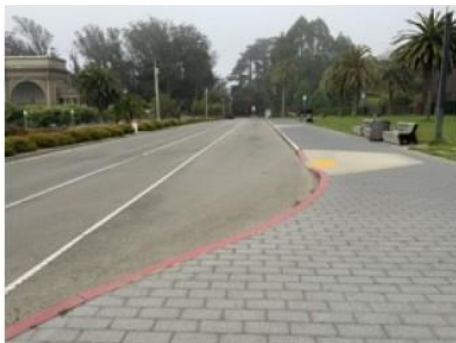
Deficiency: At Grade Transitions - Perpendicular Curb Ramp - Landing Slope

The slope of the landing at the top of the curb ramp near the drive thru ordering location is steeper than 1:48 (2.0%) in any direction. Grooves required to be maximum 1:48. Slopes at grooves is 3.1%. Typical at both drop off areas in front of de Young museum.

Measurement: 3.1 % grade

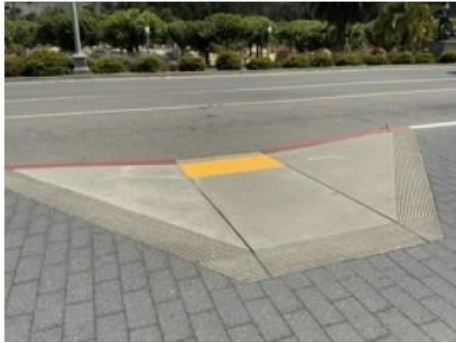
Deficiency: Passenger Drop-off/Loading - Access Aisle - Floor and ground surfaces

Vehicle pull-up spaces and access aisles serving are not at the same level as the vehicle pull-up space they serve. Slopes steeper than 1:48 (2.083).

Measurement: 6 inches

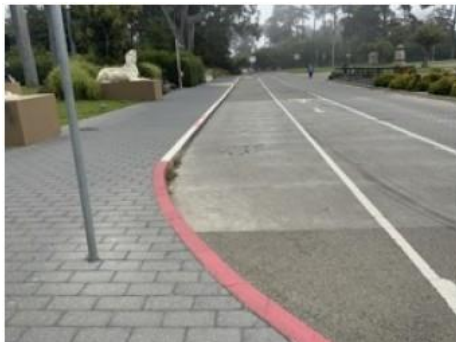
Vehicle pull-up spaces and access aisles serving are not at the same level as the vehicle pull-up space they serve.

Measurement: 0 count

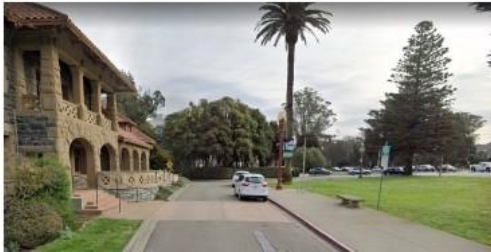
Deficiency: Bus Stops - Loading Zones - Boarding/Alighting

This area needs to be verified as measurements were not taken for shuttle stops.

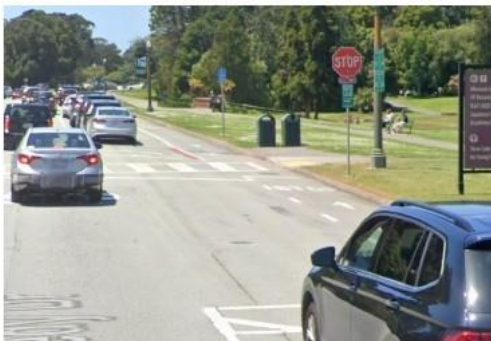
Deficiency: Bus Stops - Loading Zones - Boarding/Alighting

This area does not provide a boarding or alighting area for loading and unloading.

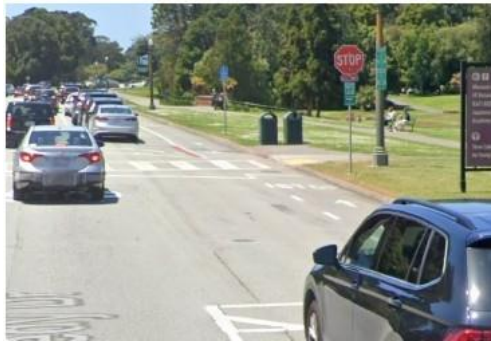
Deficiency: Bus Stops - Loading Zones - Connection

This area does not provide connection with an accessible route to the walk.

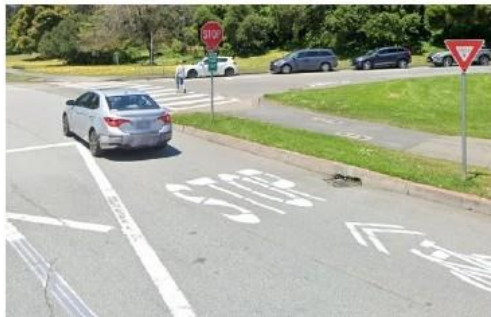
Deficiency: Bus Stops - Loading Zones - Boarding/Alighting

This area does not provide a boarding or alighting area for loading and unloading.

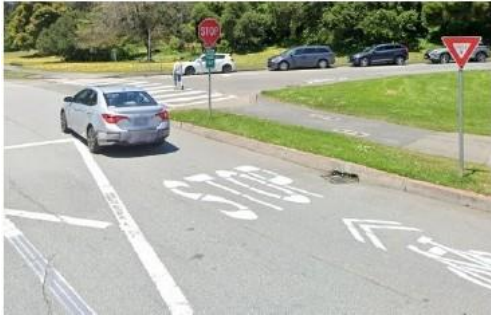
Deficiency: Bus Stops - Loading Zones - Connection

This area does not provide connection with an accessible route to the walk.

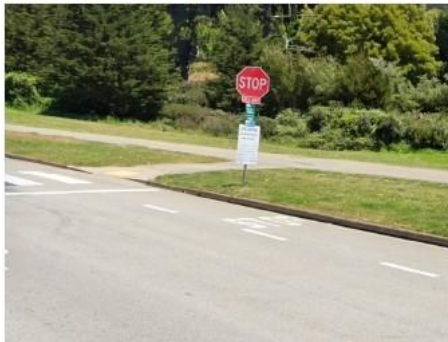
Deficiency: Bus Stops - Loading Zones - Boarding/Alighting

This area does not provide a boarding or alighting area for loading and unloading.

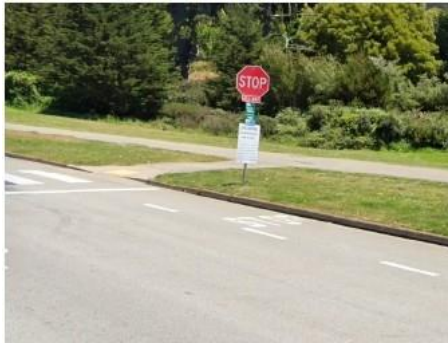
Deficiency: Bus Stops - Loading Zones - Connection

This area does not provide connection with an accessible route to the walk.

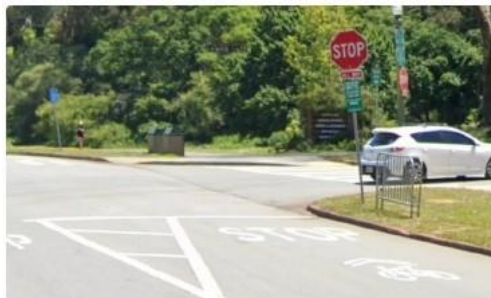
Deficiency: Bus Stops - Loading Zones - Boarding/Alighting

This area does not provide a boarding or alighting area for loading and unloading.

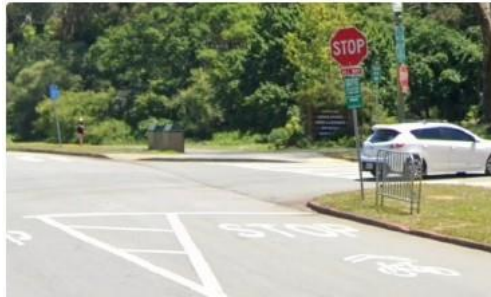
Deficiency: Bus Stops - Loading Zones - Connection

This area does not provide connection with an accessible route to the walk.

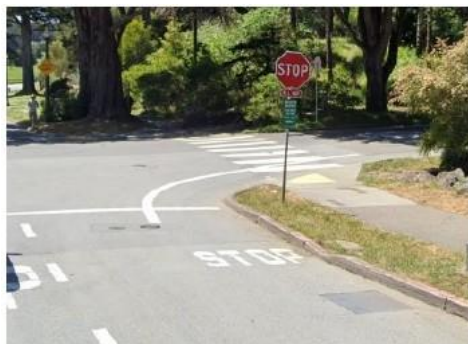
Deficiency: Bus Stops - Loading Zones - Boarding/Alighting

This area does not provide a boarding or alighting area for loading and unloading.

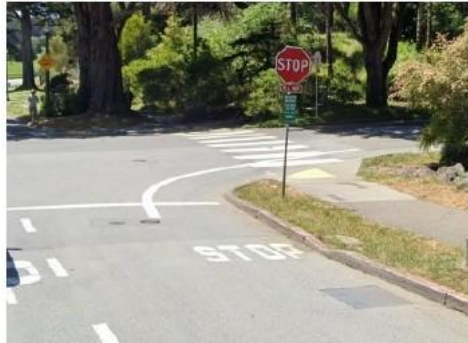
Deficiency: Bus Stops - Loading Zones - Connection

This area does not provide connection with an accessible route to the walk.

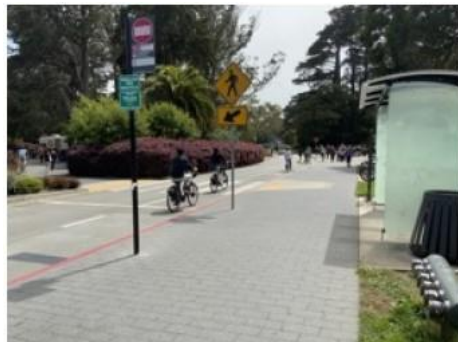
Deficiency: Accessible Route - Protrusion - Post Mounted Objects

Protruding objects posted on two posts more than 12" apart: the lowest part of the object is over 27" or under 80" above finish floor. Bottom of sign is located at 79-3/4" AFF.

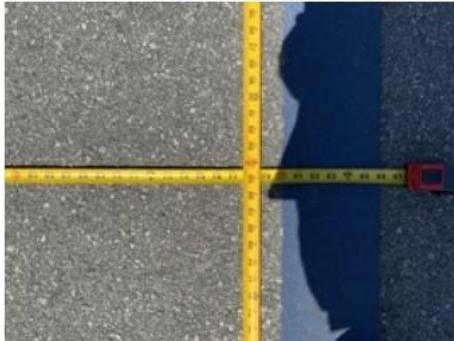
Deficiency: On-Street Parking - Accessible Stall - Width

The parking stall is less than the minimum required width of 96 inches.

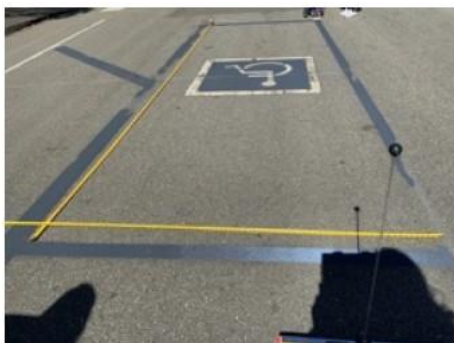
Deficiency: On-Street Parking - Accessible Stall - Width

The parking stall is less than the minimum required width of 96 inches.

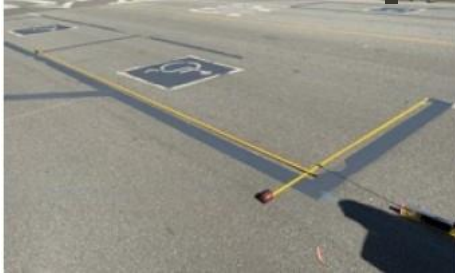
The parking stall is less than the minimum required width of 96 inches.

Measurement: 84 inches

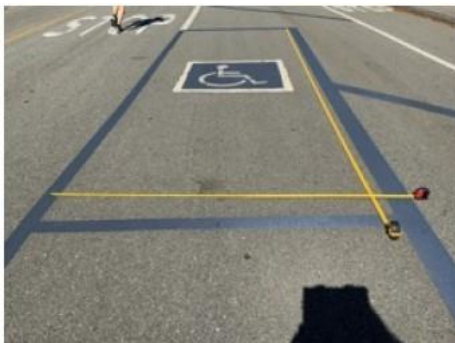
The parking stall is less than the minimum required width of 96 inches.

Measurement: 74.5 inches

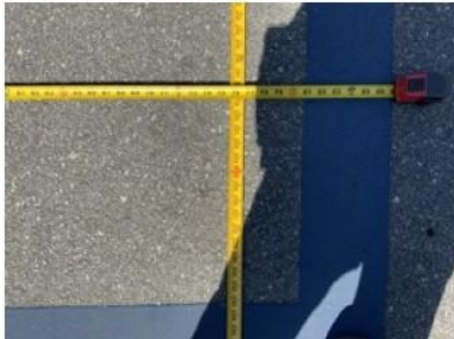
Deficiency: On-Street Parking - Accessible Stall - Width

The parking stall is less than the minimum required width of 96 inches.

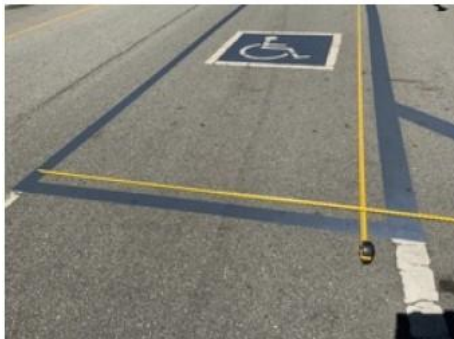
Deficiency: On-Street Parking - Accessible Stall - Width

The parking stall is less than the minimum required width of 96 inches.

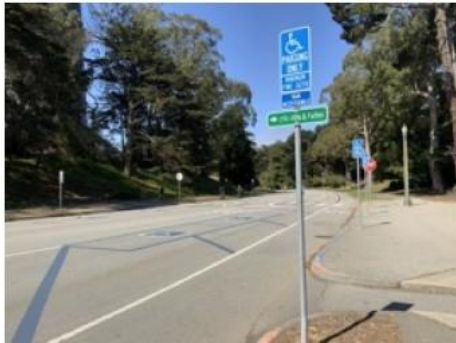
Deficiency: On-Street Parking - Accessible Stall - Width

The parking stall is less than the minimum required width of 96 inches.

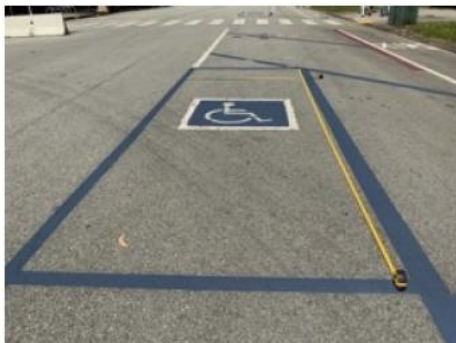
Deficiency: On-Street Parking - Accessible Stall - Width

The parking stall is less than the minimum required width of 96 inches.

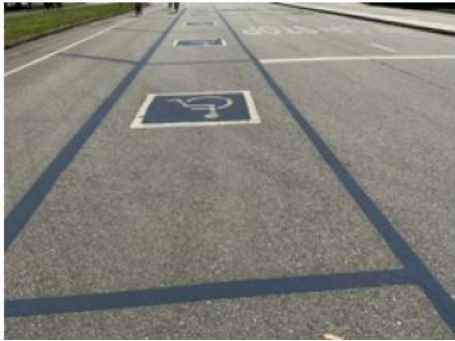
Deficiency: On-Street Parking - Accessible Stall - Width

The parking stall is less than the minimum required width of 96 inches.

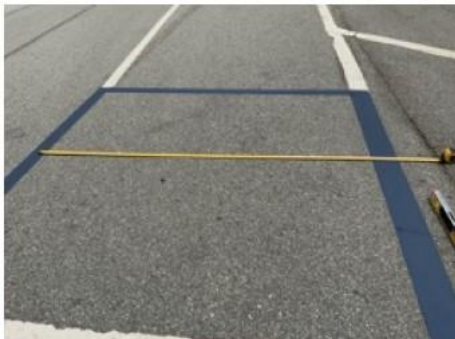
Deficiency: On-Street Parking - Accessible Stall - Width

The parking stall is less than the minimum required width of 96 inches.

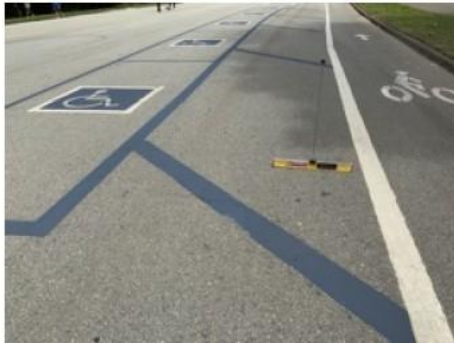
Deficiency: On-Street Parking - Accessible Stall - Width

The parking stall is less than the minimum required width of 96 inches.

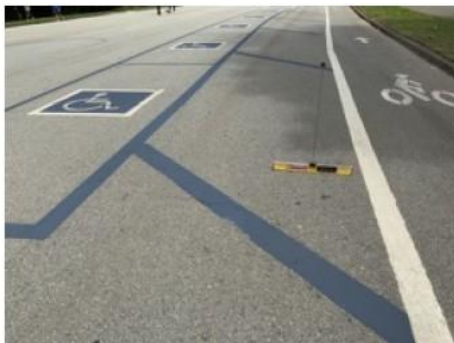
Deficiency: On-Street Parking - Accessible Stall - Width

The parking stall is less than the minimum required width of 96 inches.

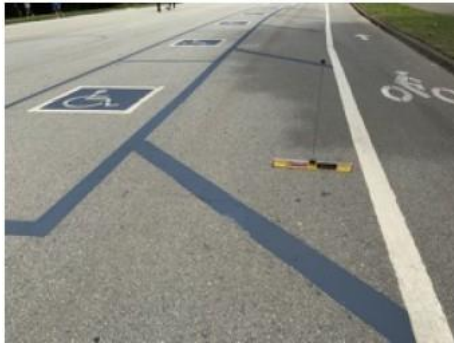
Deficiency: On-Street Parking - Accessible Stall - Width

The parking stall is less than the minimum required width of 96 inches.

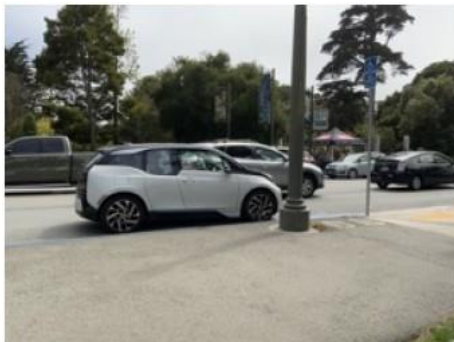
Deficiency: On-Street Parking - Access Aisle - General

No access aisle is provided at the on-street parking.

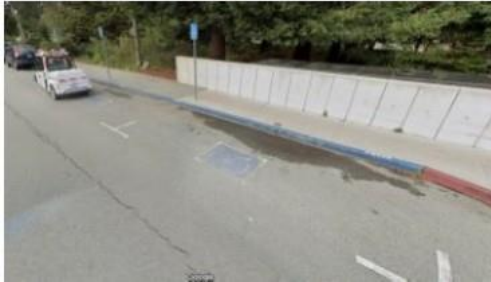
Deficiency: On-Street Parking - Access Aisle - Curb Ramp

No curb ramp is provided at on-street parking spaces 29 and 30 to provide connection to accessible route. The first on-street parking stall is served by the curb ramp behind the vehicle.

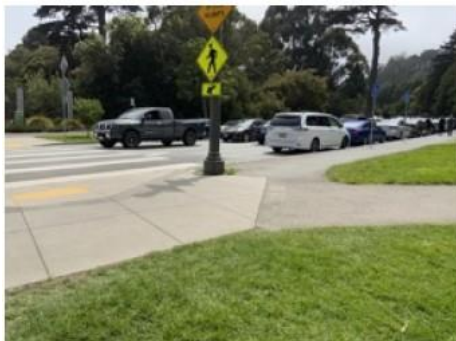
No access aisle is provided at the on-street parking.

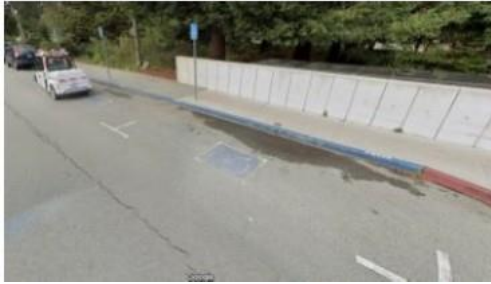
No curb ramp is provided at on-street parking spaces 29 and 30 to provide connection to accessible route. The first on-street parking stall is served by the curb ramp behind the vehicle.

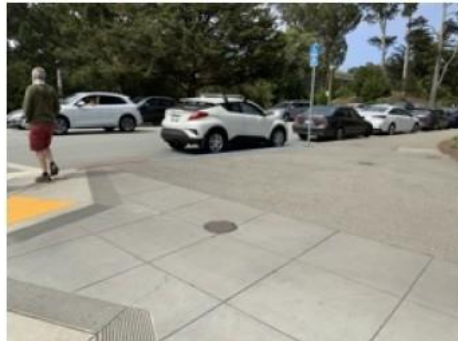
No access aisle is provided at the on-street parking.

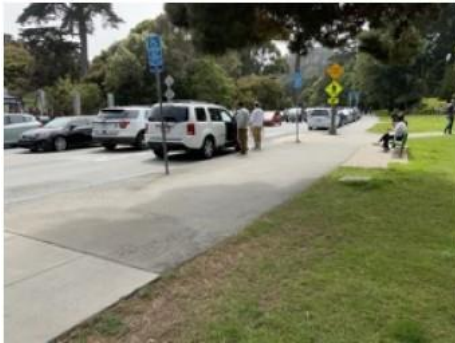
No access aisle is provided at the on-street parking.

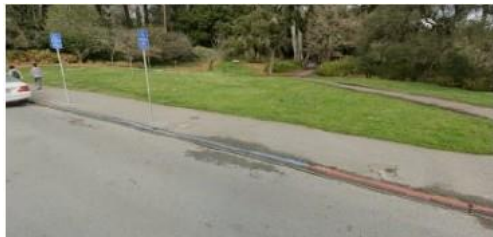
No access aisle is provided at the on-street parking.

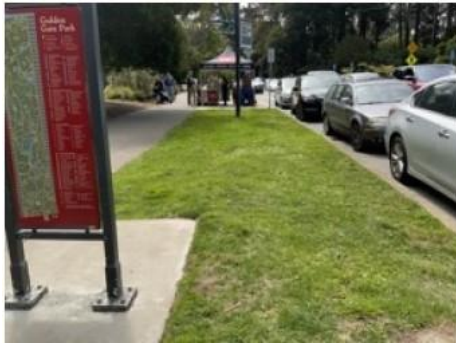
No access aisle is provided at the on-street parking. Sidewalk adjacent to designated accessible stall has a kiosk located there. This will not allow sufficient space for passenger loading/unloading.

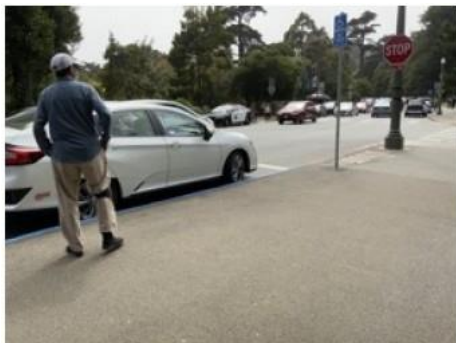
No access aisle is provided at the on-street parking.

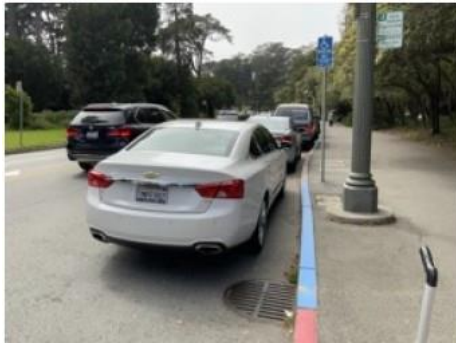
No access aisle is provided at the on-street parking and parking space is located adjacent to a light pole. This will not allow sufficient space for passenger loading/unloading.

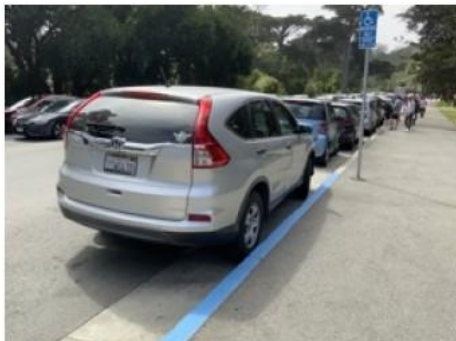
No access aisle is provided at the on-street parking.

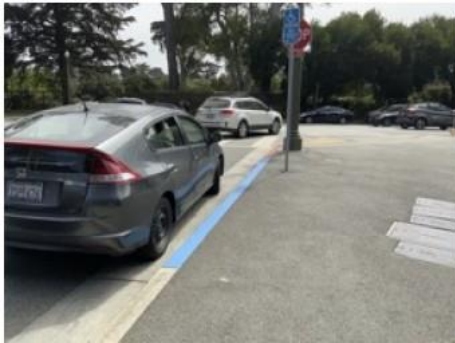
No access aisle is provided at the on-street parking.

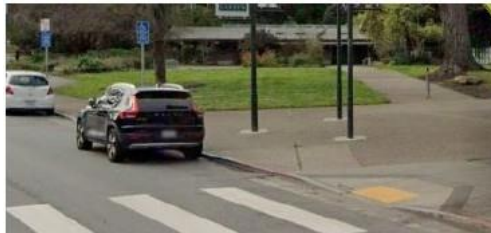
No access aisle is provided at the on-street parking.

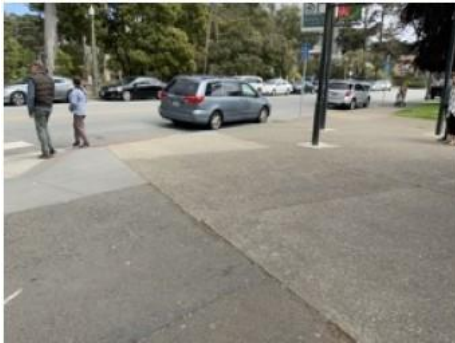
No access aisle is provided at the on-street parking.

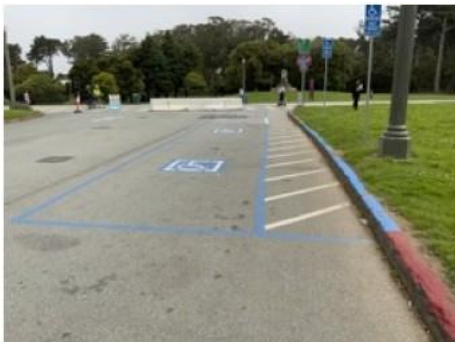
No curb ramp is provided at on-street parking to provide connection to accessible route.

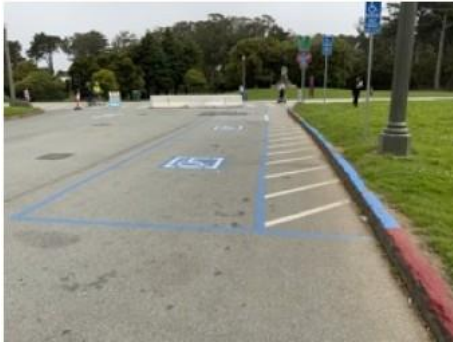
No curb ramp is provided at on-street parking to provide connection to accessible route.

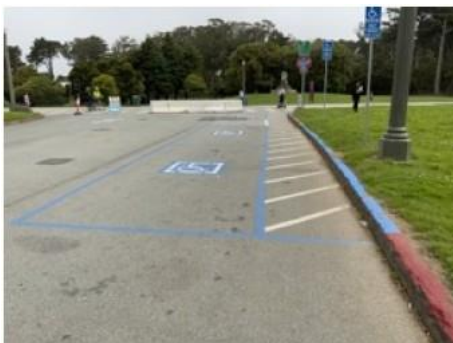
No curb ramp is provided at on-street parking to provide connection to accessible route.

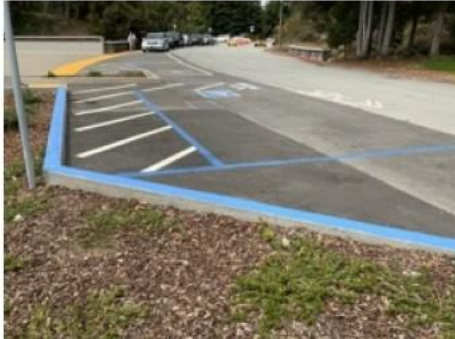
No access aisle is provided at the on-street parking, a 48-inch circulation path has been provided, but does not connect to a curb ramp leading to an accessible route.
