State of California - The Resources Agency
DEPARTMENT OF PARKS AND RECREATION
PRIMARY RECORD

Resource Name or #: (Assigned by recorder) 2485-2499 Mission Street

P1. Other Identifier: Francisco Building

Eastern Neighborhoods Mission Survey

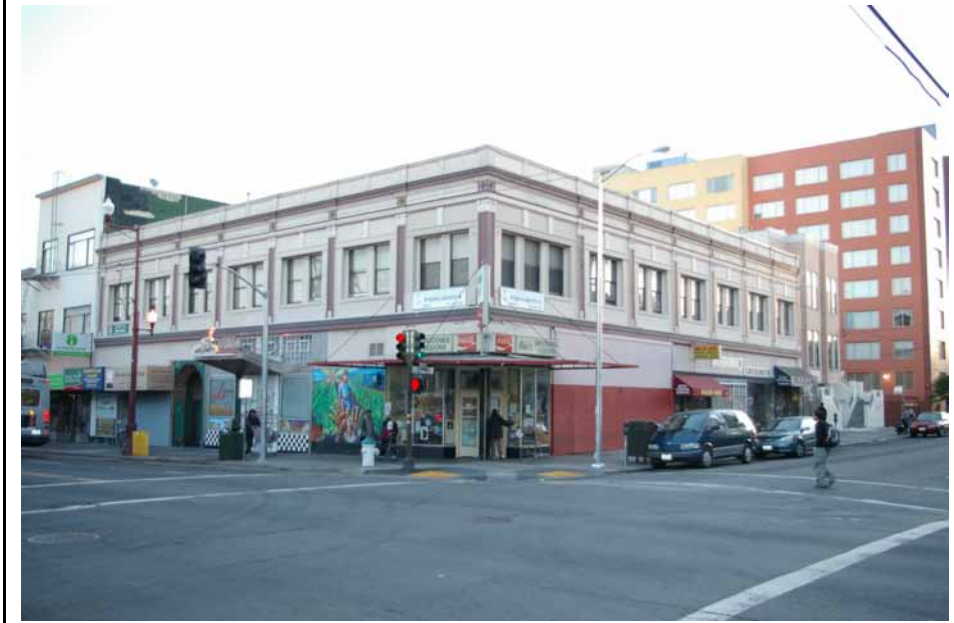
P5a. Photo

View of the southwest corner at Mission and 21st Streets. 10/16/2007

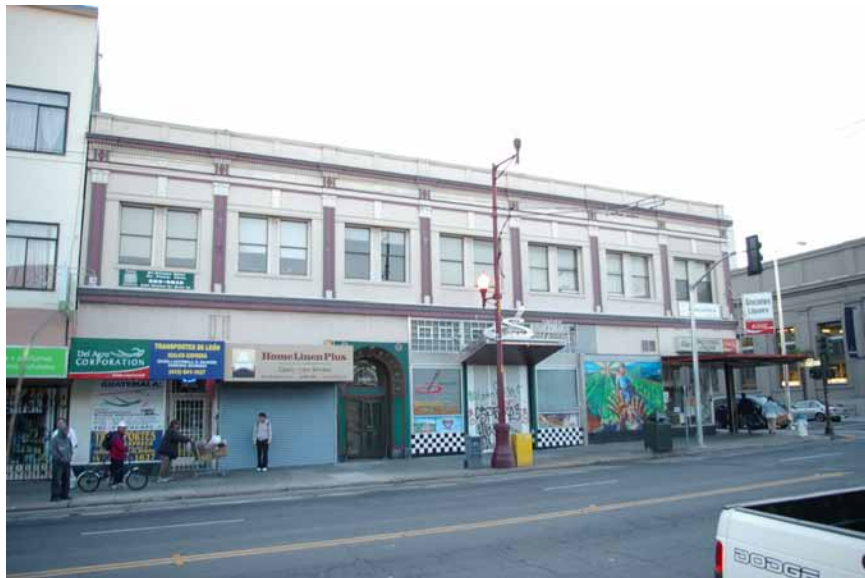
View looking southeast at the primary façade.
Source: San Francisco Planning Department, September 2007

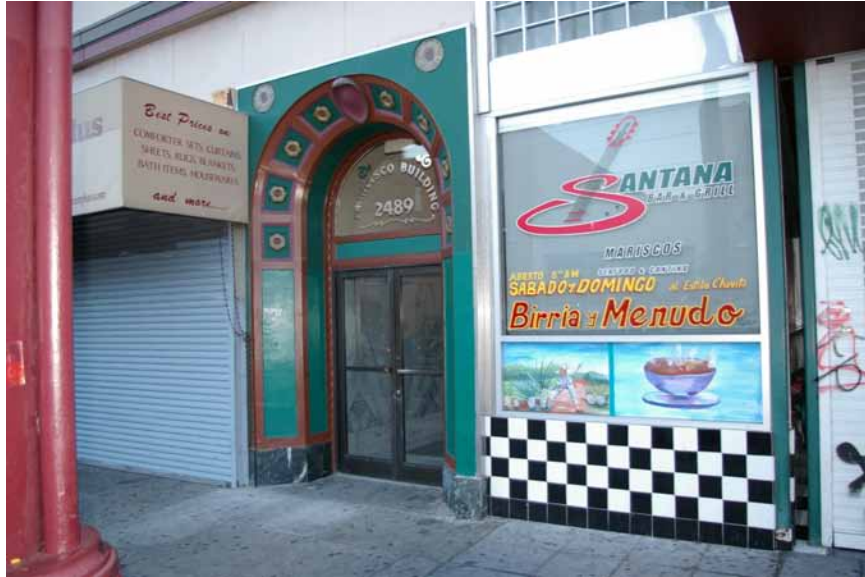
The office units are accessed by fully glazed metal double doors that are recessed and replacements. The doors have molded surrounds with decorative molded rosette buttons and are capped by a fanlight. The office windows at the upper story are primarily pairs of double-hung, vinyl windows with molded surrounds, and with pilasters in between each pair. The windows at the east elevation are squared wood frames set in arched brick openings.

View looking northeast at the residential entrance
Source: San Francisco Planning Department, September 2007

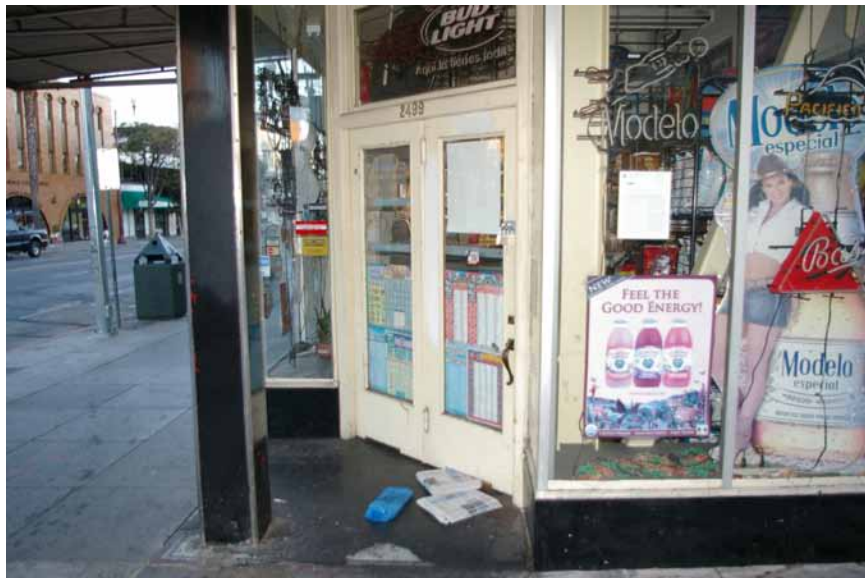
It is largely intact, consisting of wood and glass double doors with a glazed wood framed transom above. The market has a flat roof awning above the corner entrance that is supported by a rectangular Vitrolite clad post. This storefront consists of fixed plate glass steel windows. This storefront also includes illuminated box signs which read: "Mike's Groceries Liquors." Most of the other storefronts are also original. Most have the original steel framed plate glass display windows. Several have fully glazed wood doors, and angled vestibules, wood paneled soffits and glazed wood-framed transoms over doors. Several have original green marbled Vitrolite bulkheads with decorative pressed metal frets. Several have hexagonal and square shaped ceramic tile flooring at the entrance. There are also various fixed projecting and awning signs for these other storefronts. There is a mural painted on the boarded up storefront at 2495 Mission Street. The two 2491-93 Mission Street storefronts have been merged into one, and have glass block filled window openings above, and new ceramic tile work below the windows along with a projecting metal awning.

View looking north at the market entrance
Source: San Francisco Planning Department, September 2007
