State of California - The Resources Agency
DEPARTMENT OF PARKS AND RECREATION
PRIMARY RECORD

Resource Name or #: (Assigned by recorder) 2934 Cesar Chavez Street

Eastern Neighborhoods Mission Survey

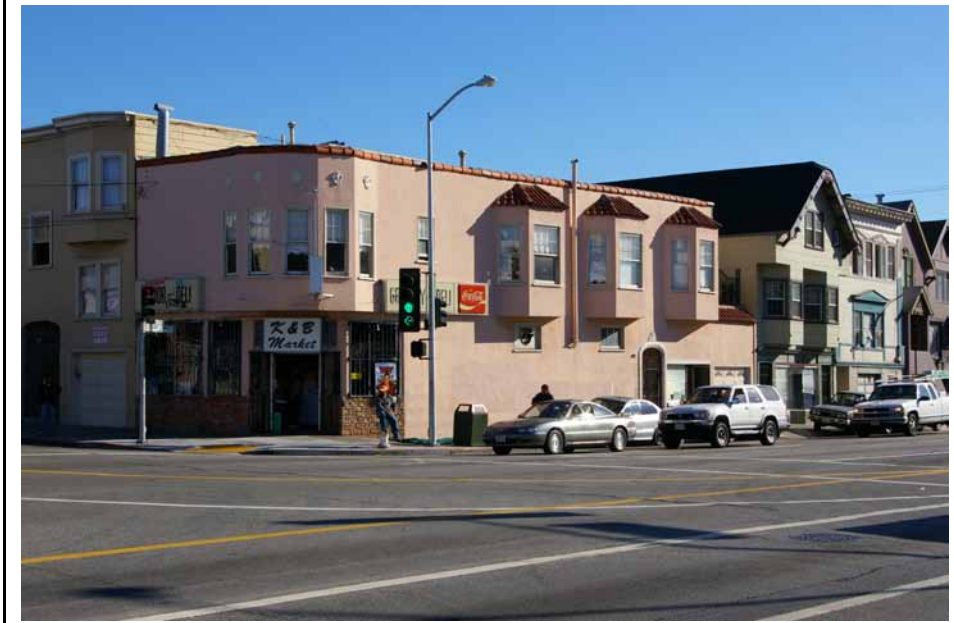
P5a. Photo

2934 Cesar Chavez Street is located on a 1,665 square foot rectangular lot on the northeast corner of Cesar Chavez and Bryant Streets. Built in 1916, 2934 Cesar Chavez Street is a two-story, wood frame, mixed use building designed in the Mediterranean Revival style. The rectangular-plan building, clad in smooth stucco, is capped by a flat roof. The coping is topped by red clay tiles and the bay windows on the south façade are also topped by red clay tiles. The foundation is not visible. The primary façade faces west and includes one angled five-sided corner bay window with decorative cartouches, and three angled bay windows on the south façade. There are two commercial units on the first floor and one street level residential entrance with an arched entryway. The primary window type is double-hung wood-sash windows with eight-over-one pane or six-over-one pane. The primary corner storefront features a permastone clad bulkhead, a glass block transom, fixed and overhanging plastic signs, and recessed corner vestibule opening. The secondary storefront facing Cesar Chavez Street features an angled vestibule, brick veneer bulkheads, and a plate glass display window. The east façade is clad with channel drop wood siding. There is a semi-attached garage located at the east end of the building. The building appears to be in good condition.

View looking northeast at the southwest corner of the building.
10/16/2007
