ASSET RESERVE ANALYSIS

35 – 45 Onondaga Avenue, San Francisco, CA

September 2016

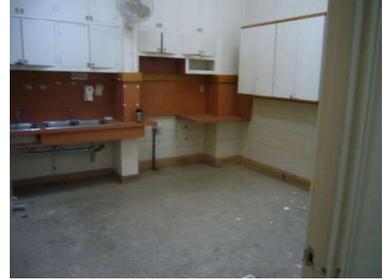
35 Onondaga

There is a room that was formerly a kitchen but there are no equipment.

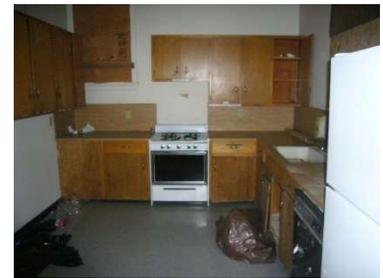
45 Onondaga

There is a small kitchen on the 2nd floor. There are cabinets with a gas range, dishwasher, and refrigerator. The operational status is unknown.
