2021 de Young Museum Accessibility Review - Key Findings

APPENDIX A: DEFICIENCY REPORT

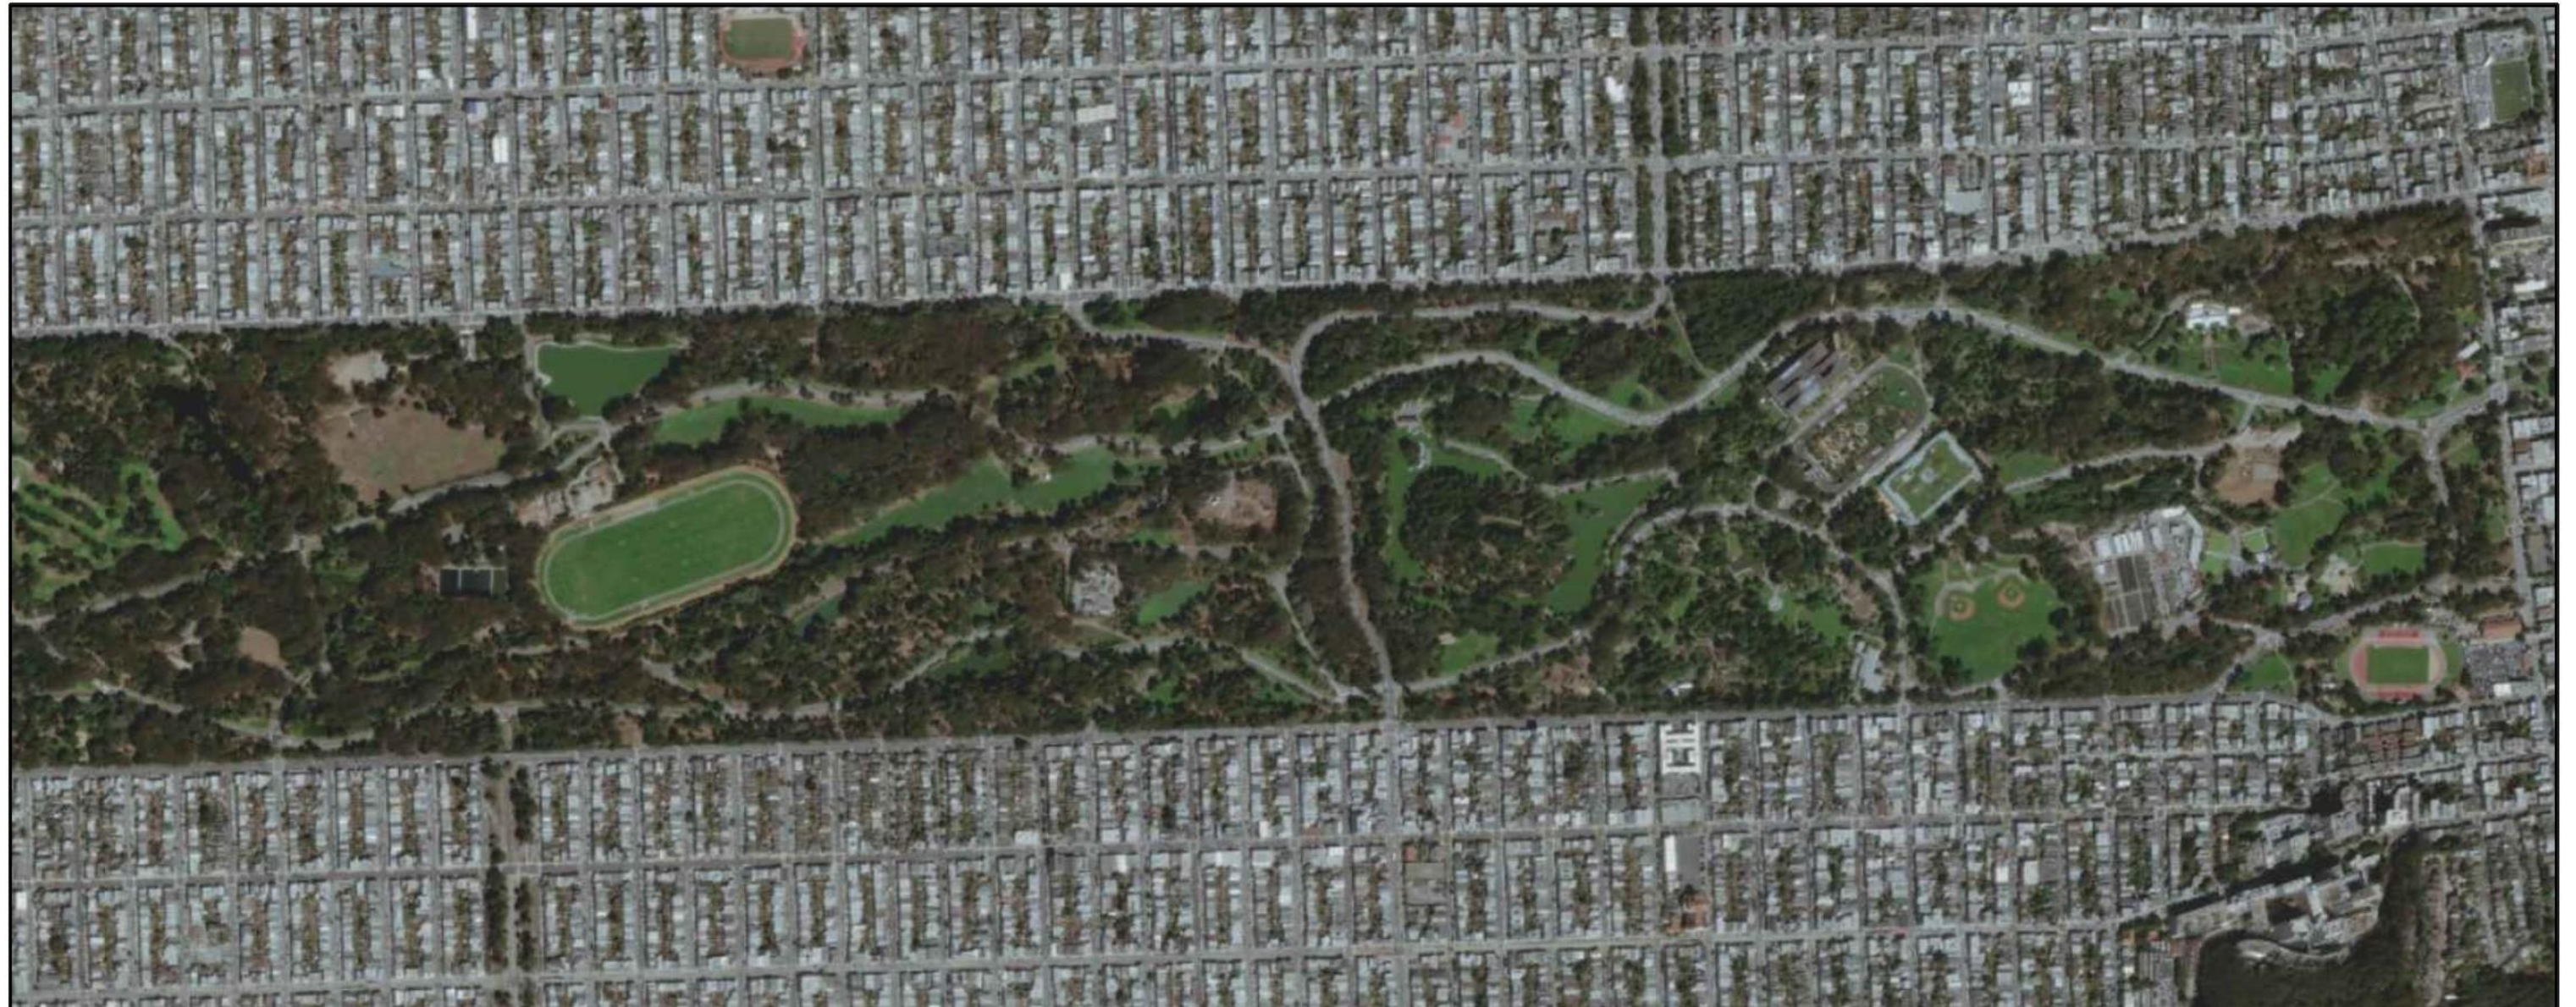
**de Young Museum
Accessible Parking Exhibit**

Overall parking within Golden Gate Park lacks the minimum required accessible spaces, as detailed later in this document and depicted in Exhibit 2 and Exhibit 4, which illustrates the accessible spaces referenced in this report and located within the vicinity of the de Young museum. Additionally, the existing accessible spaces in the immediate vicinity of the de Young Museum do not meet code requirements, as described in Section 6 *Code Requirements Analysis* of this document and further detailed in the attached *Deficiency Report*.

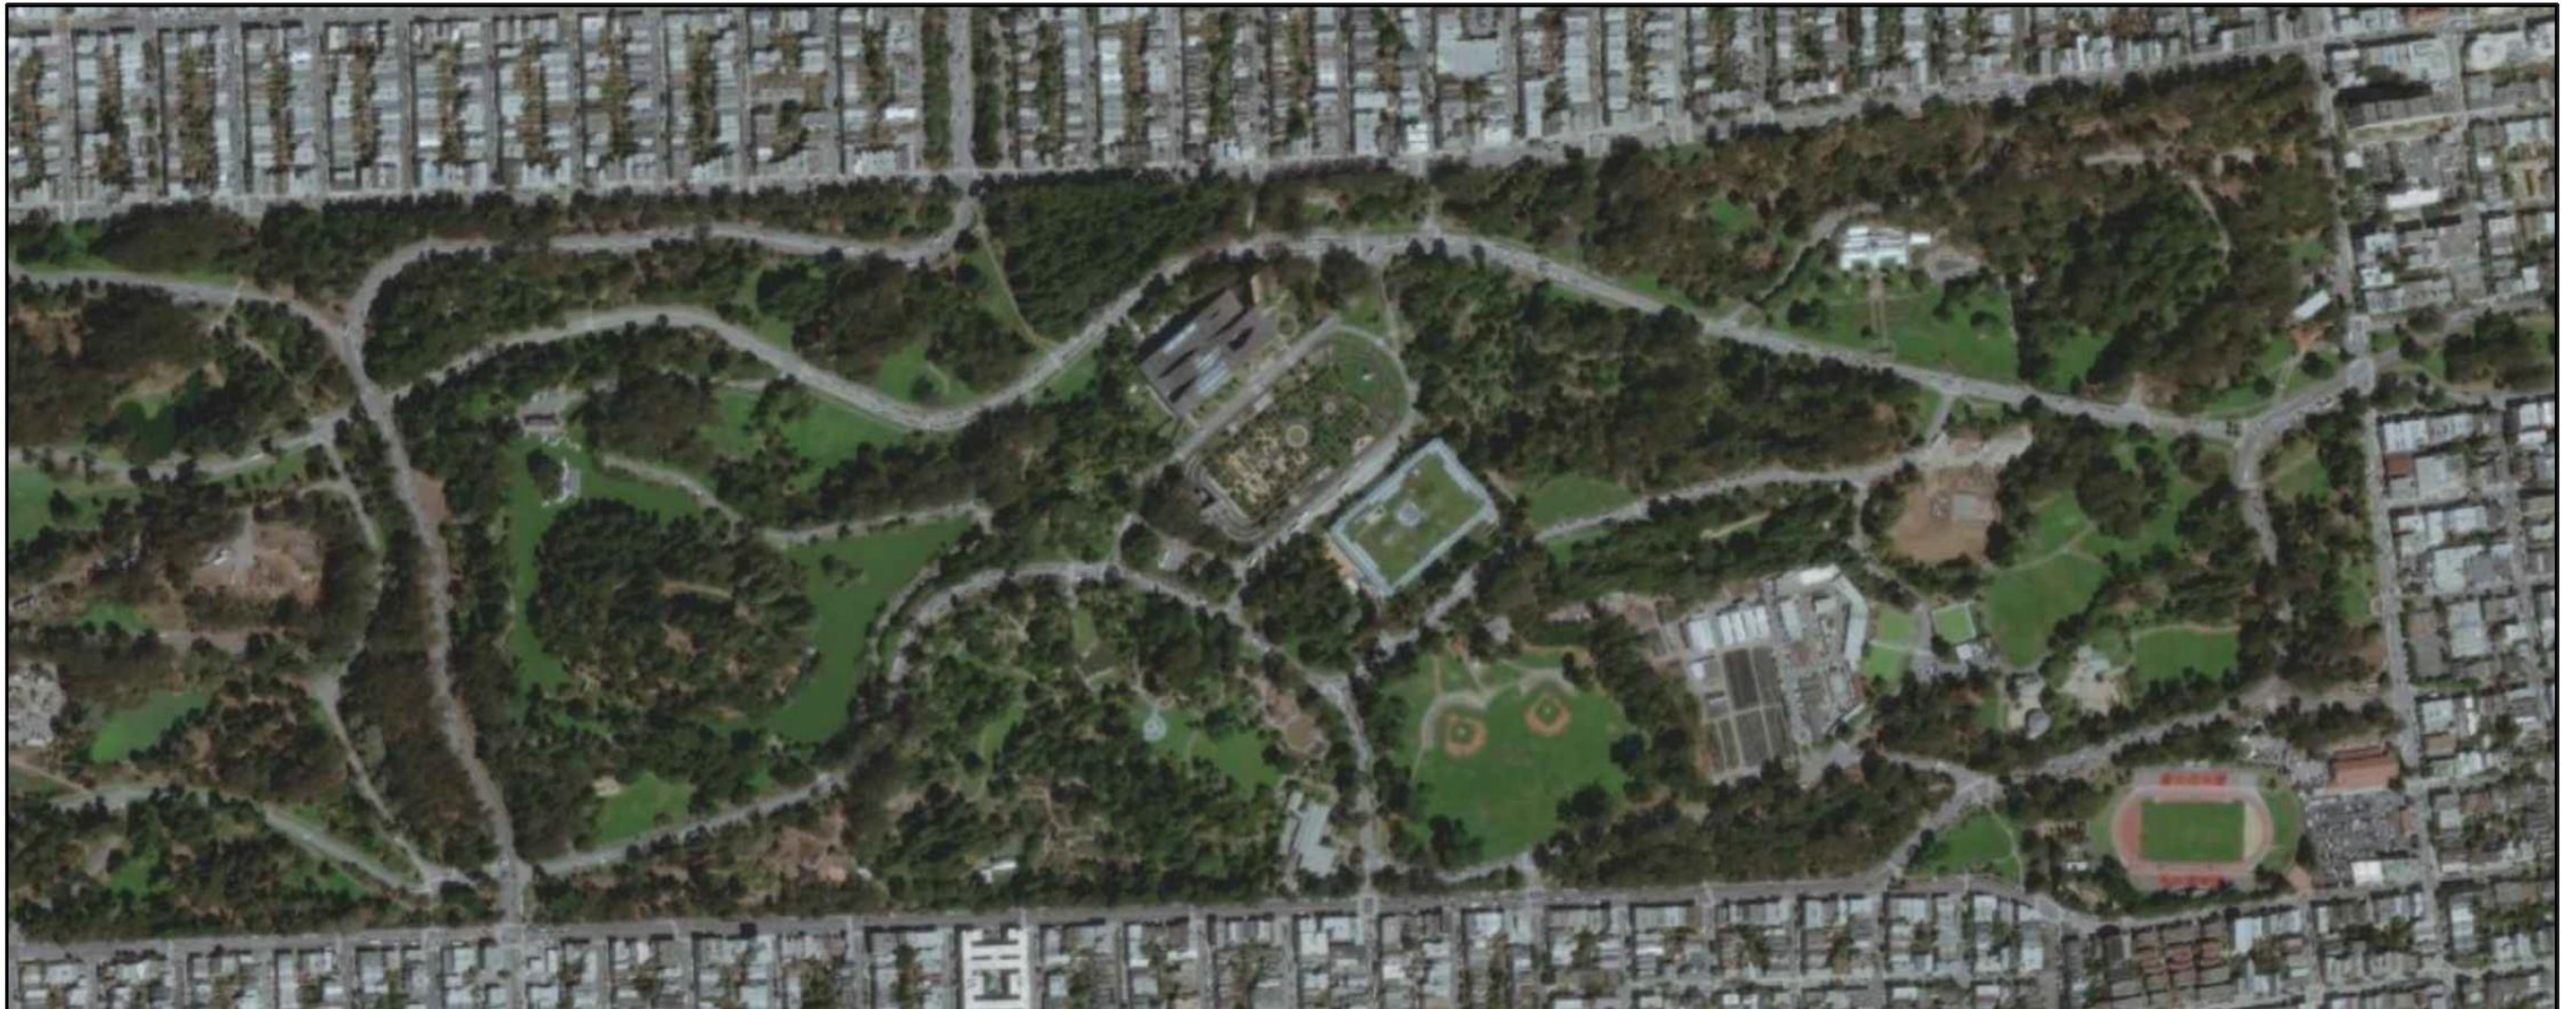
**de Young Museum
Shuttle Map Exhibit**

Current Shuttle drop-off and pick-up locations are included in Exhibit 3 and are identified in the Deficiency Report. The shuttle locations are informal, lacking devoted infrastructure. If one did not know to look for the green signs designating *Bus Shuttle Stop* currently installed along the route, one would be unaware they exist. Lack of compliant boarding areas at shuttle stops and accessible routes to and from shuttle stop locations occur at the majority of the bus shuttle locations, as shown in the attached Deficiency Report.

While on-site, MIG observed that the shuttles averaged about 30 minutes frequency at each bus shuttle location. This frequency is double the anticipated time that is noted in the Golden Gate Park Stakeholder report.

Furthermore, the shuttle service runs only on weekends and holidays. Even if all shuttle stops and associated paths of travel were accessible, it is not an adequate replacement for the removed accessible parking spaces, as many museum guests visit during the week. Shuttle service is not provided during certain park events, including special events at the museum, as these events are conducted outside of the shuttle service designated hours of 9 am to 6 pm. This service is not “equivalent facilitation” as it limits the time allowed to visit the park, and the length of visit is determined by shuttle service availability.

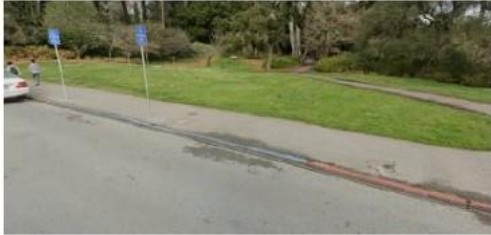
Deficiency: On-Street Parking - Access Aisle - General

No access aisle is provided at the on-street parking.

Measurement: 0 count

Recommended Remediation:

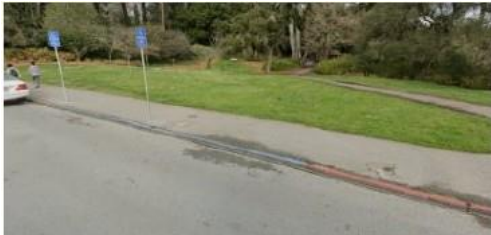
Deficiency: On-Street Parking - Access Aisle - Curb Ramp

No curb ramp is provided at on-street parking to provide connection to accessible route.

Measurement: 0 count

Recommended Remediation:
