Here Today—Here Tomorrow: The Road to Earthquake Resilience in San Francisco

Earthquake Safety for Soft-Story Buildings: Documentation Appendices

Prepared for
San Francisco Department of Building Inspection
under the Community Action Plan for Seismic Safety (CAPSS) Project

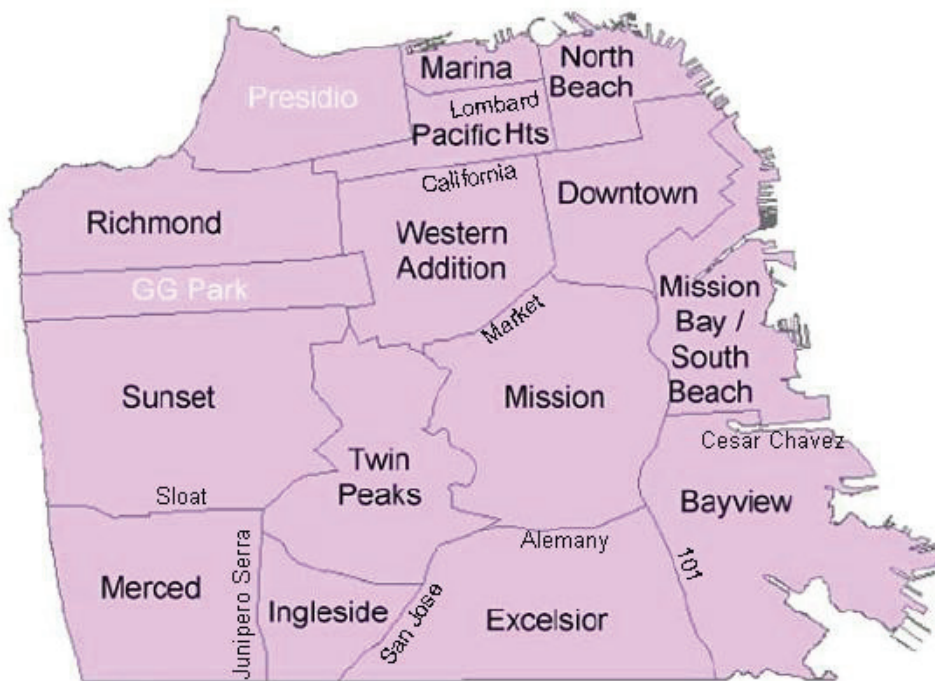
Figure 2-1 Neighborhood division used by the CAPSS project, taken from the Department of Public Works. The Presidio and Golden Gate (GG) Park (shown with white print) are excluded from this study.

Findings are presented by neighborhood, as defined by the Department of Public Works. This scheme of dividing the city was used in the preliminary CAPSS earthquake loss analysis conducted early on in the project. Golden Gate Park, the Presidio and Treasure Island are excluded from the study (see Figure 2-1).

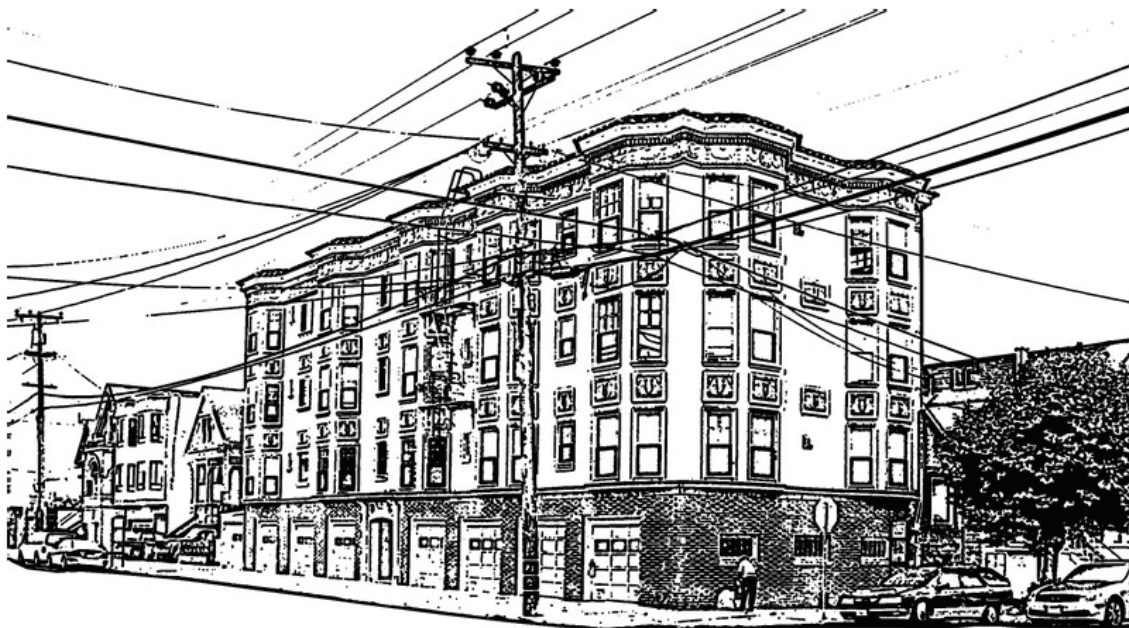
Figure 4-1 Index Building 1 elevation.

Using the candidate Index Buildings compiled by DBI staff, four buildings were selected for study. It was decided to use two corner buildings and two mid-block buildings. Variables chosen included the number of stories, the size of the building footprint, and the construction materials. Hillside buildings were not included, because a large number of the buildings are on relatively level sites, and because there were concerns regarding the accuracy of hillside building analysis. Each of the Index Buildings has an open-wall ground floor, accommodating parking and storage areas, while the upper stories have residential units with a significant amount of interior partition wall. The open wall ground floor could, in other cases, be used for commercial space; the use of the ground floor does not have a great impact for the buildings and retrofits chosen. Table 4-1 describes characteristics of the four Index Buildings. Plans and illustrations for the four Index Buildings are provided in Figures 4-1 through 4-12.

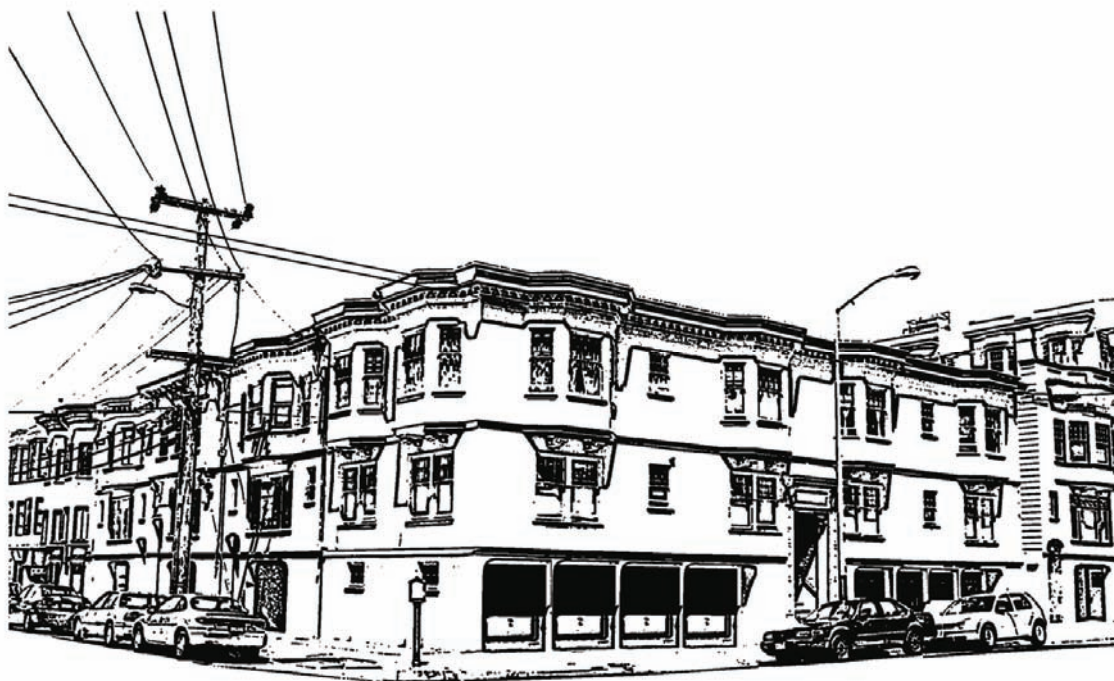
Figure 4-4 Index Building 2 elevation.

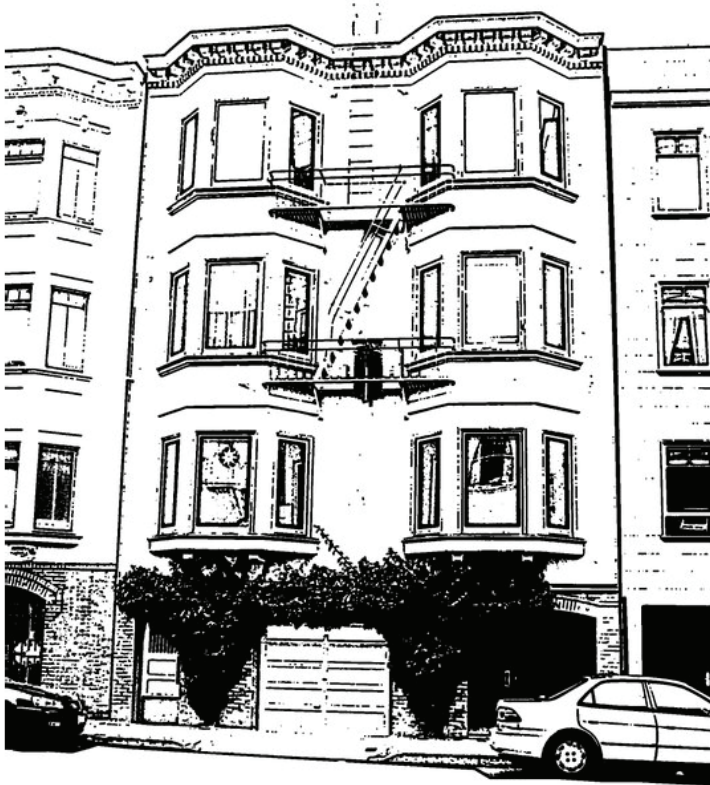
Figure 4-7 Index Building 3 elevation.

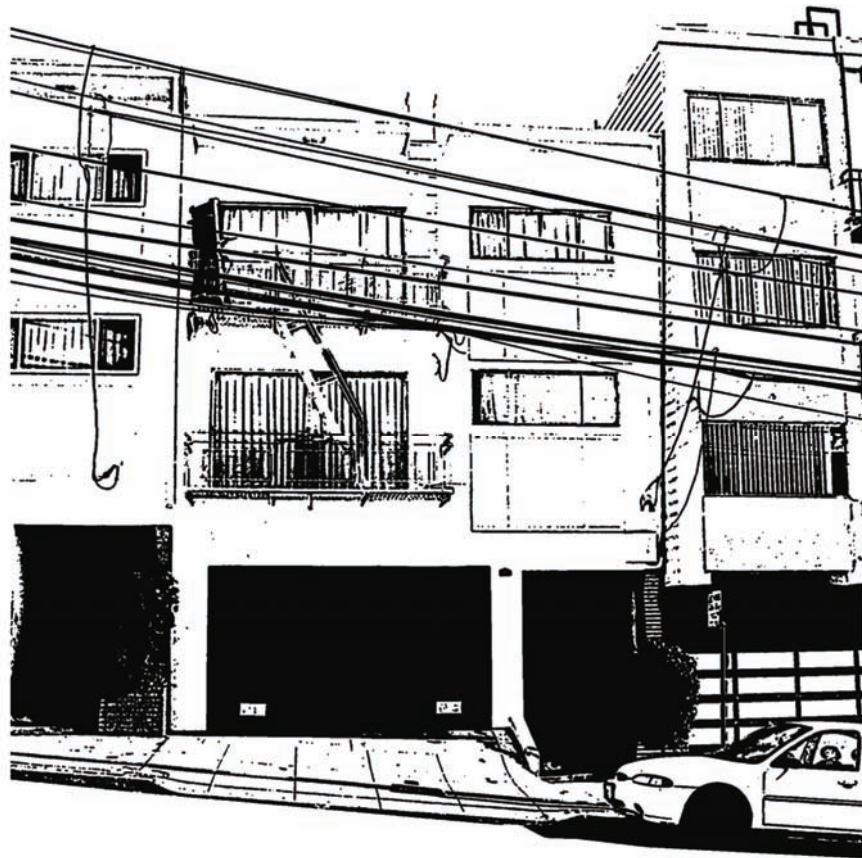
Figure 4-10 Index Building 4 elevation.

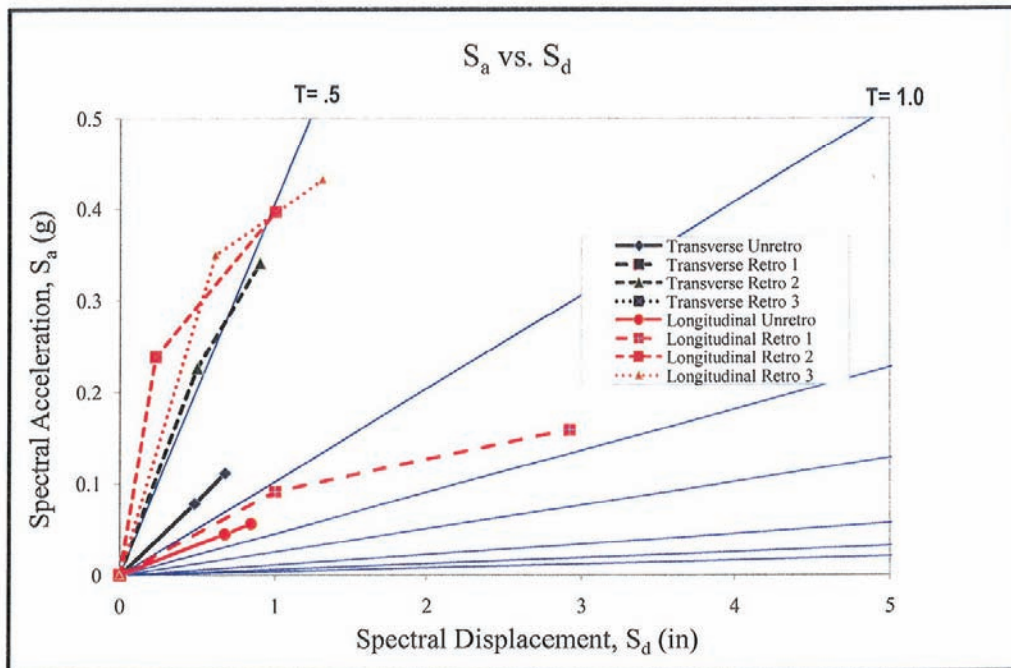
Weight of Building		k	425	$S_a = \frac{F}{\alpha W}$		$S_d = \frac{\Delta}{PF_N}$
				PF _N	0.8	
				α	1.3	
Direction	Scheme	Force k	Displ in	Spectral Accel (S _a) g	Spectral Displ (S _d) in	
Transverse Direction	No Retrofit	Yield	26.5	0.63	0.078	0.48
		Ultimate	37.7	0.88	0.111	0.68
	Retrofit 1	Yield	See No Retrofit		0	0.00
		Ultimate			0.000	0.00
	Retrofit 2	Yield	77	0.65	0	0.50
		Ultimate	116	1.17	0.226	0.90
	Retrofit 3	Yield	See Retrofit 2		0	0.00
		Ultimate			0.000	0.00
Longitudinal Direction	No Retrofit	Yield	0	0	0	0.68
		Ultimate	15.2	0.88	0.045	0.85
	Retrofit 1	Yield	31	1.3	0	1.00
		Ultimate	54	3.8	0.091	2.92
	Retrofit 2	Yield	81	0.3	0	0.23
		Ultimate	135	1.3	0.238	1.00
	Retrofit 3	Yield	119	0.8	0	0.62
		Ultimate	147	1.7	0.397	1.31

Figure 4-24 Index Building 1 capacity curves.

These material values were used as bi-linear load deflection curves, and the yield and peak capacities for each story and building were developed from these curves. For vertical distribution of seismic demands, a triangular seismic force distribution was used. Building deflections were calculated for the longitudinal and transverse directions at the center of the floor considering combined materials and, where applicable, increased in deflection due to diaphragm rotation. Resulting bi-linear capacity curves are provided in Figures 4-24 through 4-27.

Building 1 displayed significant torsional response under longitudinal loading, in both the original building configuration and Retrofit 1. In the original building configuration, the center of rigidity was at the rear longitudinal wall, while in Retrofit 1, the center of rigidity moved very close to the street front at the added moment frames. The effect of the torsion is to put very high demands on the end transverse walls. For a ground motion at an angle to the primary axes, the combination of direct and torsional load on these walls is significant and of concern. Significant damage to end transverse walls was identified in CUREE-Caltech Project testing of an open wall building on the Berkeley shake table (Mosalam et al., 2002). The particular vulnerability of this geometry of building should be taken into consideration. This behavior was not an issue on Building 2, due to the contribution of interior walls.

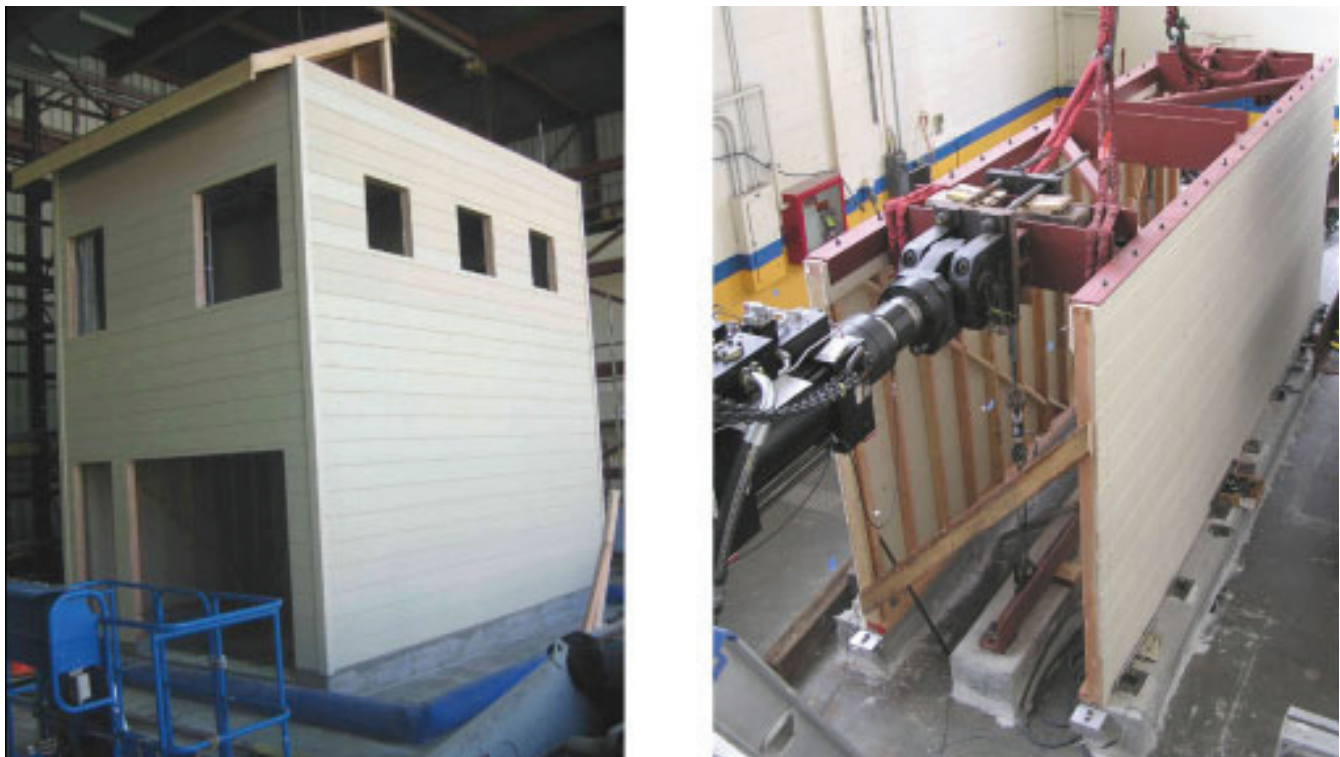
Figure 7-4 Straight-sheathed house prototype and specimens representing the lower floor longitudinal wall tested in hybrid simulation by Elkhoraibi and Mosalam (2007).

(Figure 7-4). The former was tested on a shake table and the latter, by hybrid simulation and representing the lower-floor longitudinal walls of the prototype house. In hybrid simulation, the behavior of the rest of the (generally well-understood) building is computationally simulated, with force or displacements imposed dynamically on the physical substructure whose characteristics are of interest. The response of the real specimen is fed back into the computation model in real or near-real-time. The specimens are constructed of 2x4 studs at 16 inch centers, end-nailed to the double 2x4 top plate with 2-16d common nails and toe-nailed to a 3x6 sill plate with 3-16d common nails. The straight sheathing is 1x12 shiplap siding, with 3-8d common nails per board at each stud crossing. The walls are braced by V-shaped 2x4 diagonal blocking between studs (2-16d toe common nails). All lumber is Douglas Fir-Larch.

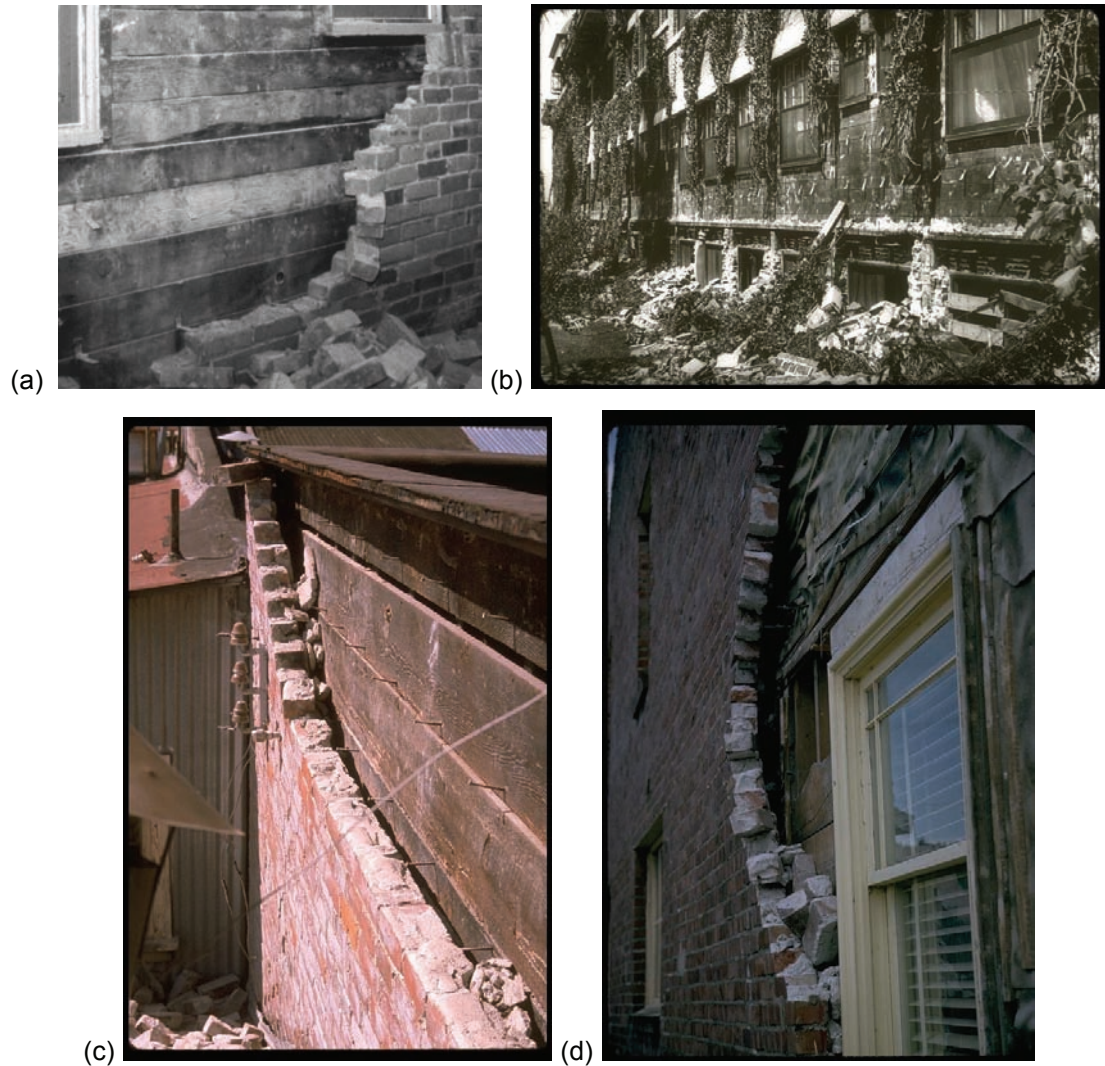
Figure 7-10 *Damaged masonry veneer over straight-sheathed wood-frame walls in (a) 1994 Northridge earthquake (the Masonry Society, via Klingner 2003); (b) 1925 Santa Barbara earthquake (Huber, via Earthquake Engineering Online Archive); (c) 1961 Hollister earthquake (Steinbrugge via Earthquake Engineering Online Archive); (d) 1965 Puget Sound earthquake (Steinbrugge, via Earthquake Engineering Online Archive).*

Figure 7-10 shows several instance of masonry veneer fallen from straight-sheathed wood-frame walls in various earthquakes. In each case, the masonry appears to have been self-supporting and anchored to the wall either by flexible metal connectors or by nails, with a gap of 1-2 inches between the sheathing and the wall.

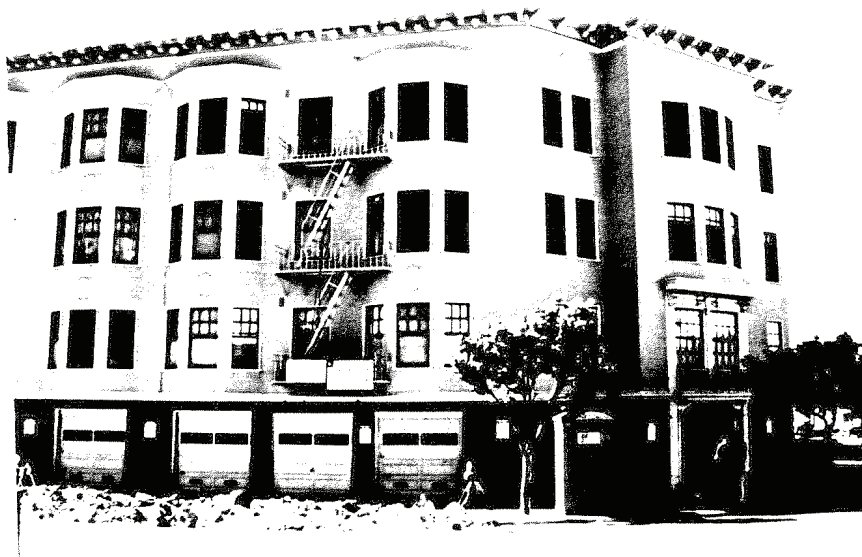
Figure 7-11 Veneer damage to 2 Alhambra St, San Francisco, 1989 Loma Prieta earthquake (Jalil et al. 1992).

Jalil *et al.* (1992) studied the performance of the building at 2 Alhambra St, San Francisco, in the 1989 Loma Prieta earthquake (Figure 7-11). In the earthquake, this four-story corner apartment building in the San Francisco Marina District was observed to have lost all of its brick veneer sheathing at the bottom story on three facades. The authors performed an elastic response spectrum structural analysis of the building with and without masonry veneer, using a record from the nearby California Strong-Motion Instrumentation Program (CSMIP) Station 58222, modified to account for site soil. They find that in the likely fundamental period range of the building, 0.3 to 0.4 sec, the 5%-damped spectral acceleration response imposed on the building was approximately 150 in/sec², or approximately 0.4g. (Dividing by R_A value to account for wood frame elastic damping of perhaps 15-20% suggests a 17.5%-damped S_a of approximately 0.3g.) The authors do not offer an opinion of the deformation at which the veneer delaminated, although they do suggest that veneer fell off before the ground story drift reached 1%. Their analyses suggest that the ground story would have experienced drifts of 0.055 and 0.156 inch its orthogonal directions with the veneer (i.e., approximately 0.055 and 0.156%), and 0.78 and 0.98 inch without the veneer (0.78 and 0.98%).

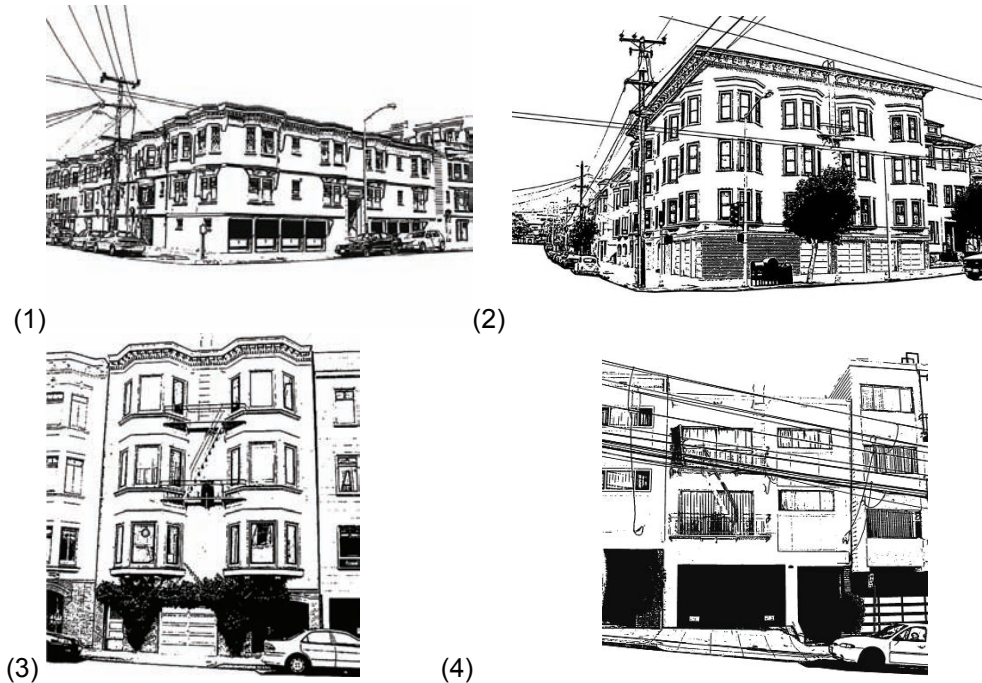
Figure 8-4 Index Buildings: four older, soft-story, wood-frame, multi-family dwellings representing a realistic range of performance of buildings of this class in San Francisco: (1) corner, 3 story, no interior walls at garage level, one street facade $\geq 80\%$ open at ground floor; (2) corner, 4 story, both street facades $\geq 50\%$ open at ground floor; (3) mid-block, 4 story, pre-WWII, neighbors on both sides; (4) mid-block, 3 story, post-1950, neighbors on both sides. Square footage is 3,600, 5,800, 2,300, and 1,800 sq. ft., respectively.

The CAPSS project sought, among other things, to assess the impacts of various realistic earthquake scenarios on the City's housing stock, with emphasis on one of its more widespread and vulnerable classes of housing: older, wood-frame, multi-family dwellings (with five or more housing units) with soft-story conditions. The relevant housing stock was idealized via four "Index Buildings" shown in Figure 8-4: (1) a 3,600-sq. ft., three-story pre-World War II (WWII), wood frame with garage door openings along one entire side of the building, with few transverse walls at ground level; (2) a 5,800-sq. ft., four-story pre-WWII, wood-frame corner building with garage door openings along two sides of the building and internal walls at ground level between several parking spaces; (3) a 2,300-sq. ft., midblock, pre-WWII, four-story building with a neighbor on both sides; and (4) a 1,800-sq. ft., midblock, three-story 1950s building, > 80% open on ground-floor façade, with neighbors on both sides.

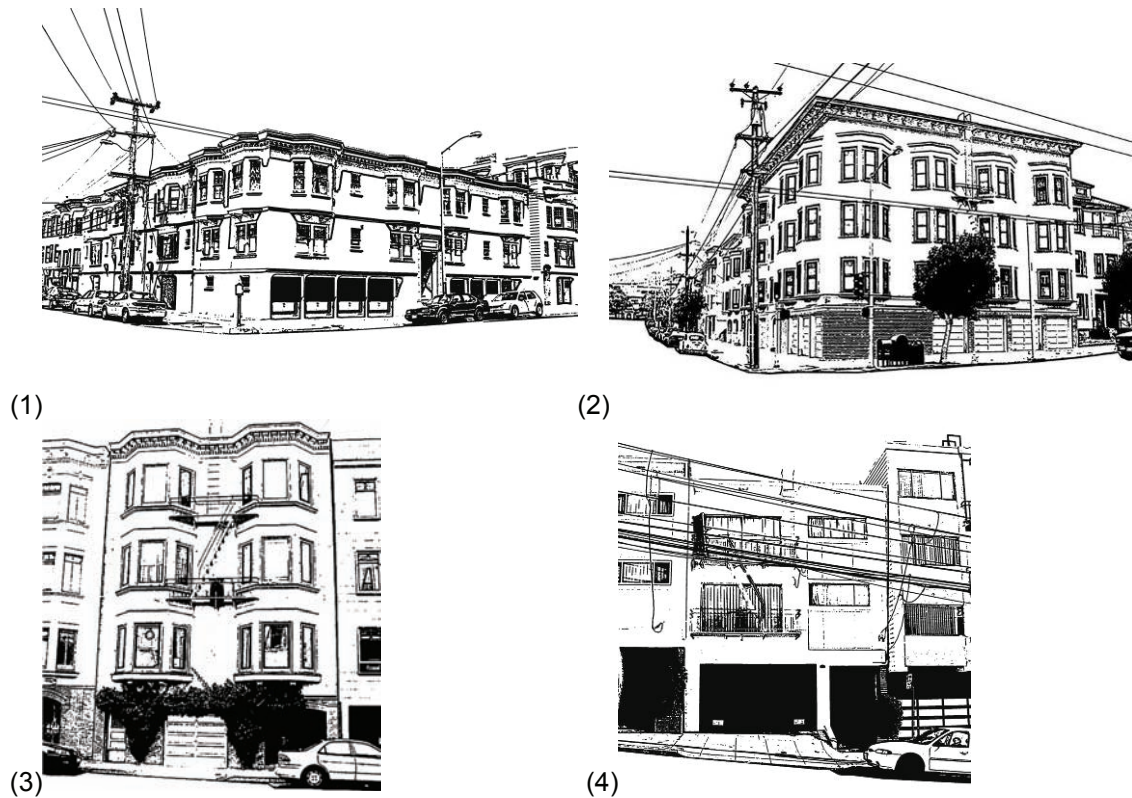
Figure 9-1 CAPSS Index Buildings. Four older, soft-story, wood-frame, multi-family dwellings representing a realistic range of performance of buildings of this class in San Francisco: (1) corner, 3 story, no interior walls at garage level, one street facade $\geq 80\%$ open at ground floor; (2) corner, 4 story, both street facades $\geq 50\%$ open at ground floor; (3) mid-block, 4 story, pre-WWII, neighbors on both sides; (4) mid-block, 3 story, post-1950, neighbors on both sides. Square footage is 3,600, 5,800, 2,300, and 1,800 sq. ft., respectively.

Cobeen (see Appendix 4) designed four prototypical Index Buildings to represent the range of housing addressed here (Figure 9-1). The designs and three retrofits each were selected in consultation with DBI and consulting structural engineers. Each building in the exposed building stock was associated with the damageability information described in Appendix 7, as follows.

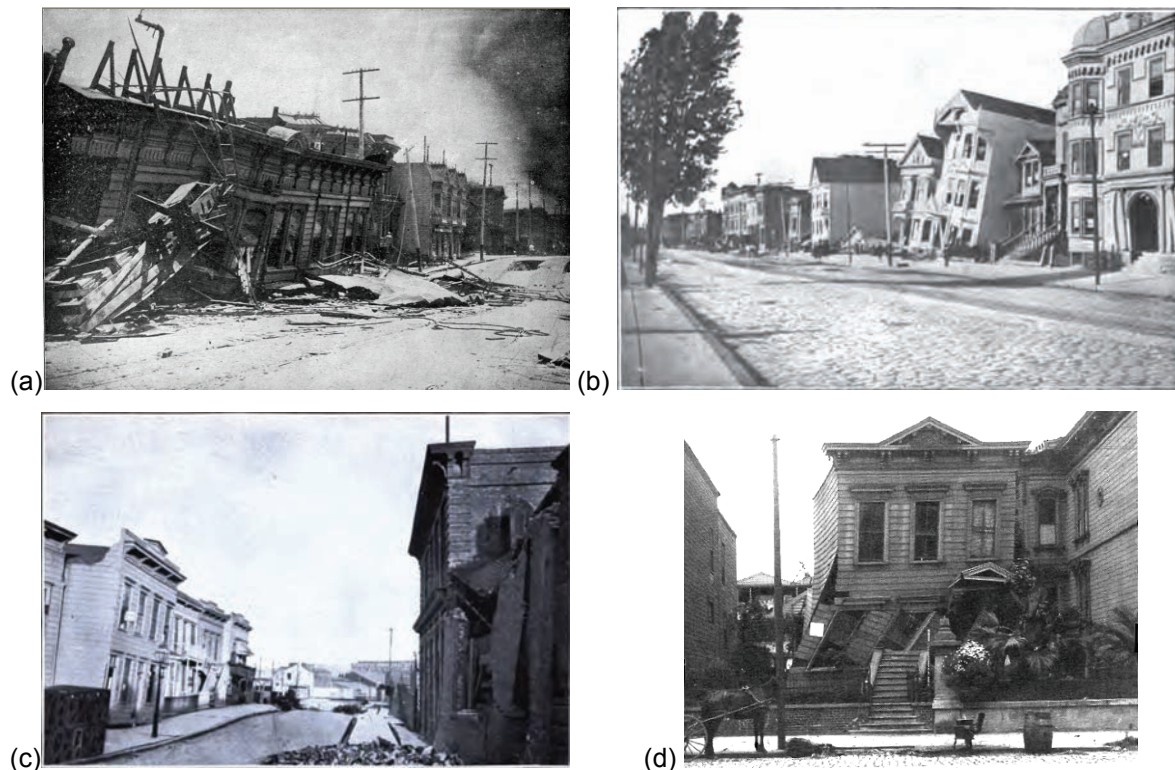
Figure 9-2 Collapses of large mid-block wood-frame building in the 1906 San Francisco earthquake: (a) Valencia St. Hotel (Pierce et al., 1906), (b) Howard St (Gilbert et al., 1907), (c) Dore St. between Bryant and Brannan (Gilbert et al., 1907), (d) unknown location, where collapse is associated with “cripple-wall and shear failure” (Tobriner, 2006).

Based on the limited 1989 earthquake data available from the Marina District, where only one of the seven collapsed buildings was mid-block, it seems that mid-block soft-story buildings are less likely to collapse than are corner soft-story buildings, all else being equal. Ultimately a very simple approach was used here to deal with pounding and adjacency. The structural models described in Appendix 4 do not treat pounding or adjacency, and the loss model makes mid-block buildings less likely to collapse than corner buildings and at least as likely as the average pre-code one- or two-story wood-frame building. It does so by setting the vulnerability term, P_c (fraction of area collapsed in buildings with complete structural damage), for as-is Index Buildings 3 and 4 to the HAZUS®-MH default value of 3%, in contrast to the 10% figure used for corner buildings (see Appendix 7).
