RECOMMENDATIONS FOR MITIGATION OF CHIMNEY HAZARDS

ESIP Task A.4.g
September 28, 2015

Recommendations for Mitigation of Chimney Hazards in San Francisco (ESIP Task A.4.g)

Prepared by
APPLIED TECHNOLOGY COUNCIL
201 Redwood Shores Parkway, Suite 240
Redwood City, California 94065
www.ATCouncil.org

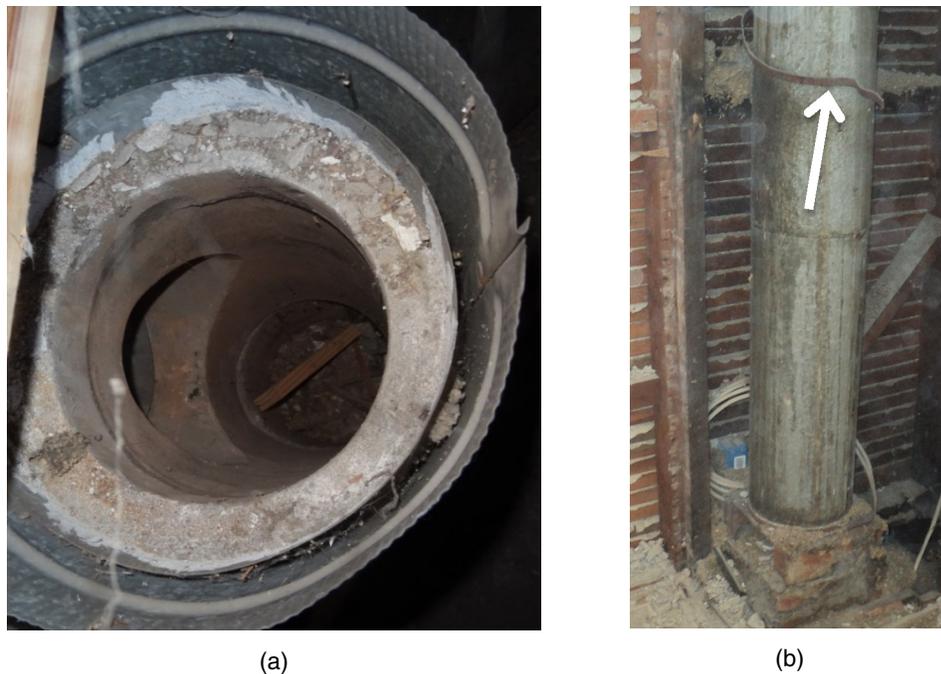
Figure 2-1 Patent flue exposed during renovation showing: (a) the cross section consisting of a ceramic liner and two light metal casings separated by an air gap; (b) installation on a masonry pad (probably with a masonry firebox below) and a strap anchor (white arrow) about four feet above the floor to attach the flue to the wall (inadequately connected in this case). (Photos courtesy of Jim Deasy)

In San Francisco, a **patent flue** is commonly used either instead of a lined chimney, as a vertical extension of a masonry chimney, or as a flue within a decorative chimney. The patent flue, so called because its design was

covered by a registered U.S. patent, was mentioned in the 1906 San Francisco Building Law as an acceptable alternative to the traditional brick flue and was used during the rebuilding that followed the 1906 earthquake. It is formed from a stack of mortared ceramic tube sections about one inch thick, surrounded by an air gap of approximately one inch, and an outer sheet metal jacket (Figure 2-1a). The patent flue usually bears on a masonry pad built up from either a masonry firebox or set on a steel plate directly over conventional wood floor joists (Figure 2-1b). Within the building, the flue is meant to be strapped to adjacent wall studs every few feet. Above the roof, the ceramic liner stops 1 to 2 feet below the top of the tubular metal jacket. Since a patent flue is not a structure that contains a flue, it is not itself considered a chimney by the building code definition.

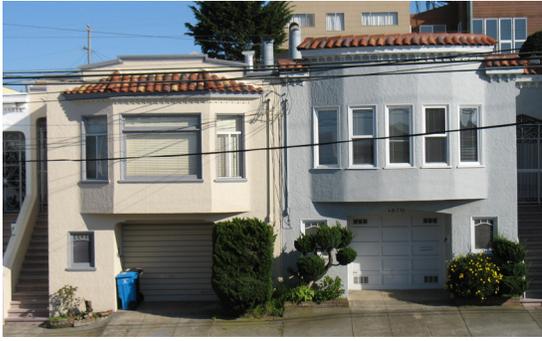
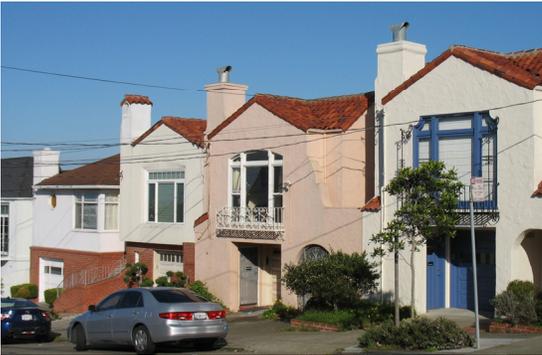
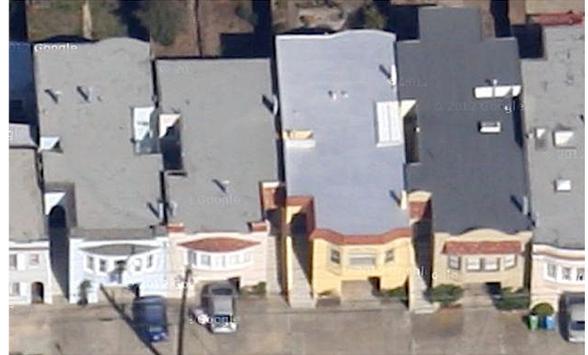
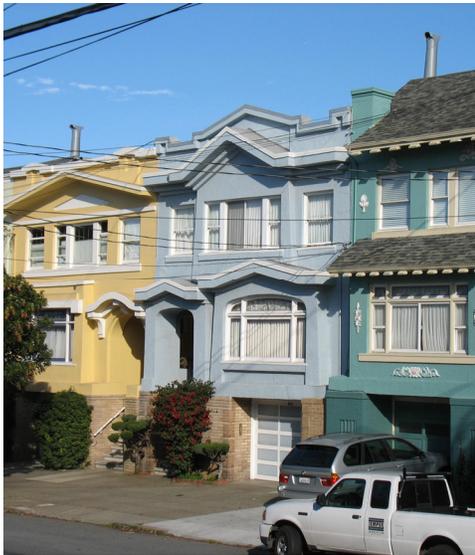
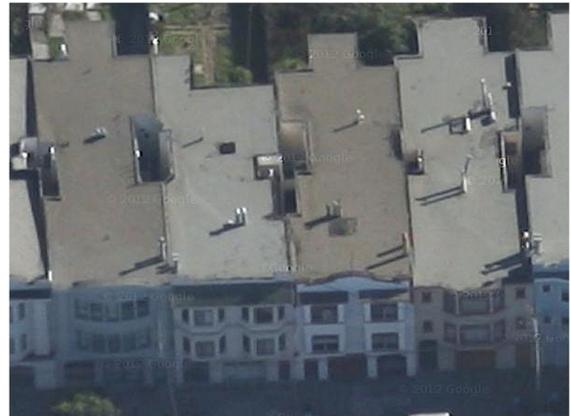
Figure 2-2 Typical San Francisco residential buildings with patent flues: Two story-dwellings in (a) through (c); three-story rowhouses in (d) and (e). (Photos from Google Maps, 2015)

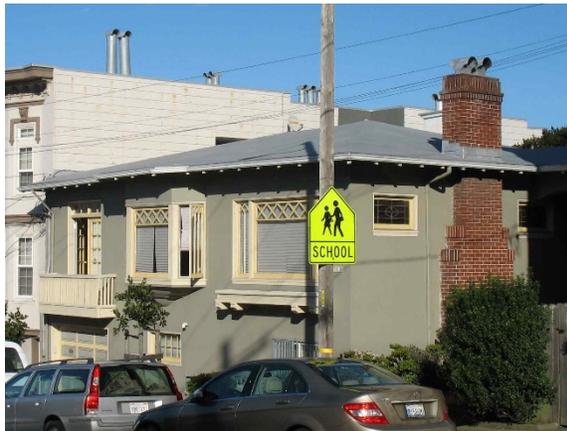
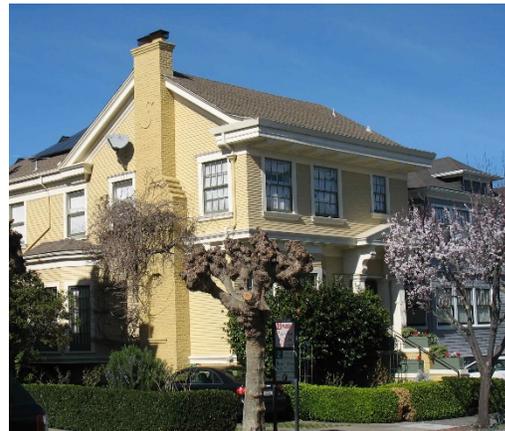
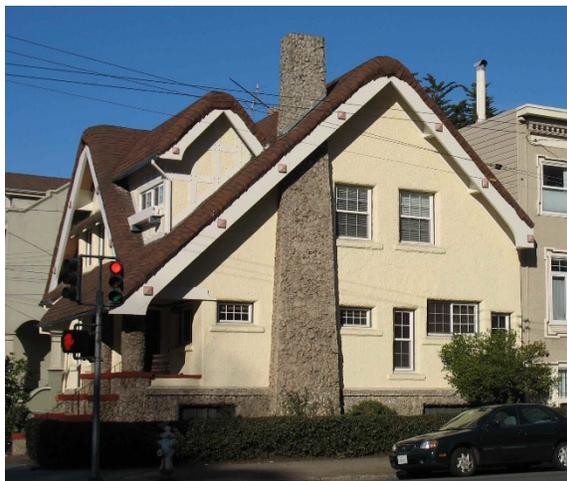
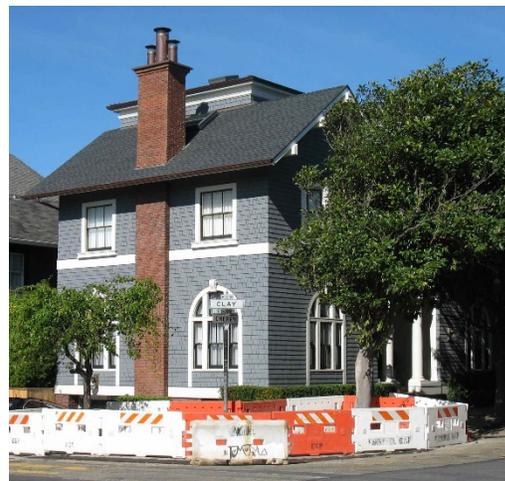
Figure 2-3 San Francisco single-family “setback” houses with masonry chimneys. Note the variety of building styles, chimney styles, and chimney locations relative to a sidewalk, a roof eave or rake, or the roof ridge. Location relative to the roof ridge determines the height of the chimney extension above the roof. Not shown are cases of chimneys within the interior of the building footprint.

Pre-1950 single-family dwellings set back on all sides from lot or property lines (as shown in Figure 2-3) are relatively rare in San Francisco, but they account for nearly all of the traditional masonry chimneys of the type addressed by existing prescriptive retrofit approaches (discussed in Chapter 3). ("Setback house" is not a conventional architectural term. This report uses it to distinguish larger detached houses, many in a shingle or Tudor style, from detached houses or single-family rowhouses with very little separation from their neighbors, such as those shown in Figure 2-2.)

- The unrestrained Victorian rowhouse chimneys with public exposure (adjacent to streets or sidewalks), while relatively few, represent an appreciable risk to public safety. A few other building types might present similar public risks (as shown in Figure 2-3c and d). A restrained chimney might also present a similar public risk if the portion above the roofline is inadequately braced and anchored.
- Apartment building boiler chimneys represent only a small or moderate safety risk but could pose a significant risk to housing habitability if damage to the chimney means a loss of heat or hot water to an entire building, or if chimney collapse renders required egress stairs unusable.

Consider, for example, the unreinforced masonry chimneys shown with the setback houses in Figures 2-3a and b. These are conventional-appearing chimneys of the type most clearly contemplated by the Los Angeles prescriptive repair provisions, with defined “throat” locations at the top of second floor fireboxes. For each of these chimneys, a prescriptive retrofit based on the Los Angeles provisions would involve removal of the masonry down to the top of the throat, about five feet above the second floor and replacement of the removed portion with a metal flue and light-framed enclosure. Applying these provisions to retrofit, the second floor firebox would remain in place, unanchored even at the second floor level.

Consider next the chimneys shown in Figures 2-3c and d and the Victorian rowhouse chimneys in Figures 2-6 and 2-7. As these do not have pronounced “throats” or “shoulders,” it is unclear how much masonry would need to be removed to reach the highest firebox. Even so, as with the previous cases, the Los Angeles provisions would not require anchorage to the second or third floor framing.

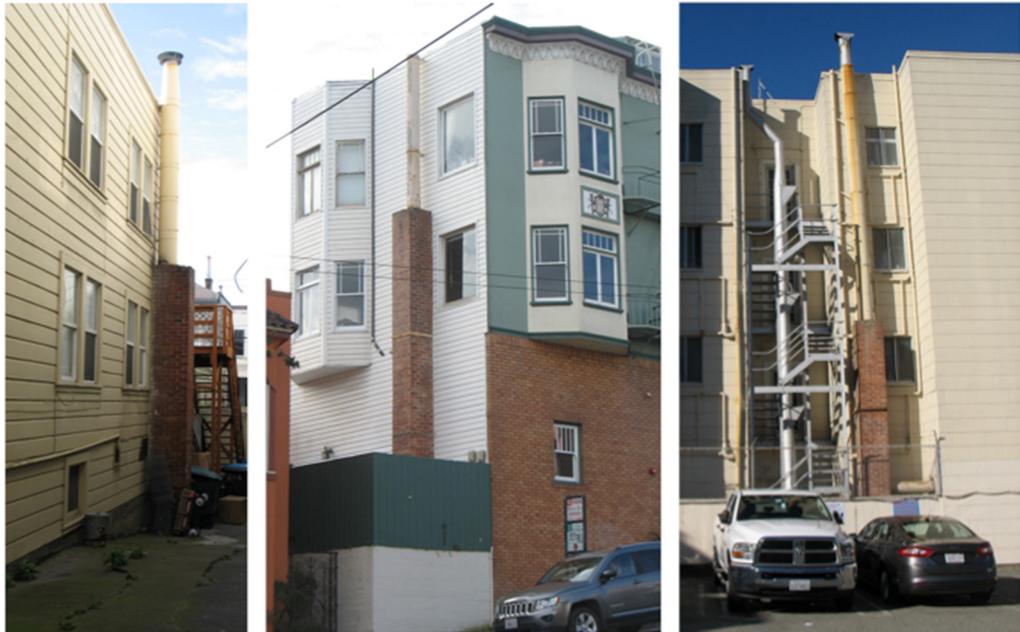
(a) (b) (c)
Figure 2-4 San Francisco apartment buildings with masonry chimneys. Note the uniformity of style, including, at (b) and (c) a nominal steel anchor strap at the second floor level.

Figure 2-4 shows three examples of this chimney type. Not every building has such a chimney, but where they do exist, they appear remarkably uniform, including in many cases a nominal steel anchor strap (often loose) at the second floor level.

Finally, consider the apartment building boiler chimneys shown in Figure 2-4. Here, there is no firebox, so application of the Los Angeles provisions for retrofit would require either removing the entire masonry stack or simply anchoring it at the second floor level.

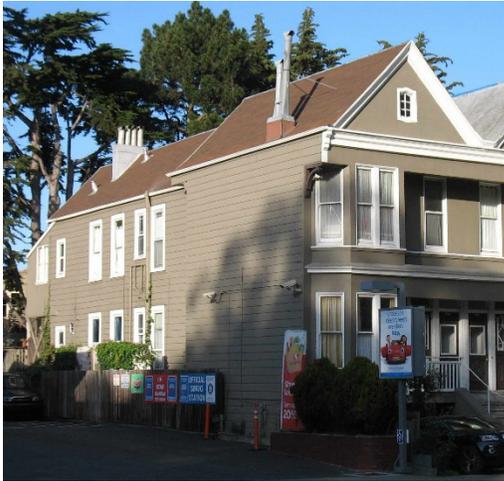
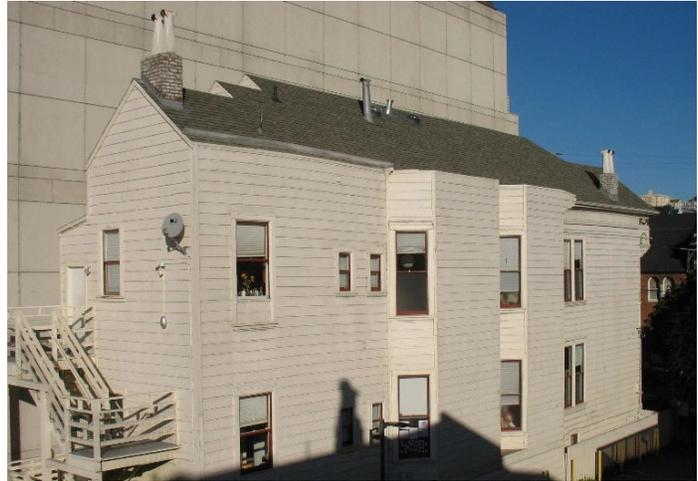
Figure 2-5 Victorian buildings with front and rear masonry chimneys.

Many Victorian rowhouses have more than one masonry chimney, as shown in Figure 2-5. One chimney, commonly located along a perimeter side wall near the front of the building, serves parlor fireplaces. Others, located in the “back of house” and typically in the interior of the space away from a side wall, serve appliances, such as gas stoves or furnaces. A Victorian single-family house will often have only the rear appliance chimney. Victorian era buildings can also have a mix of flues, for example a patent flue serving the parlor fireplaces and a brick chimney for the back of house appliances.

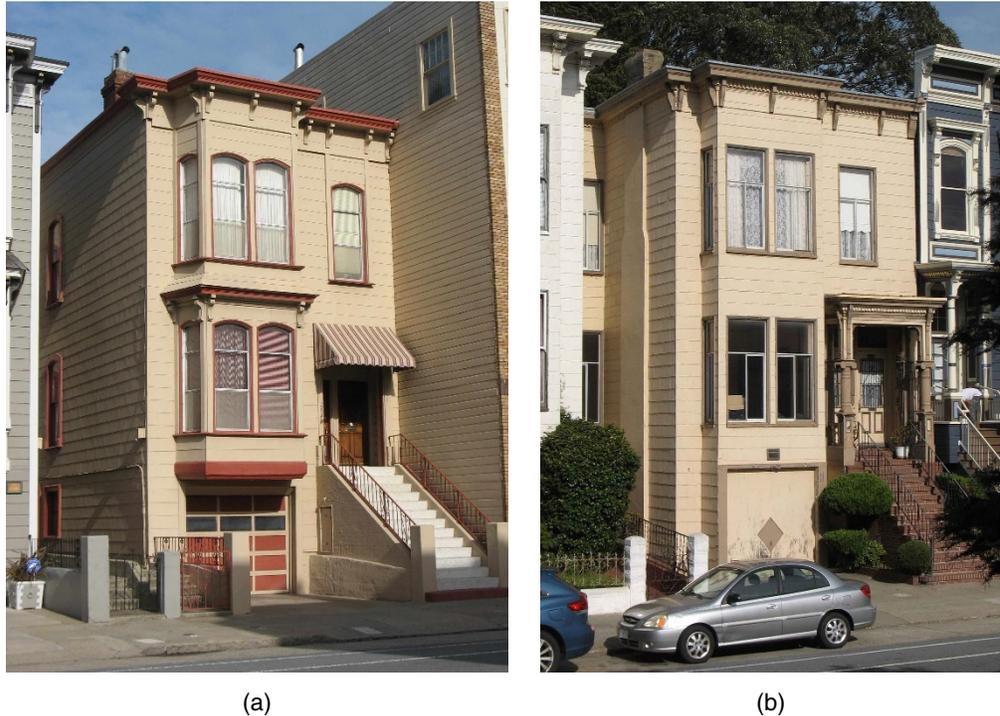
Figure 2-6 Victorian rowhouses with perimeter masonry chimneys: (a) restrained within the exterior wall sheathing; (b) unrestrained.

Figure 2-6 shows two nearly identical buildings, each with a typical perimeter chimney serving the front parlor, one restrained by the exterior wall sheathing (Figure 2-6a), and one that breaks the wall line and is restrained only by the cornice at the roof level (Figure 2-6b). In concept, a chimney entirely enclosed, or restrained, by the wall sheathing will be less of a falling hazard; even if damaged, the cracked or falling bricks are kept in place. A cornice or fascia board alone, as shown in Figure 2-6b, might be thought to provide partial restraint, and perhaps some resistance to total collapse, but such a detail is not sufficient to prevent severe or total damage. In any case, any

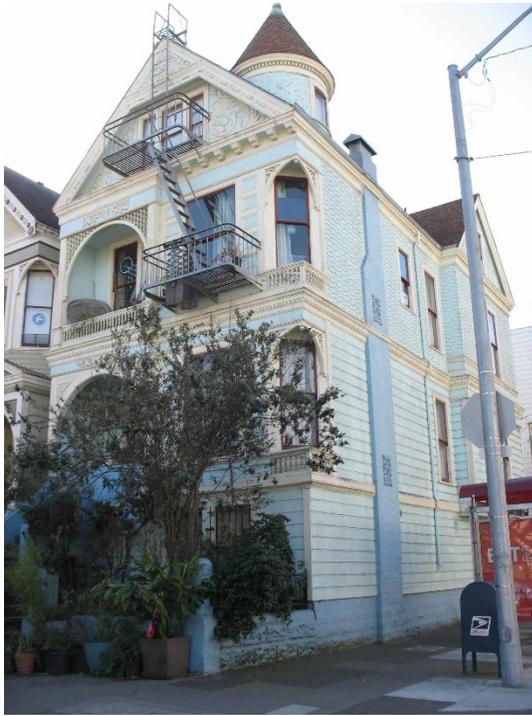
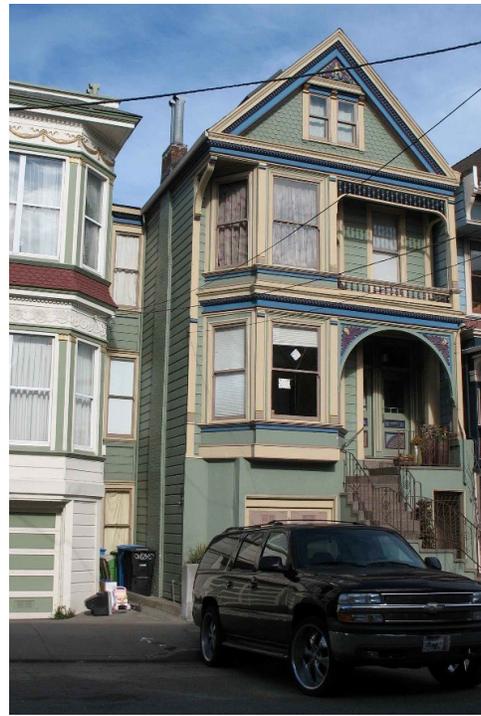
Figure 2-7 Victorian buildings with unrestrained perimeter masonry chimneys: (a) chimney posing a public risk; (b) chimney posing a private risk.

Figure 2-7 illustrates a potential difference in risk posed by similar chimneys, one adjacent to a public street or sidewalk (Figure 2-7a) and one adjacent to a courtyard or private access between buildings (Figure 2-7b). A “public” risk is most often presented by a building on a corner lot, but Figure 2-5a shows that midblock buildings can also be adjacent to public or regularly occupied spaces. (In the case of Figure 2-6a, a gas station is located on the corner lot.)

Even a “private” risk, such as that illustrated in Figure 2-7b, is not entirely that of one building owner. A falling hazard between two buildings affects also the property of the neighboring building and the safety of tenants in both buildings. Still, this is reasonably considered a different level of risk than that posed by a chimney directly adjacent to a street or sidewalk.

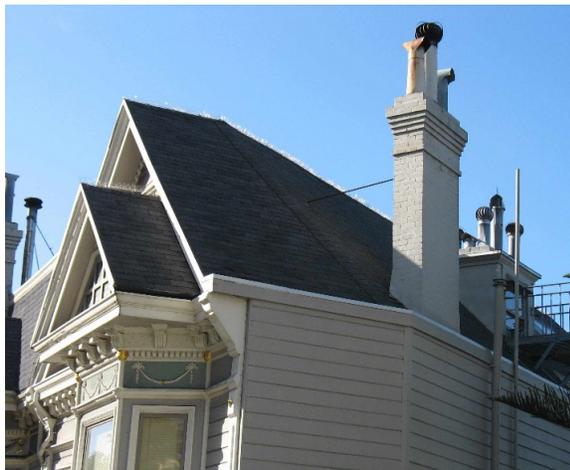
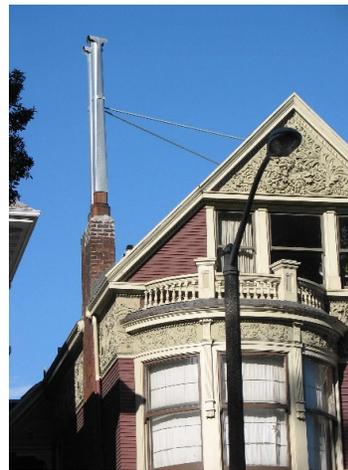
Figure 2-8 Victorian buildings with original and retrofitted perimeter masonry chimneys showing: (a) original rod bracing; (b) lowered and replaced with lightweight flue.

Though it is not considered good practice among chimney experts to change flue types mid-height, after the 1989 Loma Prieta earthquake, many Victorian chimneys were removed or braced, or had their top sections lowered and replaced by lightweight flues (McKee, 2015). Figure 2-8 shows examples of an original full height chimney and a lowered chimney.

Also, nominal rod bracing of the masonry stack, as shown in Figure 2-8a, was sometimes provided even with the original construction (Lawson et al., 1908,

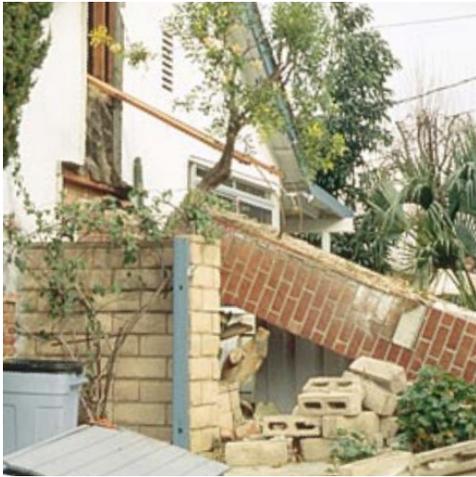
Note failure/pullout of ties to ceiling framing. (Source: City of San Leandro)

Masonry chimney damage below the roof line, modeled with "freestanding" models: (a) toppling; (b) and (c) crumbling or disintegration of unreinforced or ineffectively reinforced masonry; and (d) sliding or cracking.

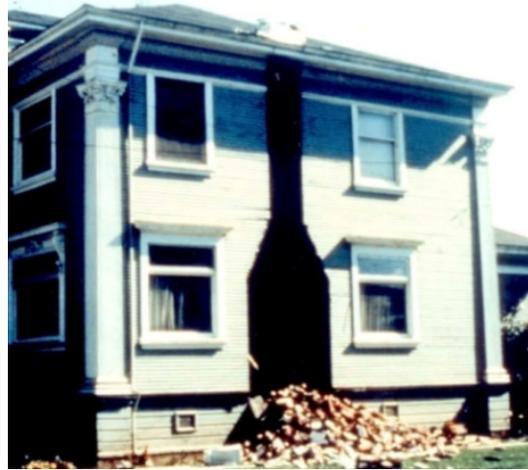
(b)

Crumbling of multi-story chimney. Note ineffectiveness of roofline "restraint." (Source: EERI)

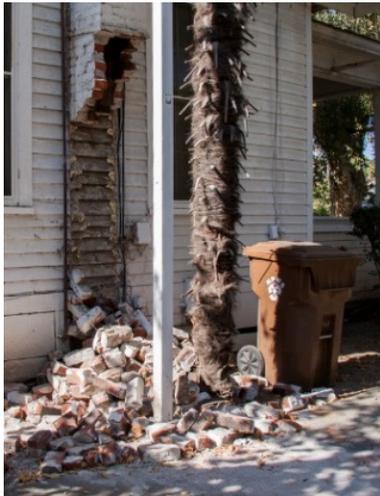
(c)

Similar to San Francisco boiler type. Note strap anchor just above crumbled lower section. (Source: FEMA)

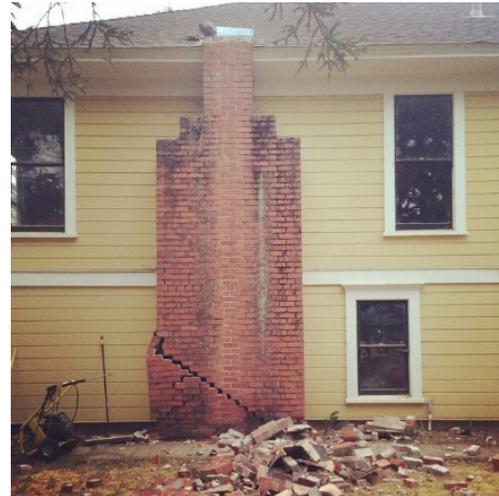
(d)

Sliding/cracking damage at firebox (plus rooftop toppling). Napa, 2014. (Source: californiawinefan.com)

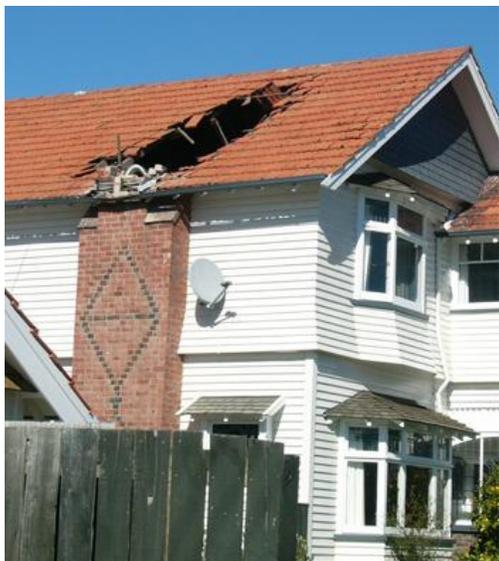
(a)

Toppling through roof framing. Christchurch, 2011.
(Source: stuff.co.nz)

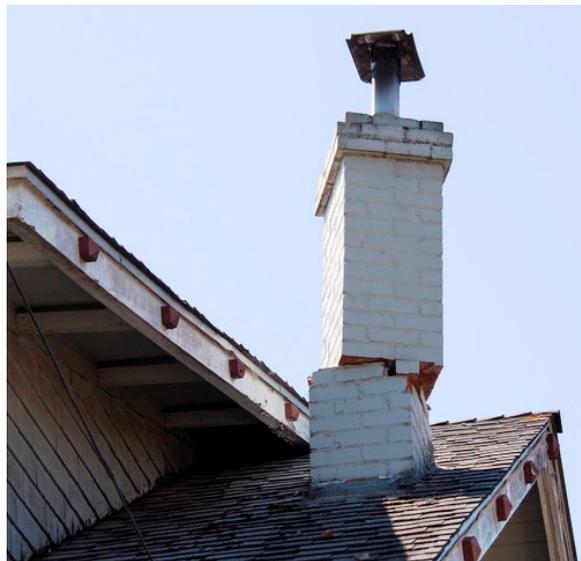
(b)

Sliding/cracking at roofline, leaving potential falling hazard.
Napa, 2014. (Source: Ellis Maynard)

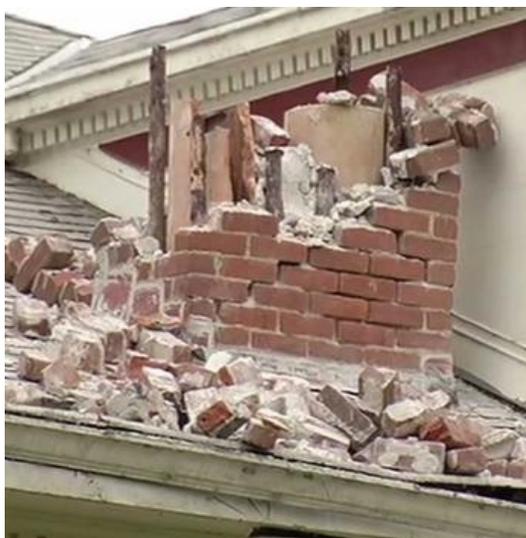
(c)

Rooftop crumbling leaves falling hazard. Napa, 2014.
(Source: ABC7news.com)

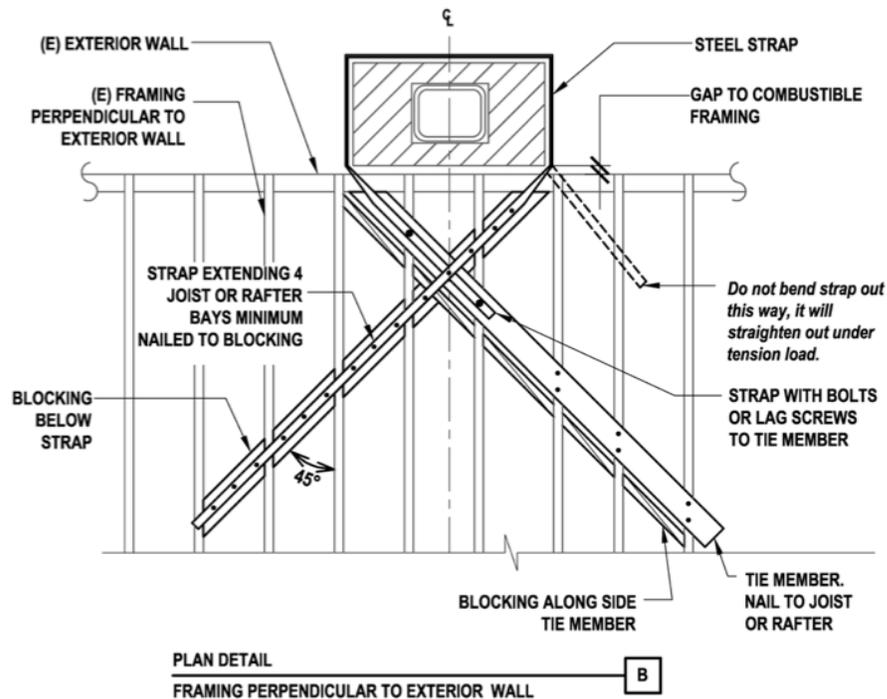
Figure 4-1 Anchorage of an exterior masonry chimney from FEMA 547 Figure 5.4.6-2B (FEMA, 2006).

The first question is whether to leave any masonry in place once the decision to retrofit has been made. Some of the prescriptive repair provisions require thorough anchorage of the remaining masonry to the building’s wood framing at floor and roof levels (Los Angeles, 2014; Seattle, 2004; Burbank, 2008). However, FEMA 547, *Techniques for the Seismic Rehabilitation of Existing Buildings*, (FEMA, 2006) adds a caution about how to angle the steel anchor straps to ensure a rigid anchorage, as shown in Figure 4-1.
