North Entrance at Union Square

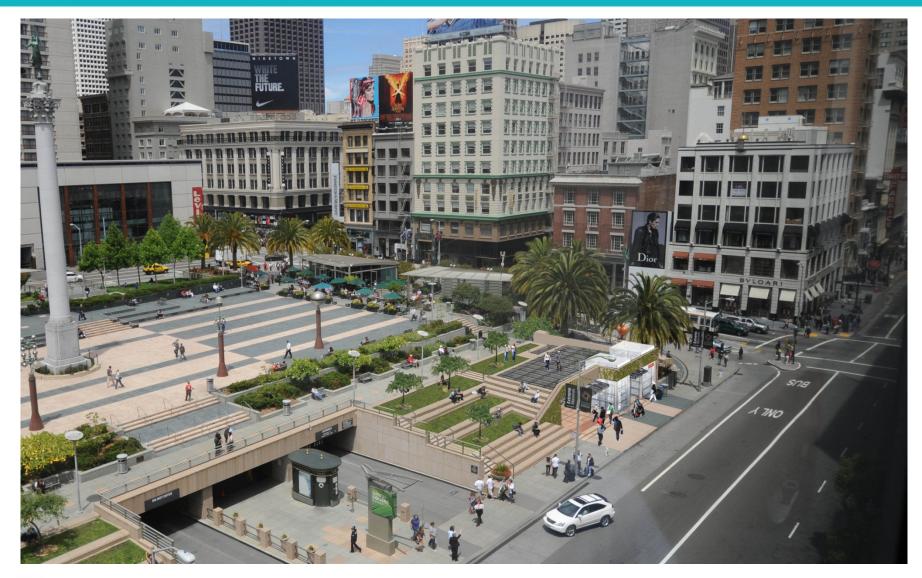
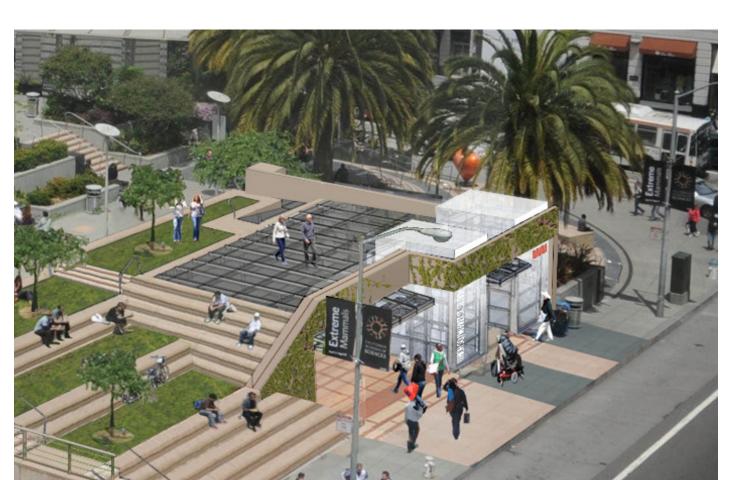
North Entrance at Union Square

- o Entrance fully integrated with existing plaza
- Articulated façade is sculptural and relates to existing stepped planters
- o Fascia above elevator glazing with vines
- Set-back fascia over entry creates a buffer from sidewalk
- Integration of façade with terraces invites circulation between levels
- Fully glazed elevators promote security and safety
- SFMTA service map on elevator glazing as public information and tie-in with Market Street elevator.

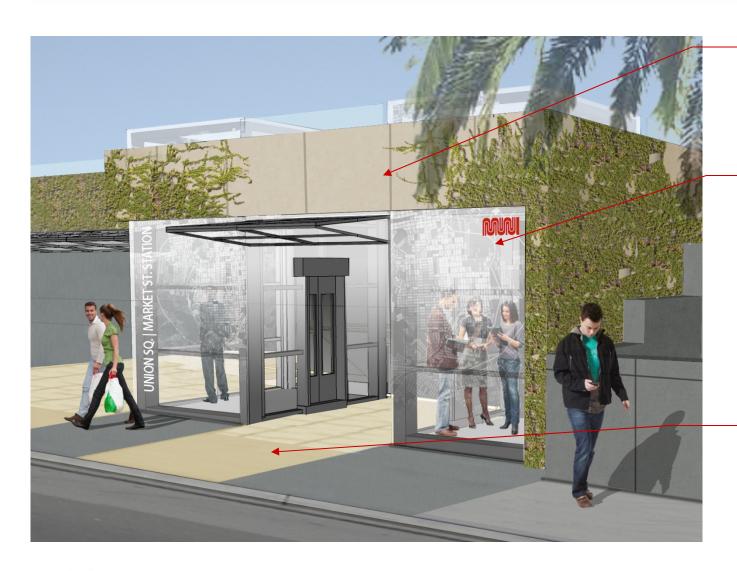
North Entrance at Union Square

"Sombrero Buff" colored precast concrete panel fascia with vine planting

Station graphics & SFMTA service map applied to elevator glazing

Colored concrete walk: "Sombrero Buff" and "Shadow Slate"
