5/17/2021

TREASURE ISLAND BUS OPERATOR RESTROOM

**BUS
OPERATOR
RESTROOM**

**TREASURE ISLAND
STAGE 2-3**
Job No: 18-05
Sheet:
A2.1

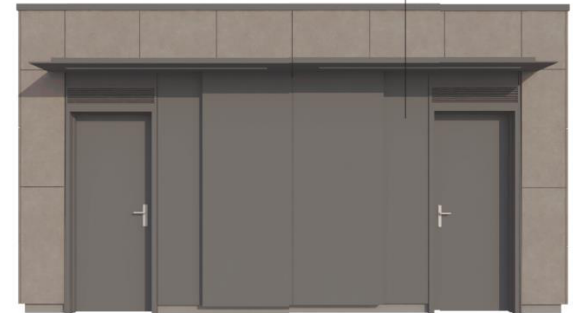
Bus Operator Restroom
Front facade

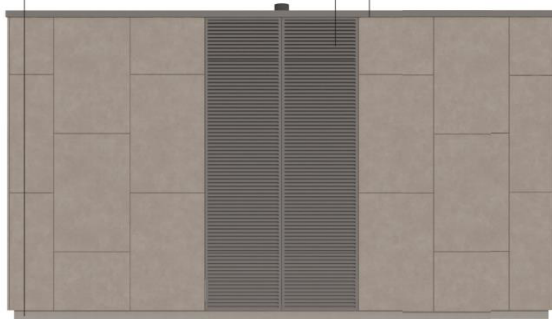
Concrete Curb
2 lbs/CY Lamp Black Added

Metal Louvers & Parapet Cap
Pearl Light Grey - RAL 9022

Porcelain Wall Tile
Porcelanosa - Baltimore Natural

Painted Metal Door
Pearl Light Grey - RAL 9022

Metal Composite Material Panel
Pearl Light Grey - RAL 9022

Bus Operator Restroom
Rear facade

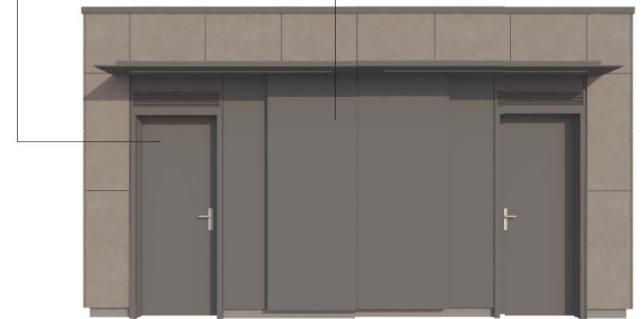
Bus Operator Restroom
Front facade
