**WORKER RIGHTS CONSORTIUM ASSESSMENT
ITIC APPAREL (DOMINICAN REPUBLIC)
FINDINGS AND RECOMMENDATIONS**

February 8, 2012

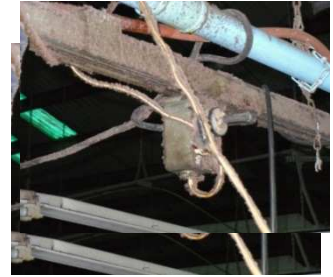
- Also in Building One, there is an overhead outlet box with open contacts that are exposed. Romex wiring was used inappropriately here. There is also an accumulation of combustible cloth fiber on an energized outlet.

- Review all electrical installations in Buildings One and Two and make repairs to the violations noted above and to any other electrical connections that do not meet Dominican legal standards.
- Develop and implement a lockout/tag-out system for the plant and train maintenance personnel on these procedures.
- Discontinue use of the elevator in Building One until such time as the manufacturer provides information about the safety of using the winch for this purpose. This information should be provided to the WRC once it has been obtained. If it is determined that the winch can safely operate the elevator, then the capacity rate for the winch-operated elevator should be visibly posted at the elevator.

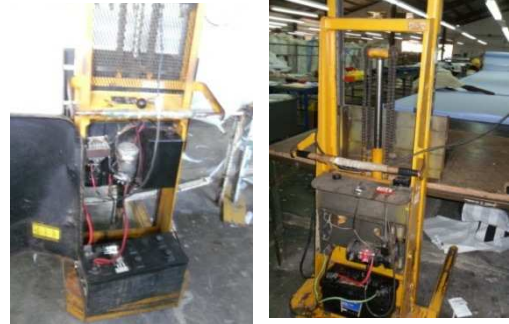
- In Building Two, the forklifts used for carrying cloth rolls have open, exposed and/or energized electrical equipment. There are oversized battery blocks on the hinged panel door of one forklift and on the other forklift the panel has been removed altogether.

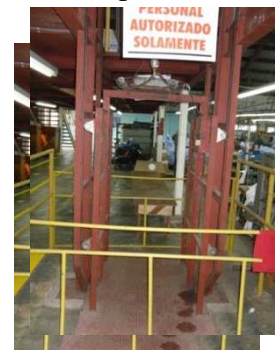
- In Building One, the elevator to the second floor storage area is operated by an electric-powered winch that has been fastened to overhead beams. Neither the elevator nor the winch includes information about their designed rated capacities. Additionally, the manufacturer of the winch should verify whether or not the winch can safely be used in this manner.
