## MEMORANDUM

### **COIT TOWER WATER INCIDENT**

Re: SFAC Coit Tower Monitoring CS20080

This memo serves as a report for mural inspection and moisture monitoring performed at Coit Tower from September 29<sup>th</sup> to October 15<sup>th</sup>, 2020. ARG/CS was contacted by the San Francisco Arts Commission to monitor the tower frescoes after a water leak was reported on *[date]*. The cause of the failure was related to the water storage tanks housed on the fifth floor of the building. These tanks were inspected by divers who could not determine a source of the leak from the interior of the tank. The exact cause and location of the leak remains unknown.

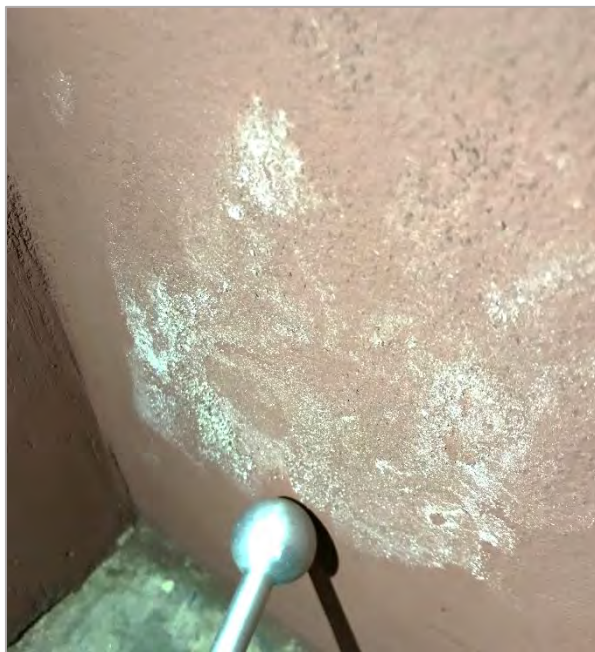
Figure 8: Detail of efflorescence on the same area.

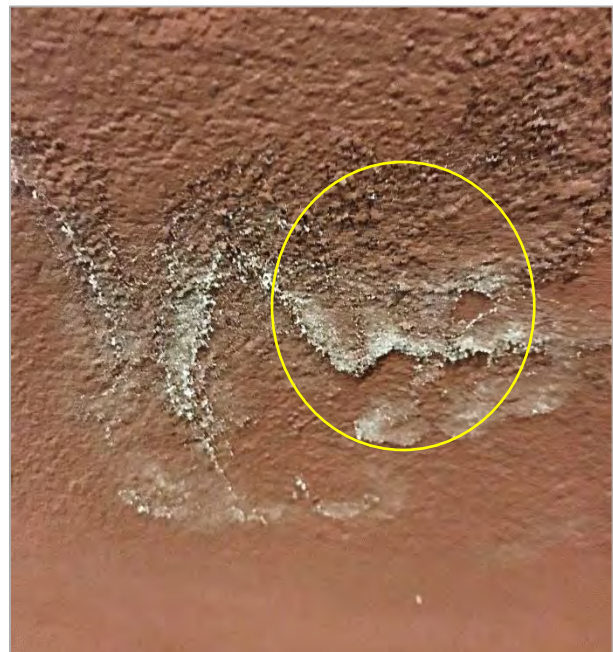
Figure 9: Detail of efflorescence on the same area. Yellow circle shows detail of the stucco paint being pulled away by efflorescence.

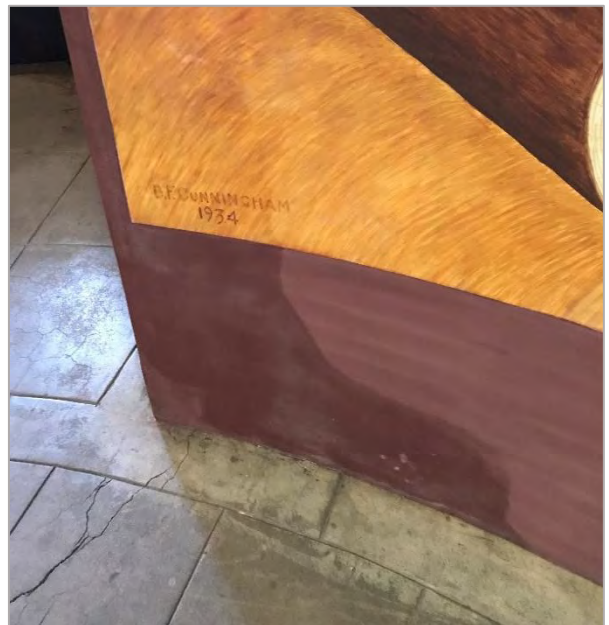
Figure 13: Detail of efflorescence on the *Outdoor Life* mural. Light accretions were emerging on the wall.

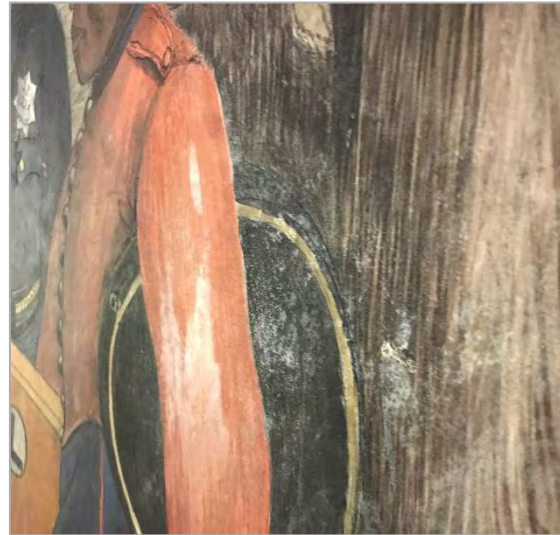
Figure 33: Detail of glossy film and white stains (possible efflorescence) on the *Powell Street* mural.

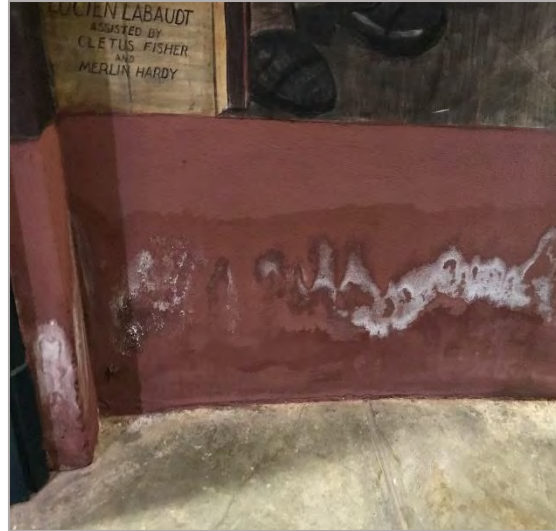
Figure 47: Detail of growing efflorescence at the bottom of the stairs on the stucco frame surrounding the *Powell Street* mural.

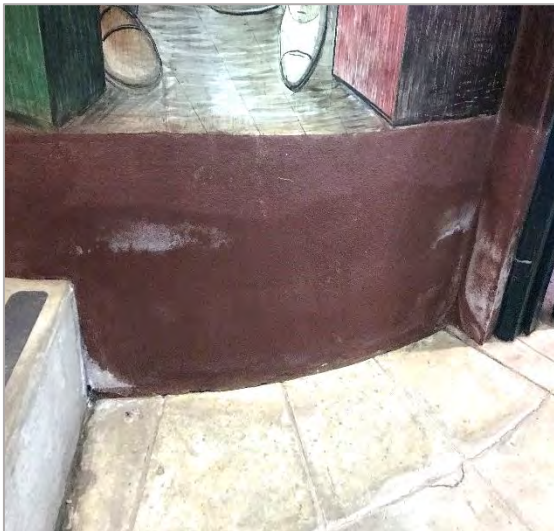
Figure 48: Detail of new efflorescence at the bottom of the stairs adjacent to the first-floor elevator door.

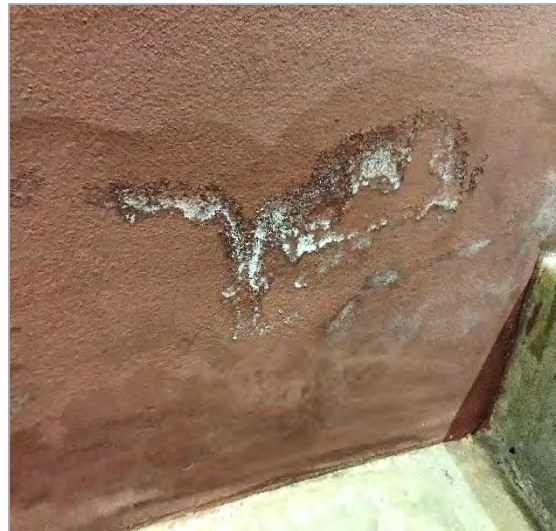
Figure 49: Detail of observed efflorescence and other damages on the *Powell Street* mural stucco frame.

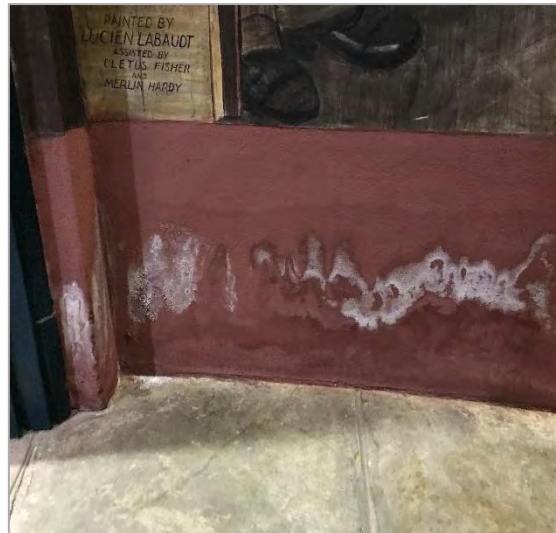
Figure 61: Detail of growing efflorescence at the bottom of the stairs on the stucco frame surrounding the *Powell Street* mural.

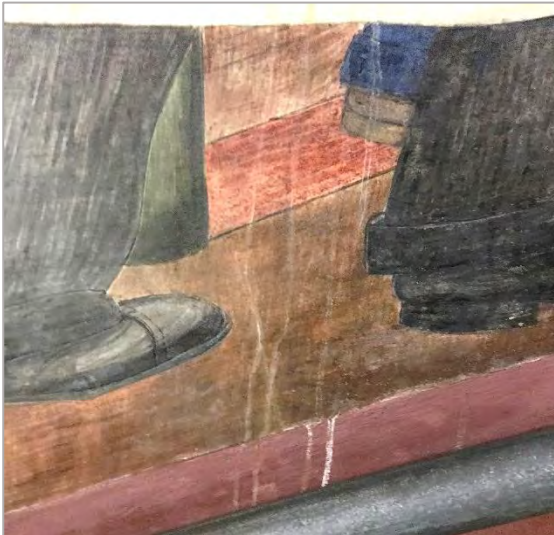
Figure 62: Detail of water stains on the central lower part of the *Powell Street* mural.
